# Seawall Condition and Resiliency Assessment Town of Bay Harbor Islands

October 2019 (Updated)

**Cummins Cederberg, Inc.**

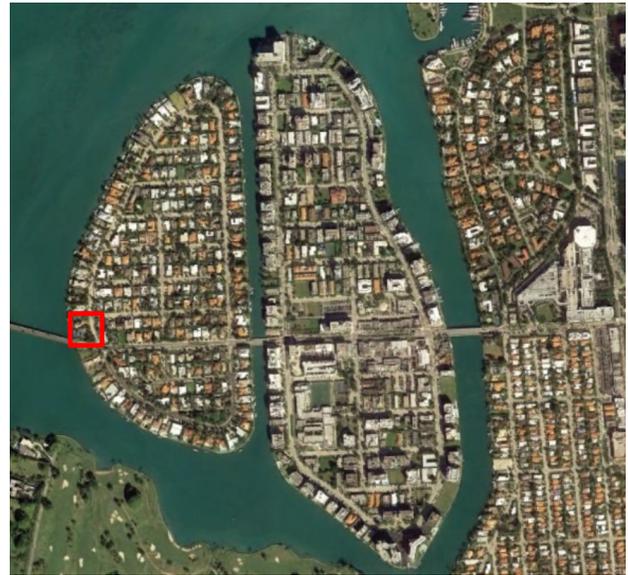
- Cap - Moderate cracking at wet face and soffit of cap
- T-Piles - Moderate necking at tidal zone
- Wall Panels – Moderate concrete erosion at tidal zone

• Seawall Rating: Fair      • Dock Rating: N/A

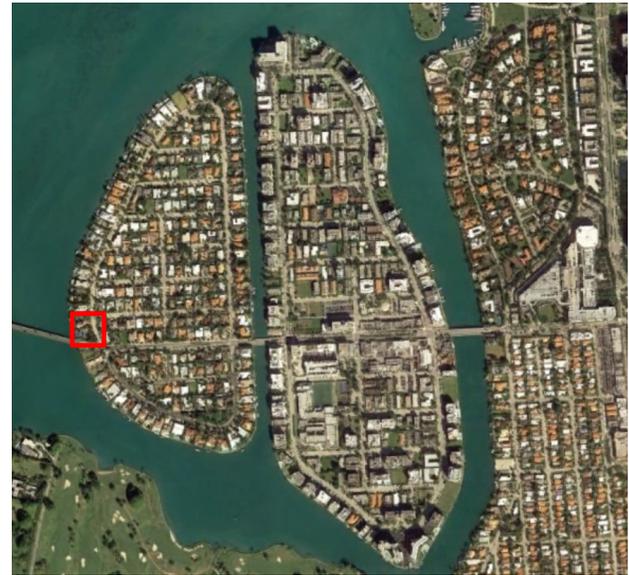
- Cap - Moderate cracking with exposed corrosion staining at wet face
- Cap – Spalling with exposed steel reinforcement at pile/cap
- T-Pile – Moderate concrete erosion at splash zone
- Dock – Moderate corrosion at fasteners and straps

• Seawall Rating: Fair    • Dock Rating: Fair

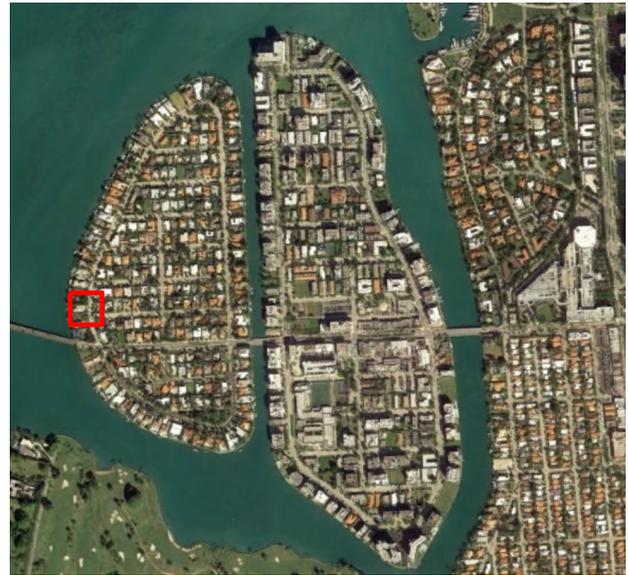
- Cap - Minor cracking at wet face
- Wall Panels - Moderate concrete erosion cracking at tidal zone
- T-Piles – Moderate necking at tidal zone
- Batter Piles – Minor cracking and spalling
- Dock – Severe corrosion at straps

• Seawall Rating: Fair    • Dock Rating: Fair

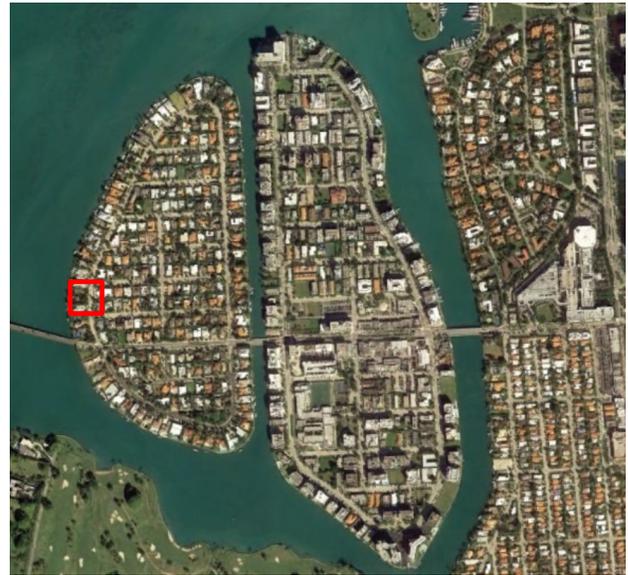
- Cap - Minor cracking along the wet face
- Mild erosion and necking at piles and concrete wall panels
- Dock – Corrosion at fasteners

• Seawall Rating: Satisfactory      • Dock Rating: Satisfactory

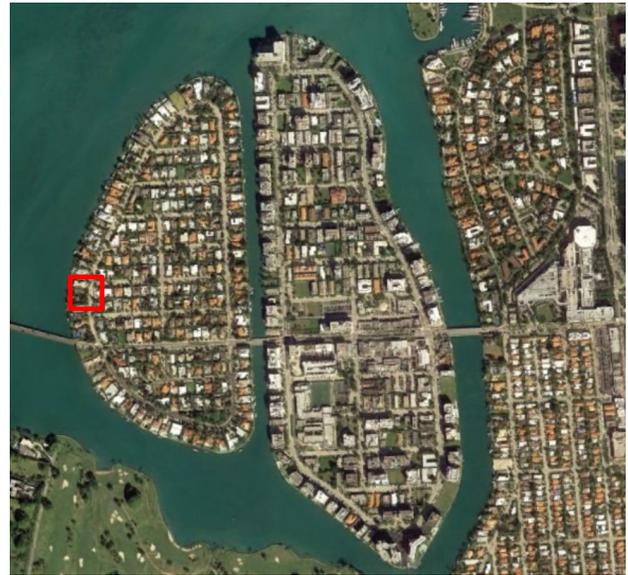
- Cap – Moderate horizontal cracking along top face
- Wall Panels – Concrete overpour on existing seawall cap
- Dock – Satisfactory Condition

• Seawall Rating: Satisfactory      • Dock Rating: Satisfactory

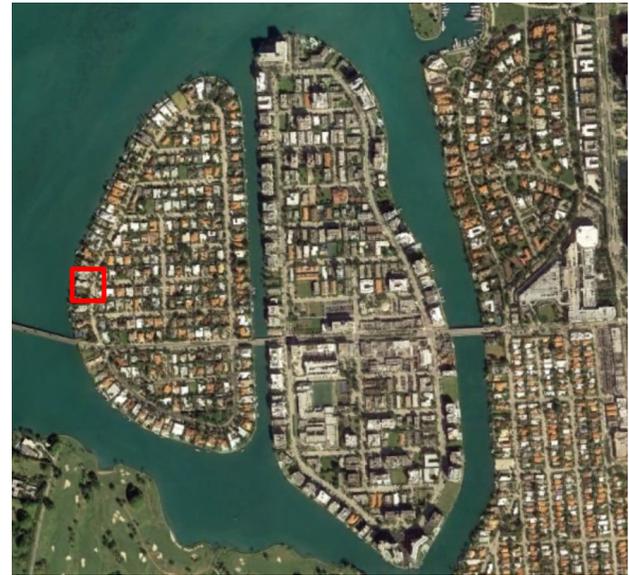
- Wall Panels – Moderate concrete erosion at tidal zone
- T-Piles - Moderate cracking and necking at tidal zone
- Batter Piles – Moderate cracking
- Dock – Severe corrosion at fasteners
- Dock – Unsecured connections at beam bearing ends and unsecured/missing decking

• Seawall Rating: Fair      • Dock Rating: Critical

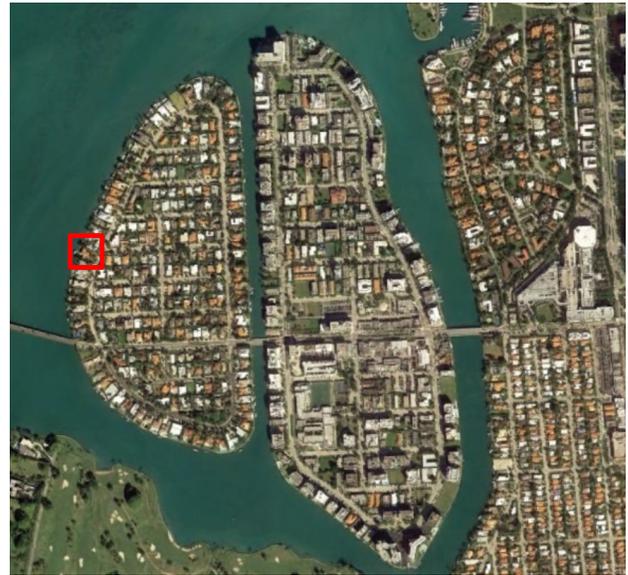
- Wall Panels – Cracking adjacent to outfall
- Wall Panels – Moderate concrete erosion at splash zone
- Cap – Moderate longitudinal cracking
- T-Piles – Moderate concrete erosion and cracking
- Batter Piles – Minor to moderate cracking
- Dock – Corrosion at fasteners/straps, wood splitting

- Seawall Rating: Fair
- Dock Rating: (North) Satisfactory  
(South) Fair

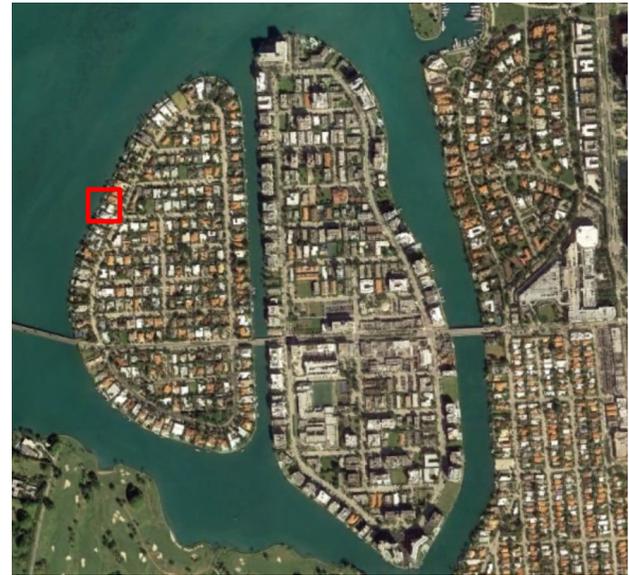
- Cap – Minor spalling and cracking at soffit
- T-Piles – Pile/panel separation with sediment accumulation
- Batter Piles – Impact cracking at pile heads
- Dock – Moderate corrosion at fasteners/straps

• Seawall Rating: Fair      • Dock Rating: Fair

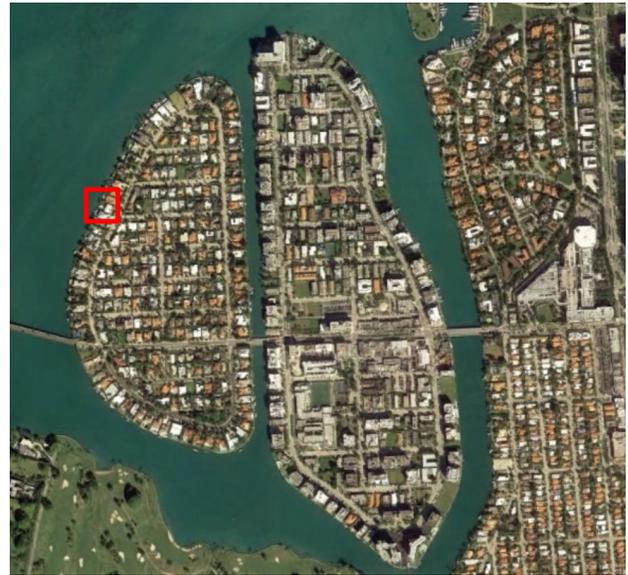
- Wall Panels – Moderate cracking at tidal zone
- Cap – Moderate cracking with corrosion staining
- T-Piles – Pile/panel separation with sediment accumulation
- Batter Piles – Severe cracking and spalling below cap
- Dock – Joists toe nailed to beams, capacity should be verified with enhanced oil recovery

• Seawall Rating: Poor

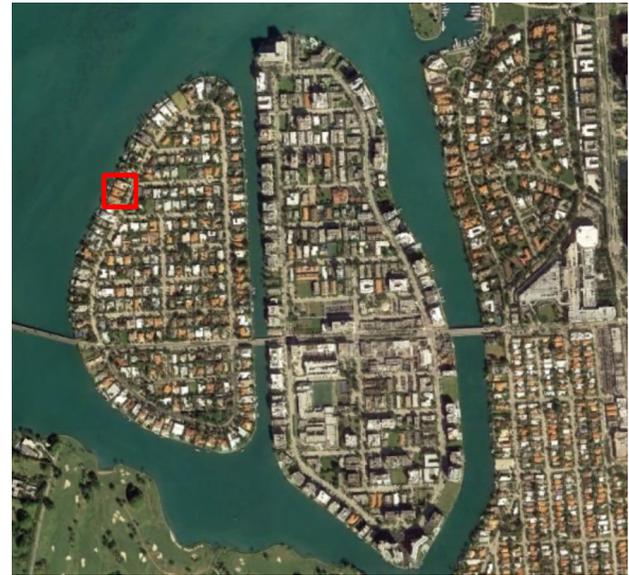
- Wall Panels – Moderate concrete erosion and spalling
- Cap – Minor to moderate cracking
- T-Piles – Moderate concrete erosion and necking
- Dock – Minor to moderate cracking at joists/beams

• Seawall Rating: Fair      • Dock Rating: Fair

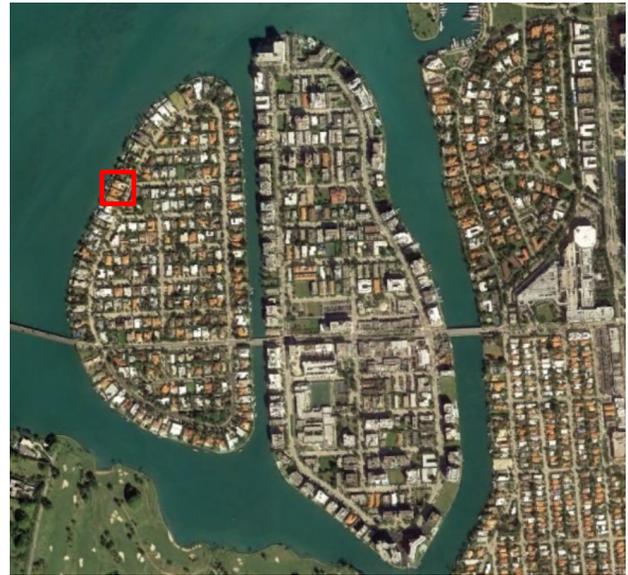
- Cap – Minor to moderate cracking with corrosion staining
- T-Piles – Moderate concrete erosion and necking
- Batter Piles – Cracking at pile heads
- Docks – Moderate to severe corrosion at fasteners/straps

• Seawall Rating: Fair      • Dock Rating: Fair

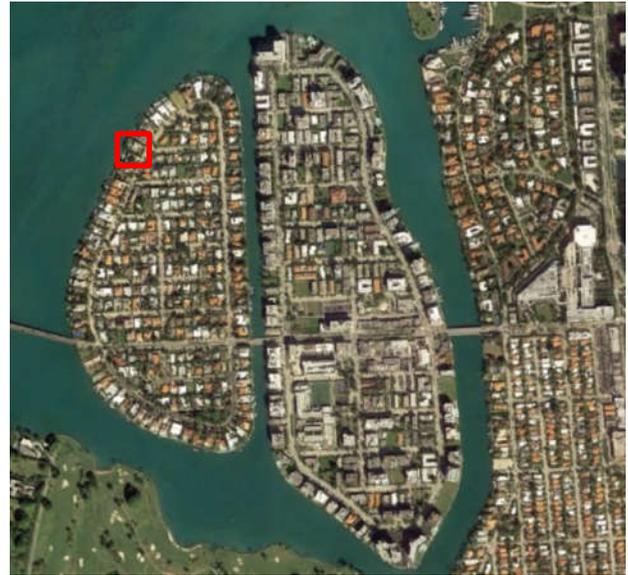
- Cap – Cracking with corrosion staining at soffit and wet face
- T Piles – Moderate cracking and Minor concrete erosion
- T Piles – Moderate concrete erosion and separation from wall panels
- Dock – Corrosion at beam and pile bolts
- Dock – Moderate deterioration of piles

• Seawall Rating: Fair      • Dock Rating: Fair

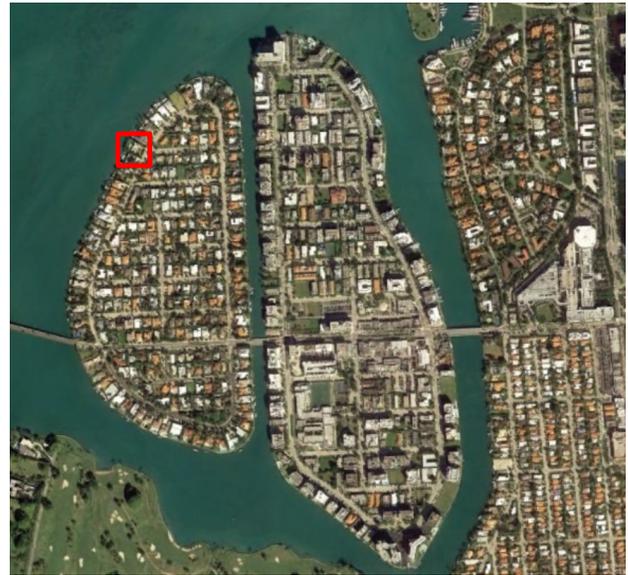
- Cap – Moderate cracking along the wet face
- Wall Panels – Moderate concrete erosion and cracking at tidal zone
- Piles – Moderate necking and concrete erosion
- Dock – Deck demolished

• Seawall Rating: Poor      • Dock Rating: N/A

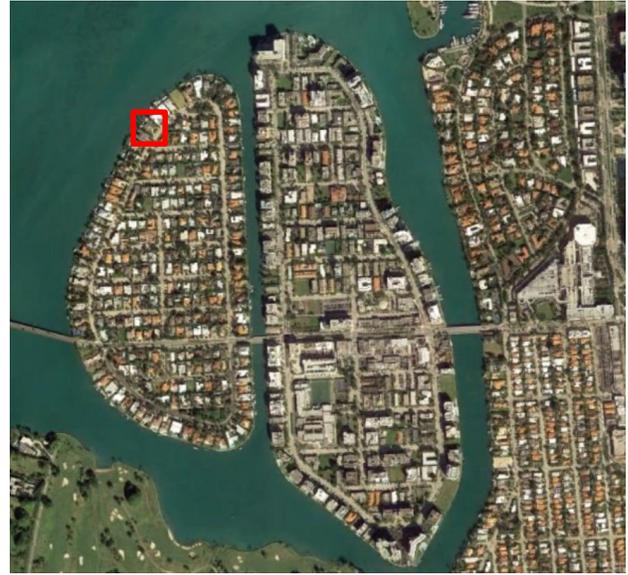
- Wall Panels - Severe spalling at top of North panels
- King Piles – Severe spalling and deterioration with exposed steel reinforcement
- T-Piles - Moderate erosion with severe cracking and an exposed bar. Deterioration at top
- Seawall experiences heavy wake

• Seawall Rating: Poor

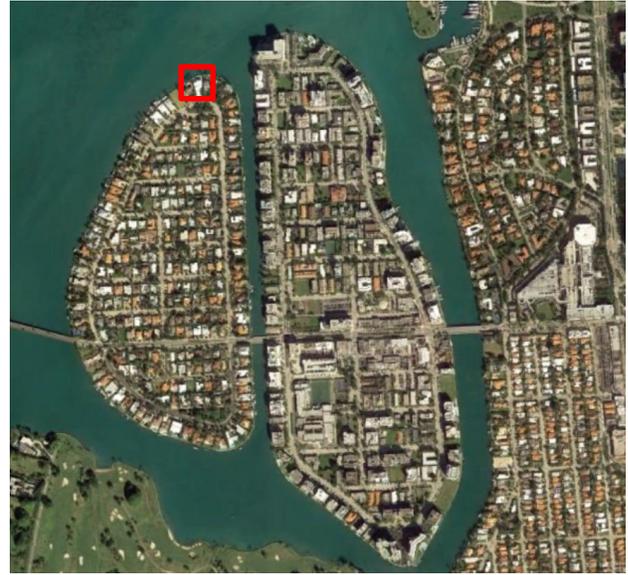
- Wall Panels – Rotation of the wall along bottom panels
- Cap – Moderate cracking at wet face and soffit
- T-Piles – Pile/panel separation
- Toe Wall – Separation from wall panels, partial collapse

• Seawall Rating: Fair      • Dock Rating: Satisfactory

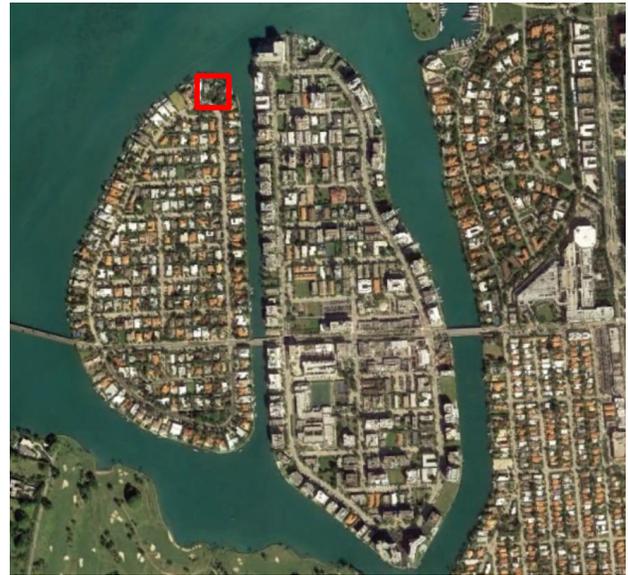
- Wall Panels – Minor concrete erosion at tidal zone
- King Piles – Moderate cracking at pile heads
- T-Piles- Moderate cracking and necking at tidal zone
- Dock – Corrosion at fasteners
- Dock Piles – Moderate “salt-kill”

• Seawall Rating: Fair    • Dock Rating: Fair

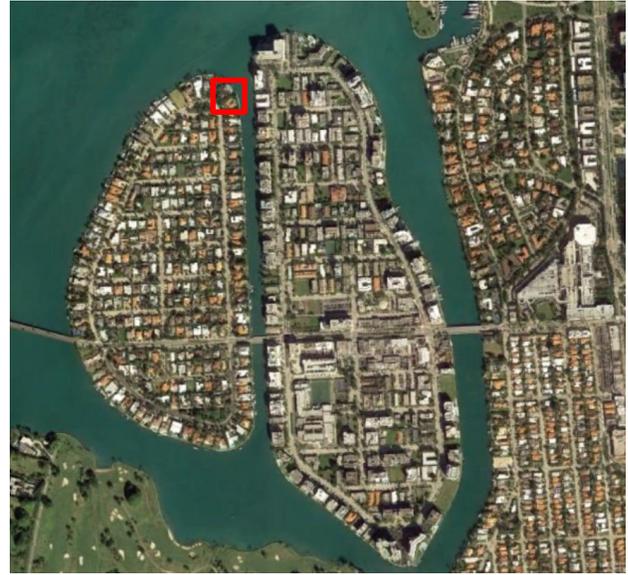
- Wall Panels – Rotation of the wall with moderate to severe cracking
- Cap – Severe cracking and concrete erosion at wet face and soffit at bump-outs
- T-Piles – Pile/panel separation through unsealed fillets
- T-Piles – Corrosion at pile anchor heads
- T-Piles – Deterioration at pile heads

• Seawall Rating: Fair                      • Dock Rating: N/A

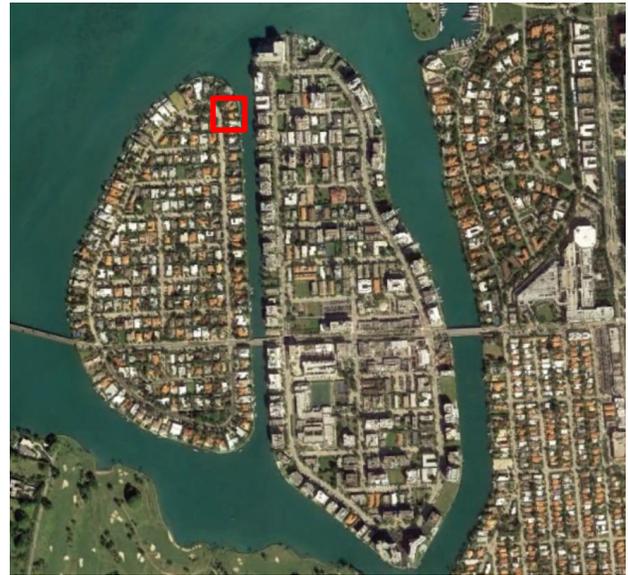
- Cap – Moderate cracking with corrosion staining at soffit
- Cap – Poured new cap topping original cap
- Wall Panels – Minor to moderate concrete erosion at tidal zone
- Dock – Minimal size at threaded rod fasteners

• Seawall Rating: Fair    • Dock Rating: Satisfactory

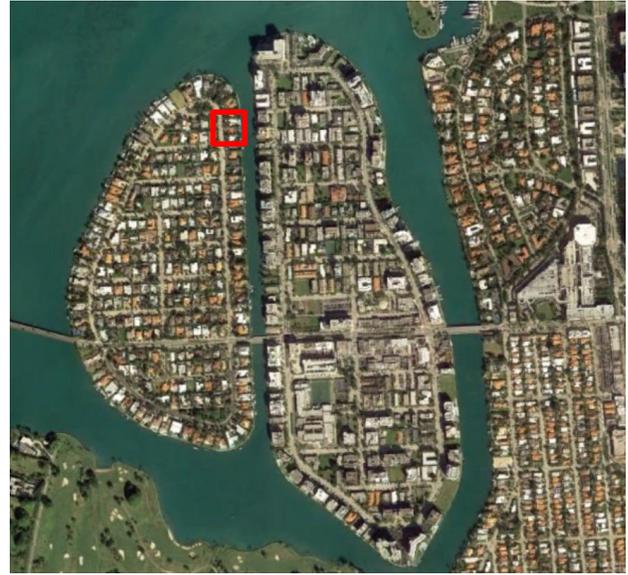
- \*Cap – Moderate cracking at soffit with corrosion staining
- \*Wall Panels – Moderate cracking
- \*T-Piles – Moderate necking and cracking at tidal zone
- \*Dock – Moderate to severe corrosion at fasteners
- \*Dock – Timber pile bearing on rock with no embedment
- \*Dock – Rotation at Northern pile

• Seawall Rating: Fair      • Dock Rating: Critical

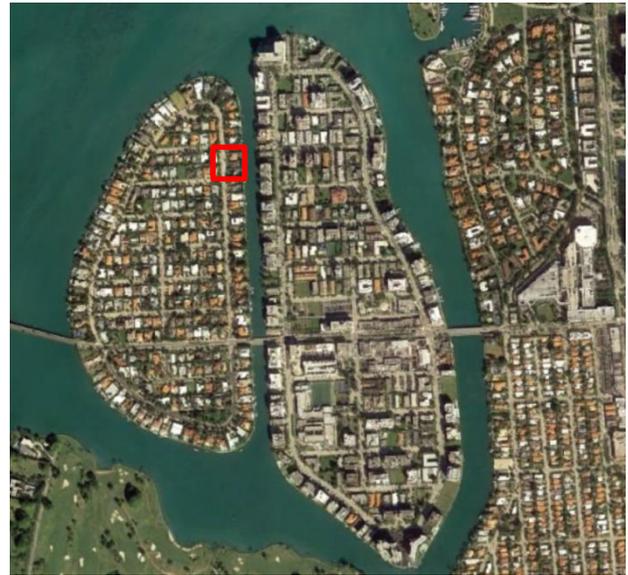
- Cap – Minor cracking of the wet face and soffit
- Cap – Moderate spalling and honeycombing
- King Pile – Anchor head corrosion
- Dock – Mooring piles deteriorating
- Dock – Fastener corrosion

• Seawall Rating: Fair                      • Dock Rating: Fair

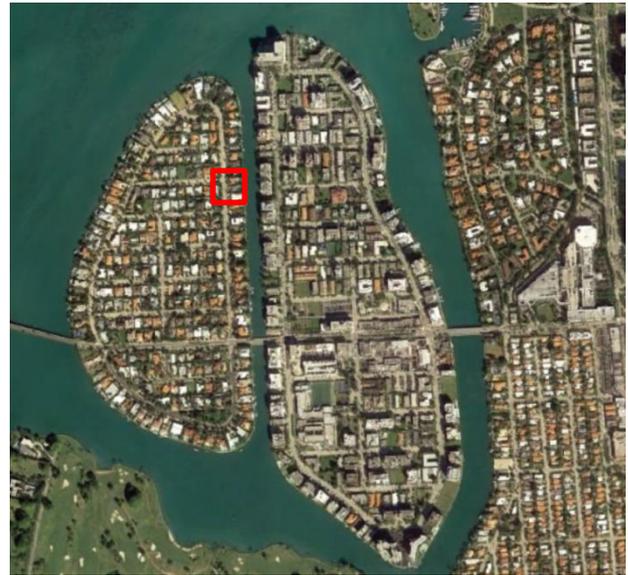
- Cap – Minor cracking with corrosion staining at wet face
- T-Piles – Exposed anchor heads with moderate corrosion
- Wall Panels – Moderate concrete erosion at tidal zone with moderate rotation
- Dock – Moderate corrosion at fasteners and straps
- Dock – Piles exhibit salt kill

• Seawall Rating: Fair      • Dock Rating: Fair

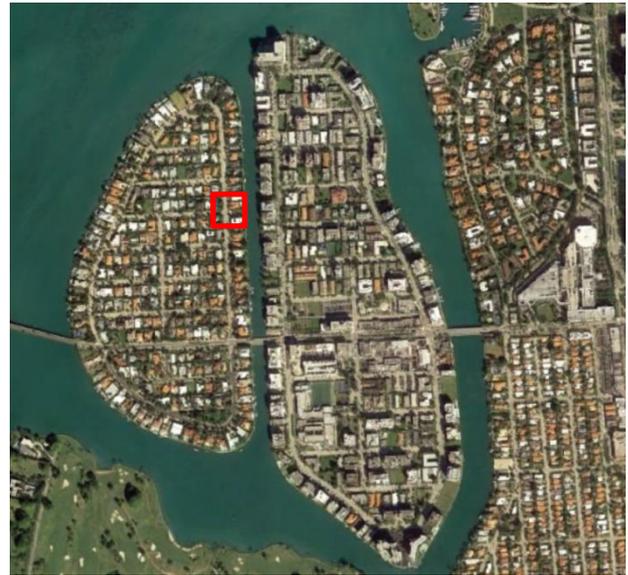
- Cap – Moderate cracking at wet face and soffit
- Wall Panels – Moderate to severe cracking along panels
- Wall Panels – Moderate concrete erosion at tidal zone
- Batter Piles – Moderate cracking
- Dock – Stringers unsecured
- Dock – Wood rotting, corroded fasteners

• Seawall Rating: Fair      • Dock Rating: Poor

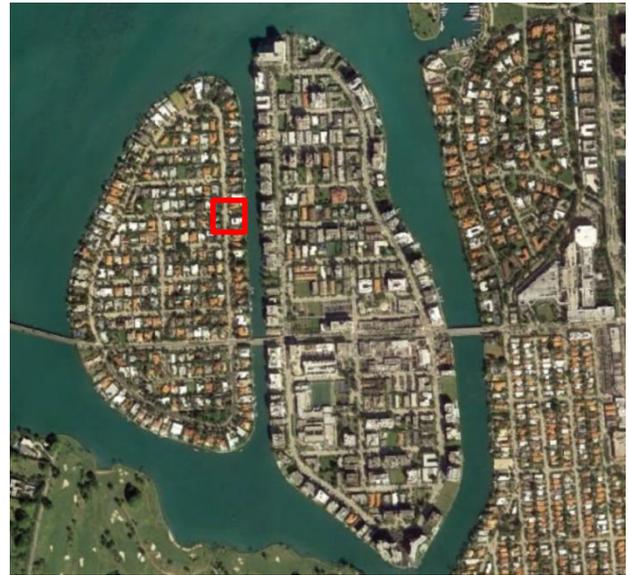
- Wall Panels – Minor spalling at outfall
- Wall Panels – Concrete erosion at tidal zone
- Wall Panels – Minor to moderate horizontal cracking
- Cap – Spalling
- T-Piles – Moderate vertical cracking and sediment loss through fillets, anchor head corrosion

• Seawall Rating: Fair      • Dock Rating: Satisfactory

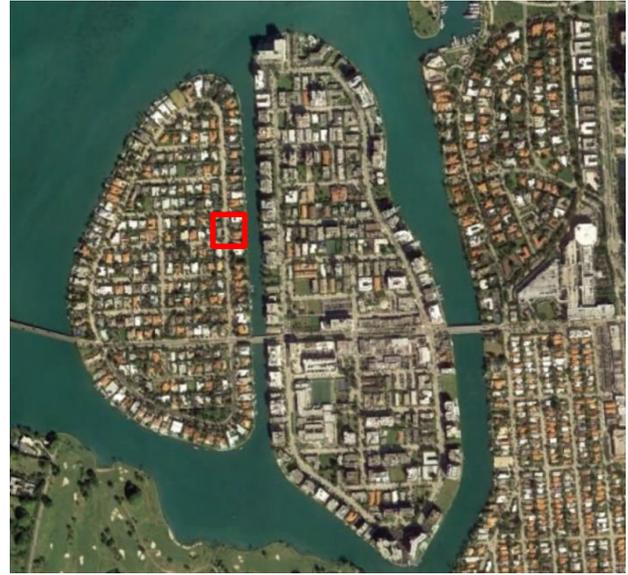
- Cap – Minor cracking at soffit
- Wall Panels – Minor spalling adjacent to outfall
- Wall Panels – Minor to moderate horizontal cracking
- T-Piles – Minor concrete erosion at splash zone
- T-Piles – corrosion of the anchors

• Seawall Rating: Fair      • Dock Rating: Satisfactory

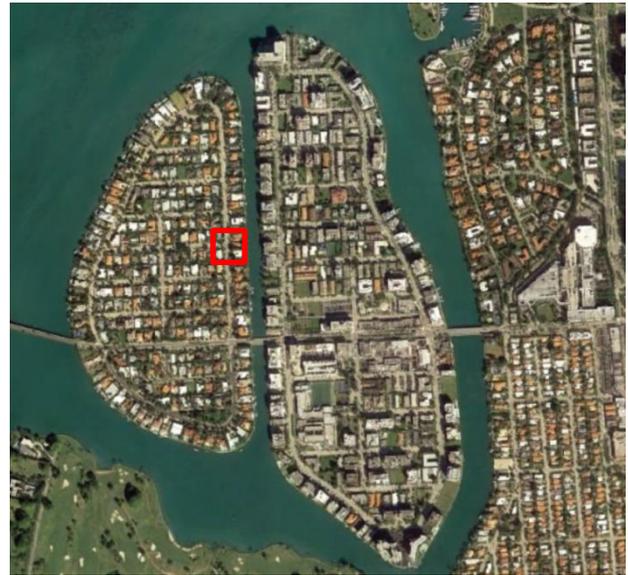
- \*Cap– Moderate cracking at the soffit
- \*Wall Panels – Moderate rotation of the wall
- \*T-Piles – Moderate corrosion at anchor heads
- \*T-Piles – Pile/panel separation with sediment loss at fillets
- \*Previous cracks repairs inadequate

• Seawall Rating: Fair                      • Dock Rating: N/A

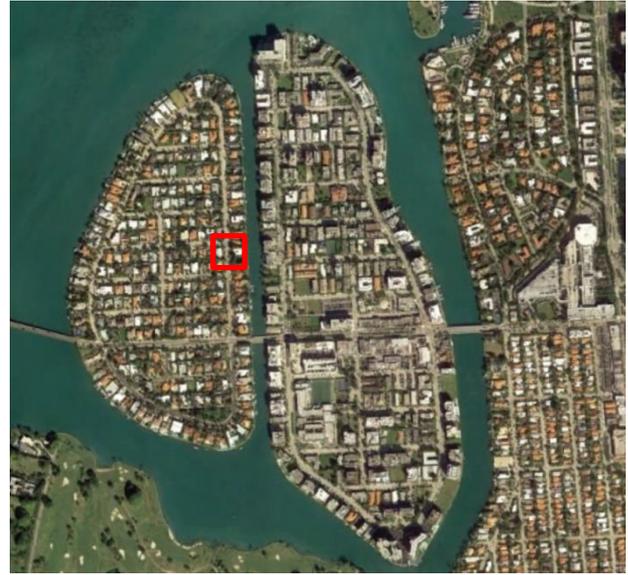
- T-Piles – Moderate corrosion at anchors
- T-Piles – Anchor corroded and pulled waterward
- Wall Panels – Rotation and chipping at splash zone
- Dock – Severe corrosion at fasteners
- Dock – Severe deterioration at timber piles above sleeves

• Seawall Rating: Poor      • Dock Rating: Critical

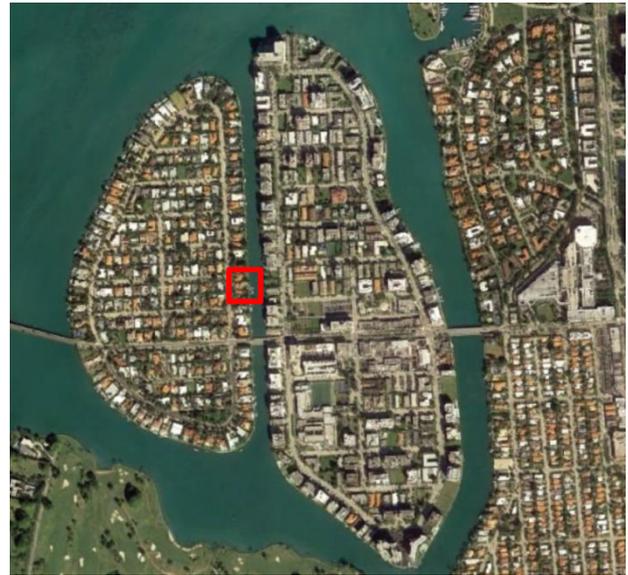
- \*Cap – Moderate cracking at the soffit
- \*Wall Panels – Soil loss through fillets
- \*Wall Panels – Moderate cracking along panels
- \*Wall Panels – Moderate rotation of wall
- \*Dock – Fastener corrosion
- \*Dock – Wood decay/splitting

• Seawall Rating: Fair      • Dock Rating: Fair

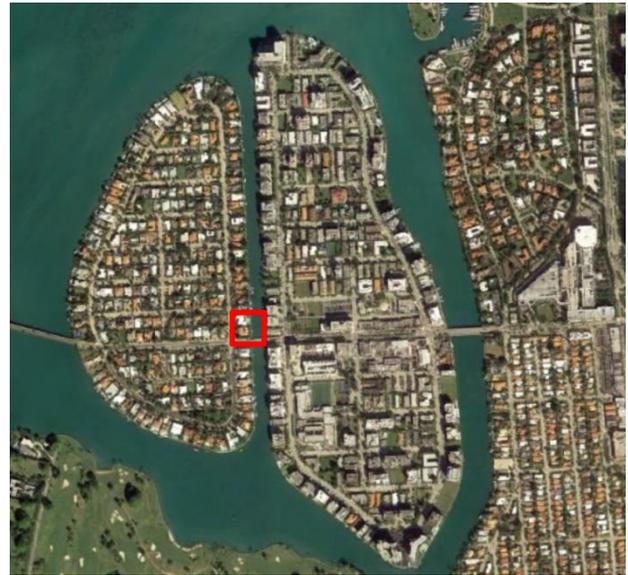
- Cap – Moderate cracking at wet face
- Cap – Poor vibration during concrete installation
- Wall Panels – Rotation of wall
- Wall Panels – Severe cracking throughout panels
- Wall Panels – Upland depressions at cracking locations
- T-Piles – Cracking at spot locations
- Dock – Fastener corrosion

• Seawall Rating: Serious

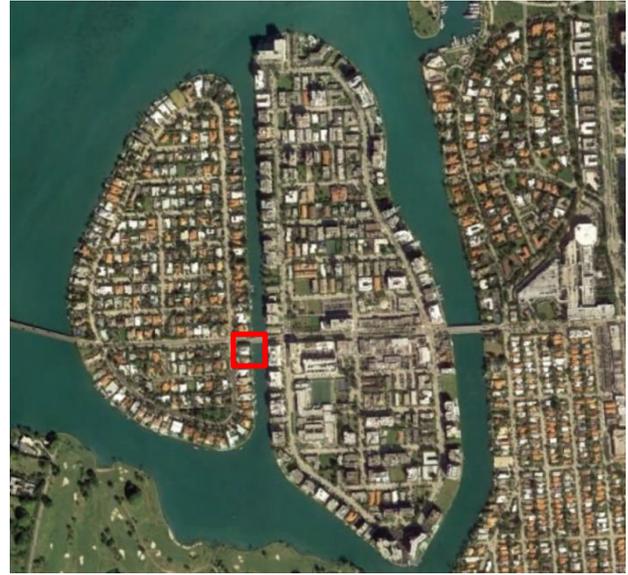
- \*Cap – Severe cracks at the wet face
- \*Cap – Retrofit caps at batter piles
- \*Wall Panels – Horizontal cracking along top panels
- \*Wall Panels – Cracking above North outfall
- \*T-Piles – Minor cracking at spot locations
- \*Dock – Moderate corrosion at ledger bolts, pile deterioration

• Seawall Rating: Fair      • Dock Rating: Fair

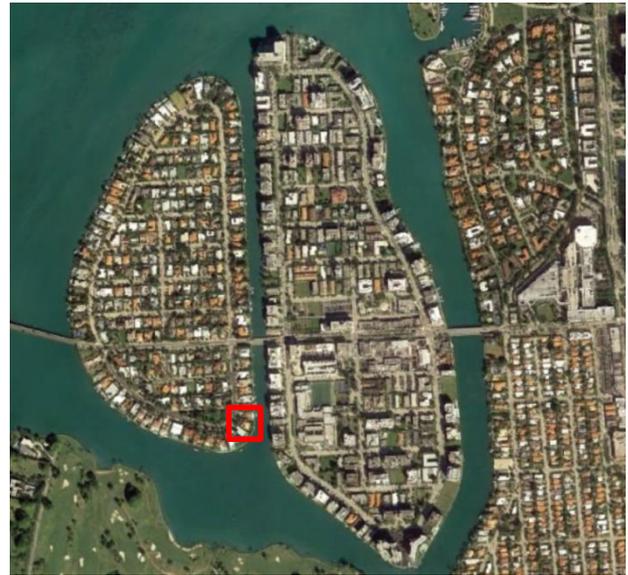
- Wall Panels – Moderate cracking with prior repairs
- T-Piles – Moderate deterioration at rounded corner
- T-Piles – Severe corrosion at anchor heads
- Dock – Splitting at bolt connections
- Dock – Bolts coated with anti-corrosion material
- Dock – Timber piles exhibit salt kill

• Seawall Rating: Poor

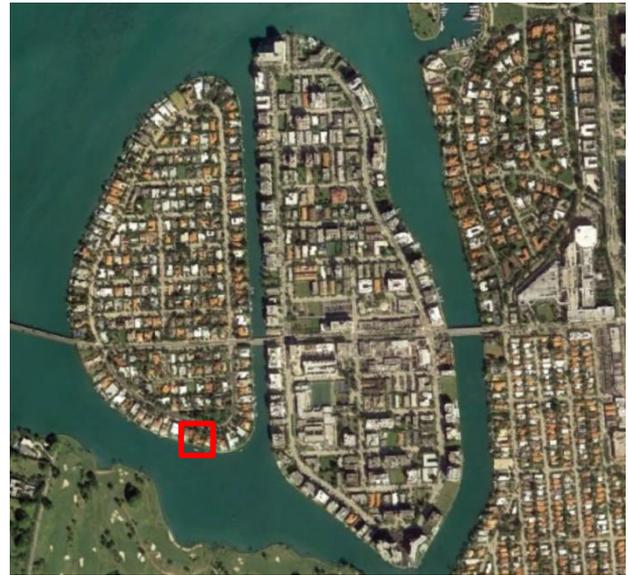
- Cap – Moderate cracking at the soffit and wet face
- T-Piles – Severe cracking
- King Piles– Severe cracking
- Batter Piles– Severe cracking and deterioration
- Dock– Minor corrosion at fasteners

• Seawall Rating: Poor      • Dock Rating: Satisfactory

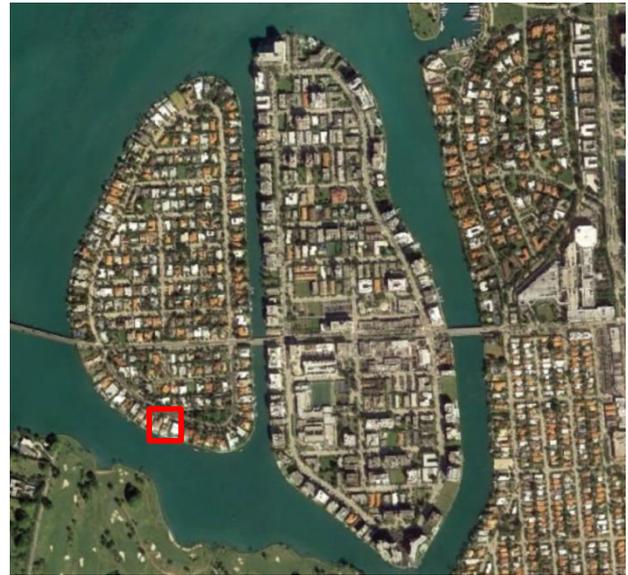
- Cap – Severe cracking and spalling along cap/retrofit caps
- T-Piles – Moderate concrete erosion and cracking
- T-Piles – Severe corrosion at anchor heads
- Batter Piles– Severe cracking and spalling
- Dock – Corrosion at fasteners and straps
- Dock – Missing east end support

• Seawall Rating: Poor      • Dock Rating: Critical

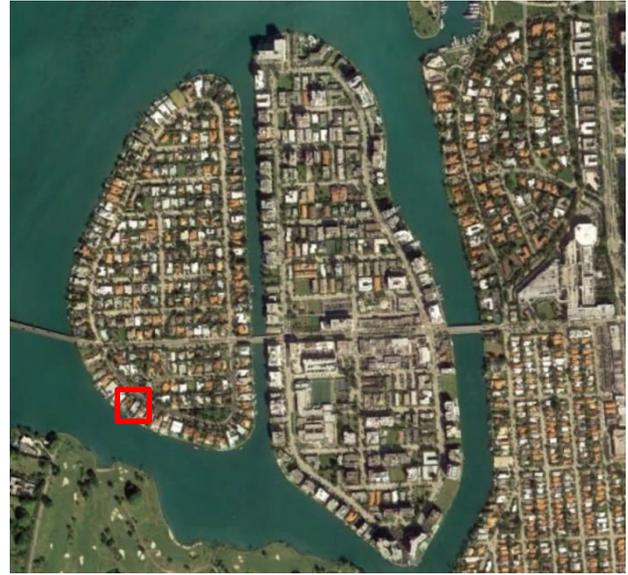
• Seawall Rating: Fair      • Dock Rating: Critical

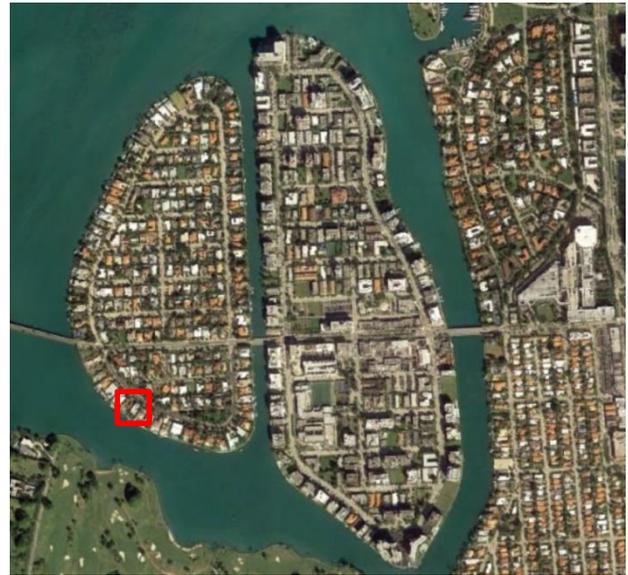
• Seawall Rating: Fair                      • Dock Rating: Fair

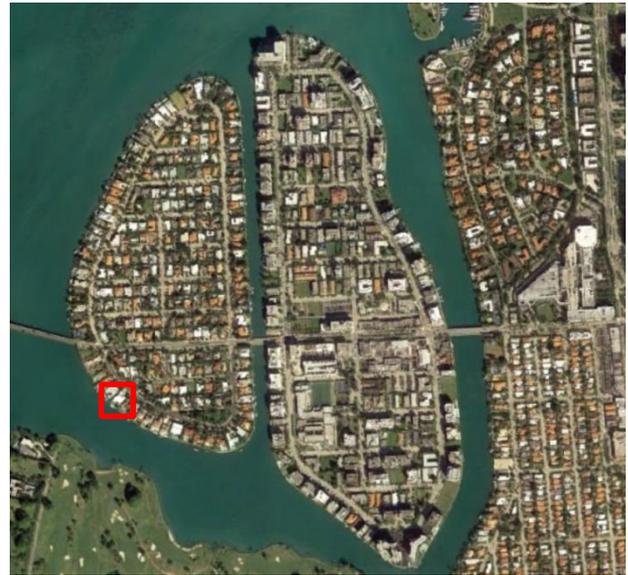
• Seawall Rating: Fair      • Dock Rating: Fair

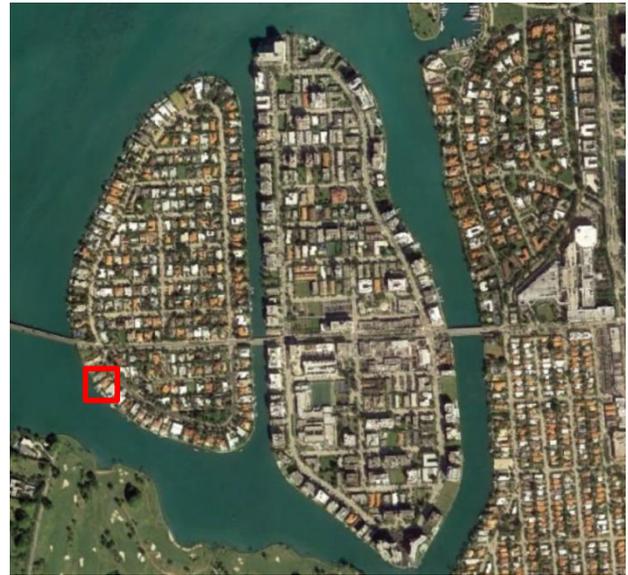
• Seawall Rating: Fair                      • Dock Rating: Fair

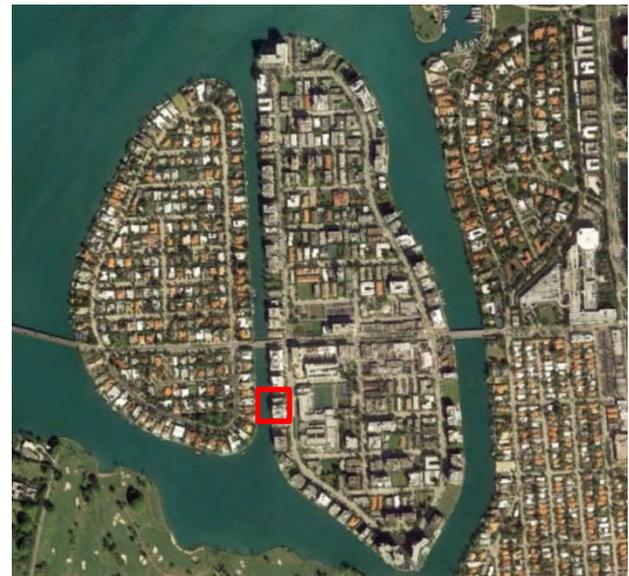
• Seawall Rating: Fair                      • Dock Rating: Fair

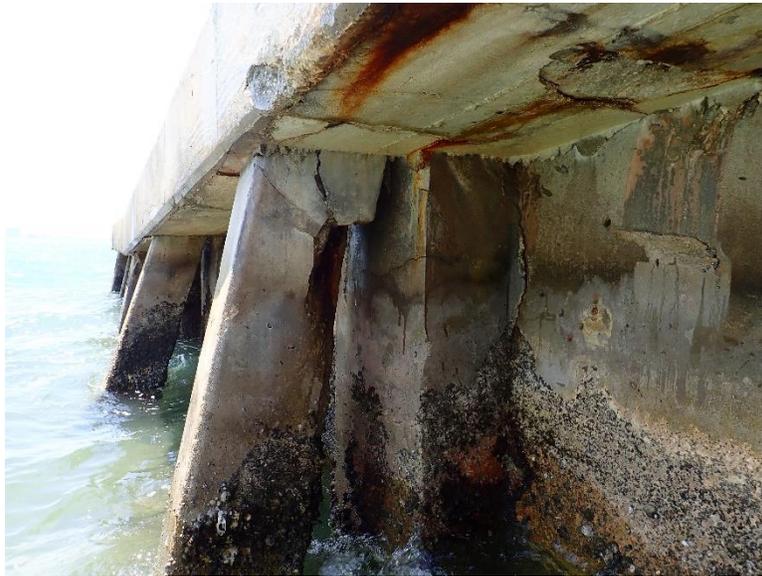
**Photo C.3: Cracking and section loss at batter pile at South East seawall**

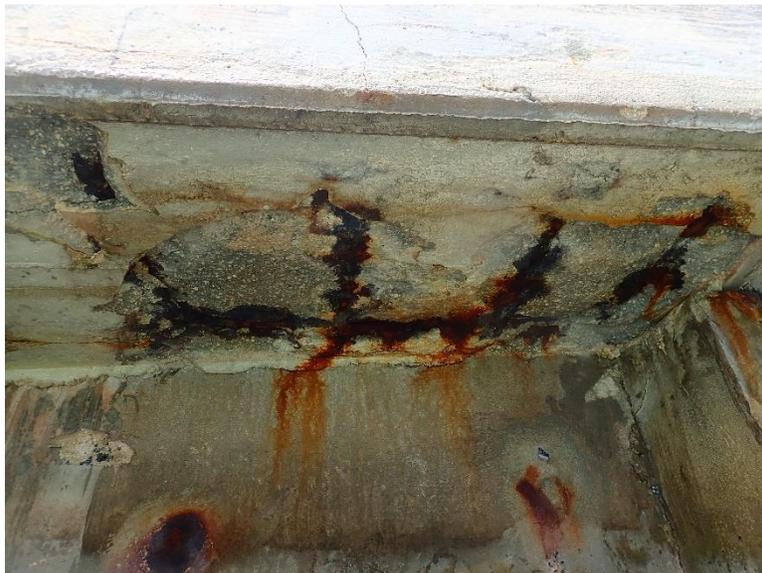
**Photo C.4: Exposed steel reinforcement at the cap soffit at South East seawall**

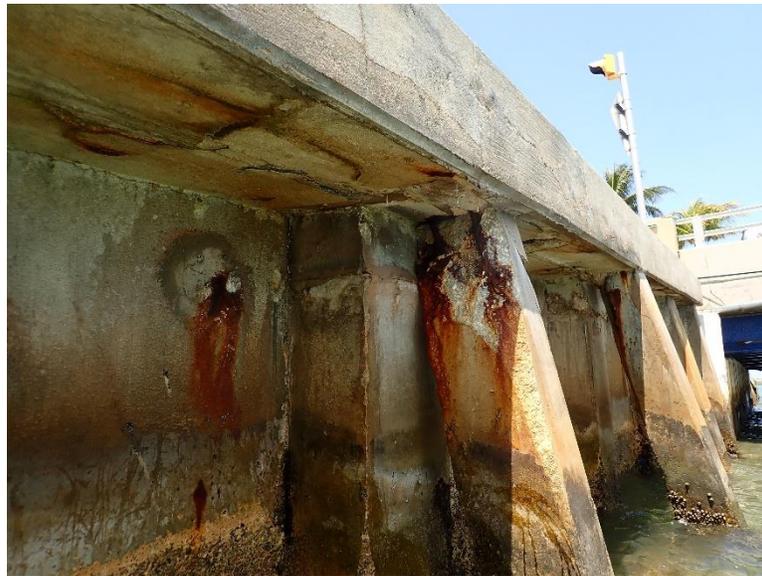
**Photo C.5: Severe cracking, spalling and exposed steel reinforcement at cap soffit and batter pile heads at East seawall**

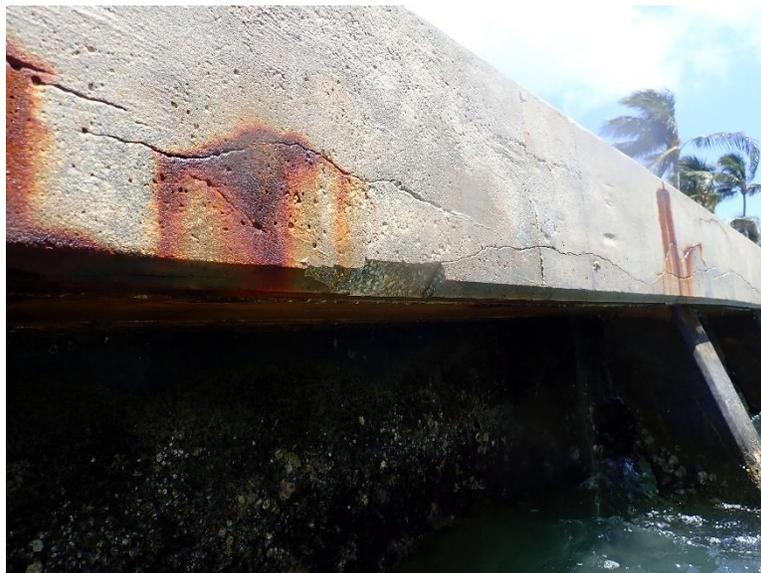
**Photo C.6: Cracking with corrosion staining at wet face of concrete cap at East seawall**

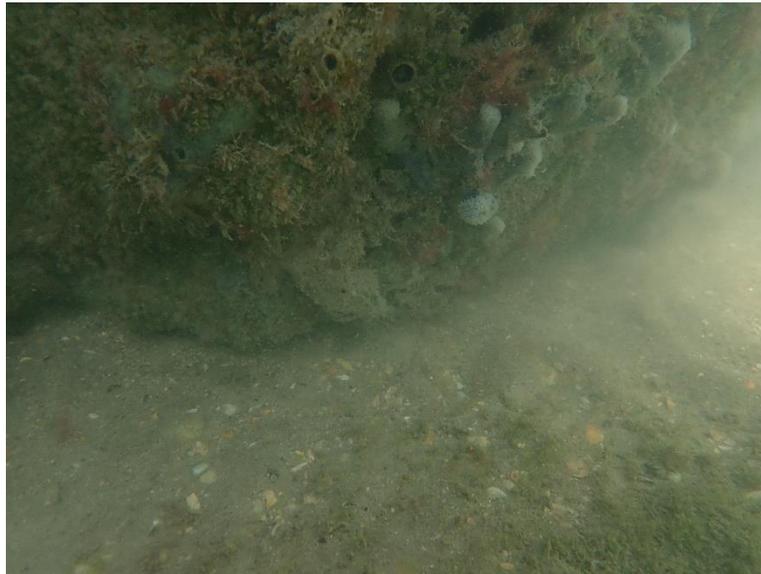
**Photo C.7: Sediment loss and undermining adjacent to seawall seabed**

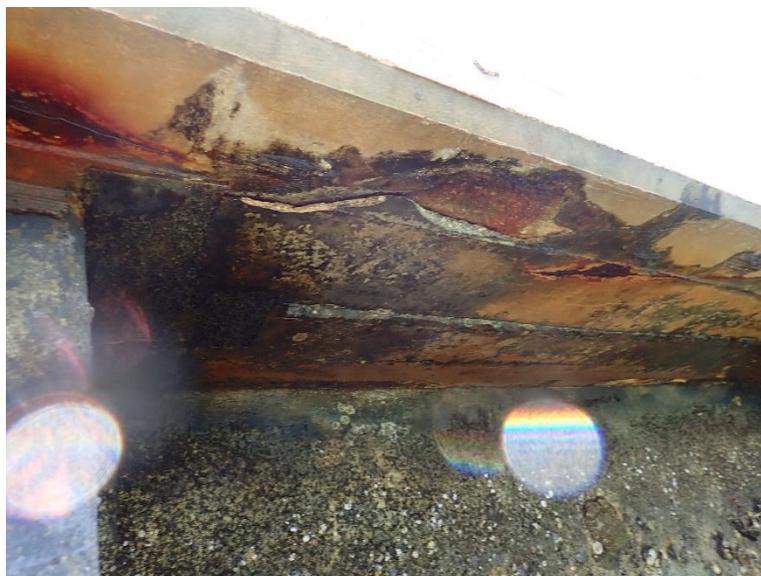
**Photo C.8: Cracking with corrosion station at the soffit at East seawall cap**

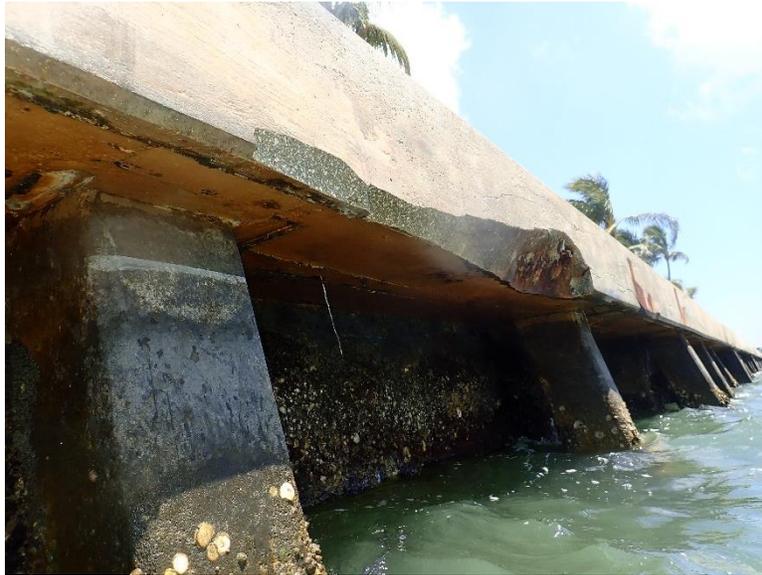
**Photo C.9: Spalling at wet face and soffit at South East seawall cap**

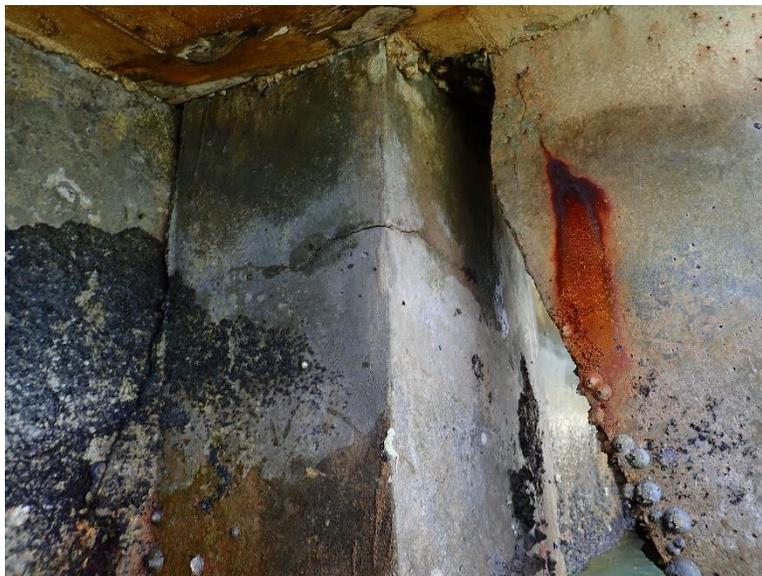
**Photo C.10: Cracking at king pile head with spalling and corrosion staining at batter pile**

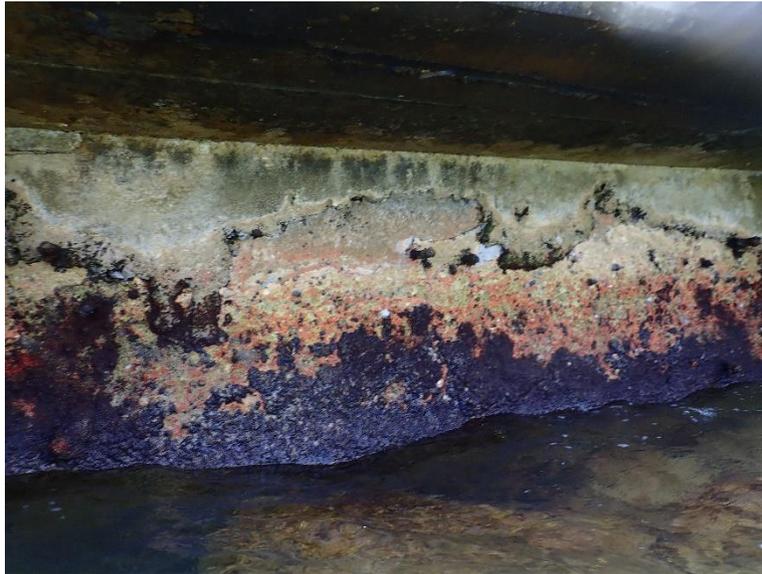
**Photo C.11: Concrete erosion along wall panels of East seawall  
North of bridge**

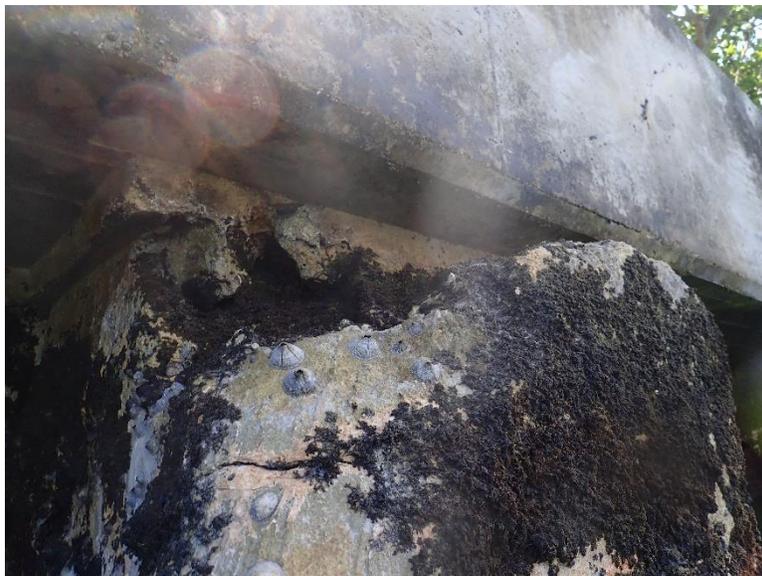
**Photo C.12: Concrete spalling and section loss at batter pile  
heads at North East seawall**

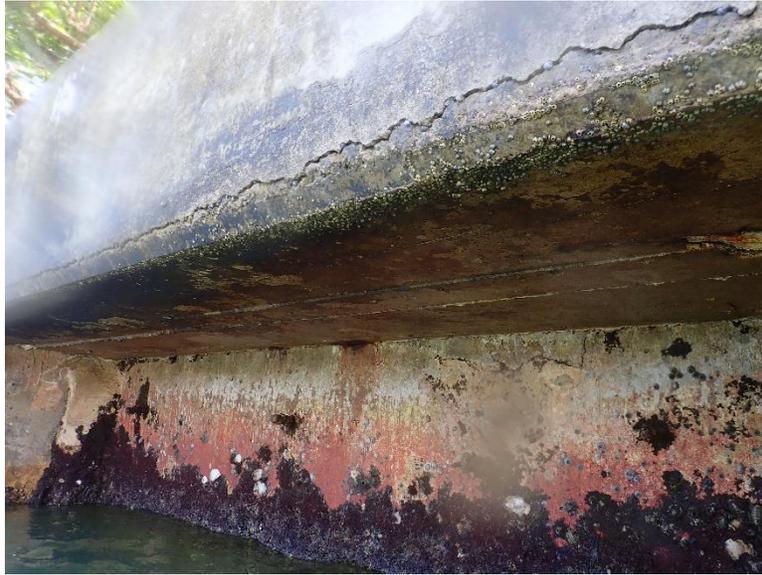
**Photo C.13: Cracking along wet face of cap at North East seawall**

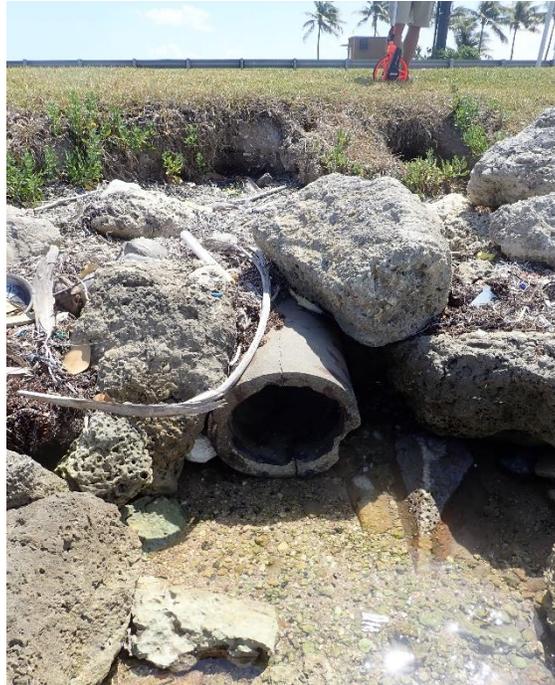
**Photo C.15: Outfall and concrete debris along Northern rock revetment**

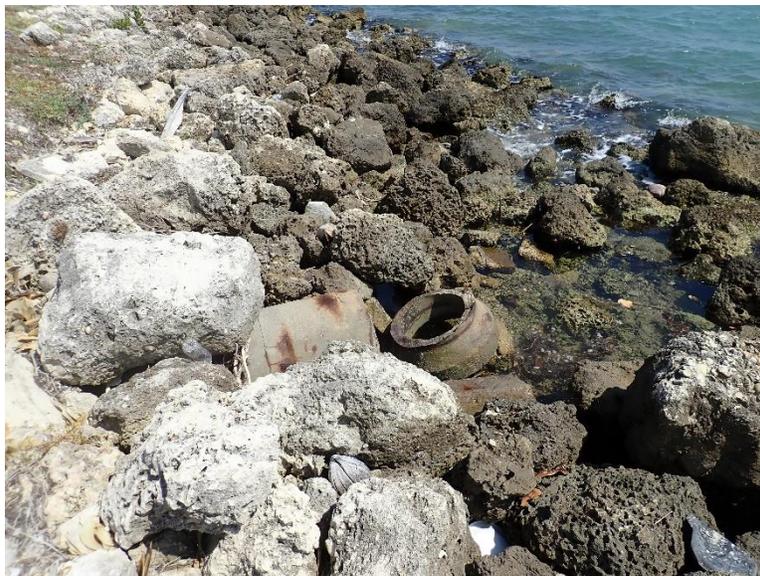
**Photo C.18: Washout and debris along South shoreline rock revetment**

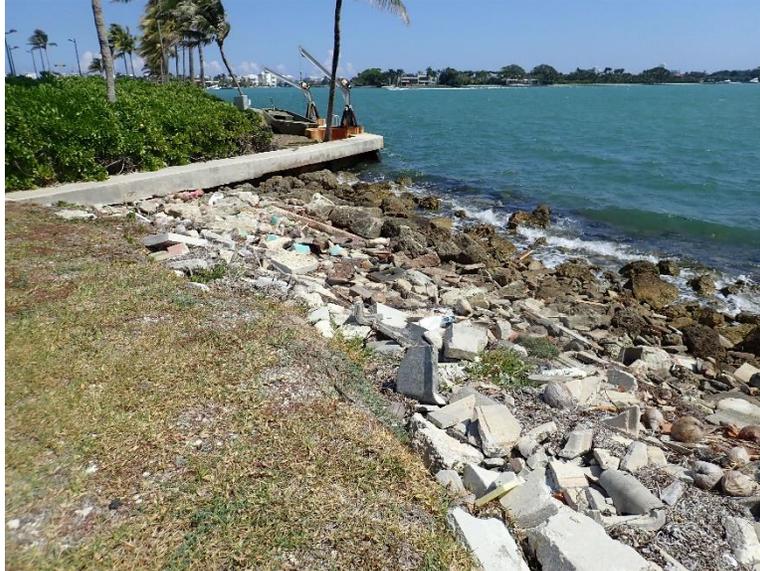
**Photo C.21: View of return seawall at Station 39+50' with wash out and debris at shoreline rock revetment**
