# FINAL CONTAMINATION SCREENING EVALUATION REPORT

TOWN OF BAY HARBOR ISLANDS

BROAD CAUSEWAY BRIDGE REPLACEMENT  
PROJECT DEVELOPMENT & ENVIRONMENT STUDY

May 2024

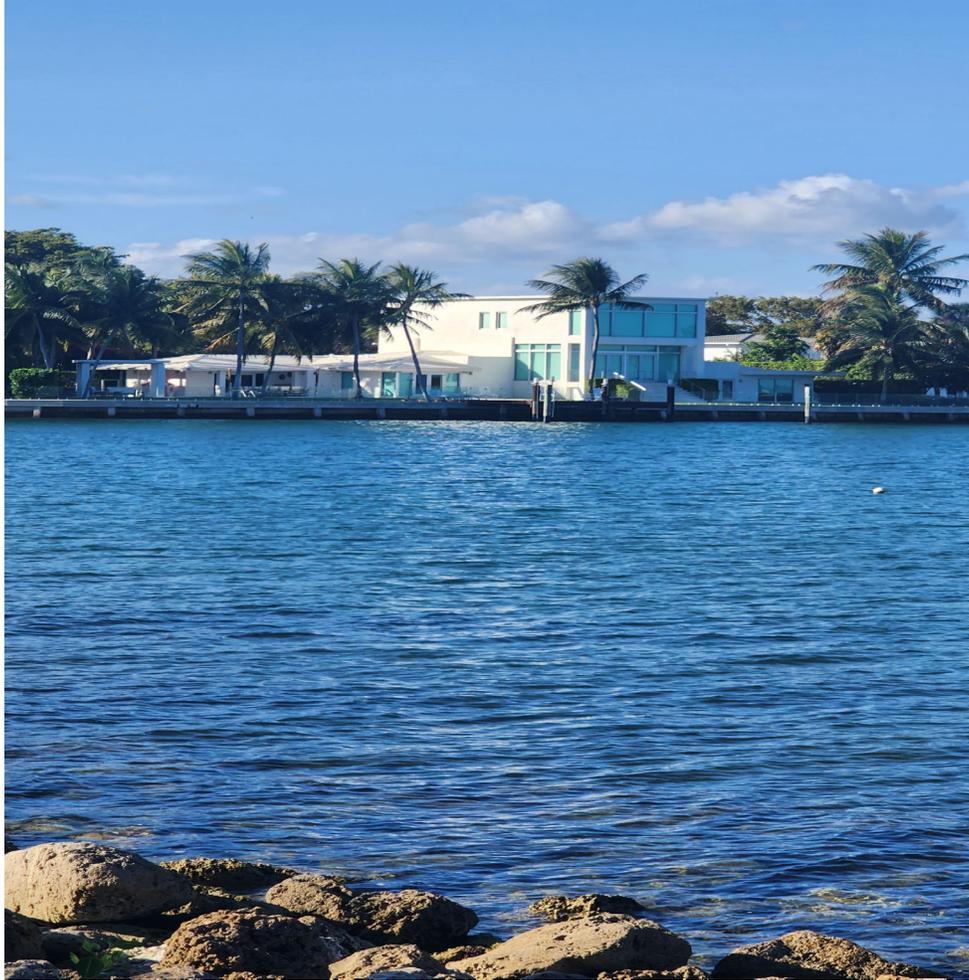
**Photo #1: Site 1 – Reported Oil Spill, as viewed from the Broad Causeway Island.  
The spill occurred in 1995 and has been rated Low.**

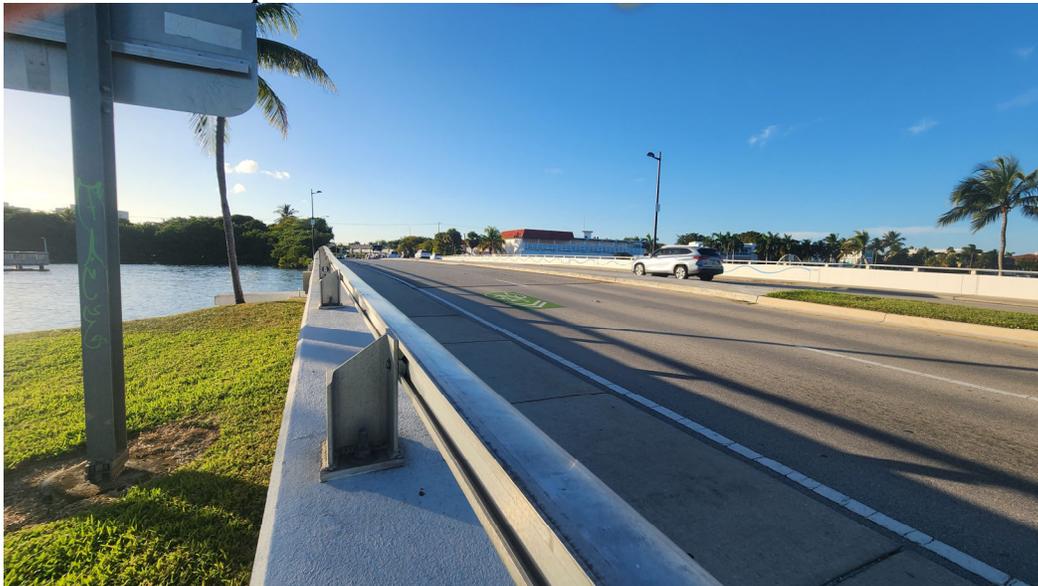
**Photo #2: Site 2 – Broad Causeway West Relief Bridge, as viewed from the east.  
This site obtained a Generic NPDES construction permit and is rated No.**

### 8.2.2 Site 2 – Broad Causeway West Relief Bridge

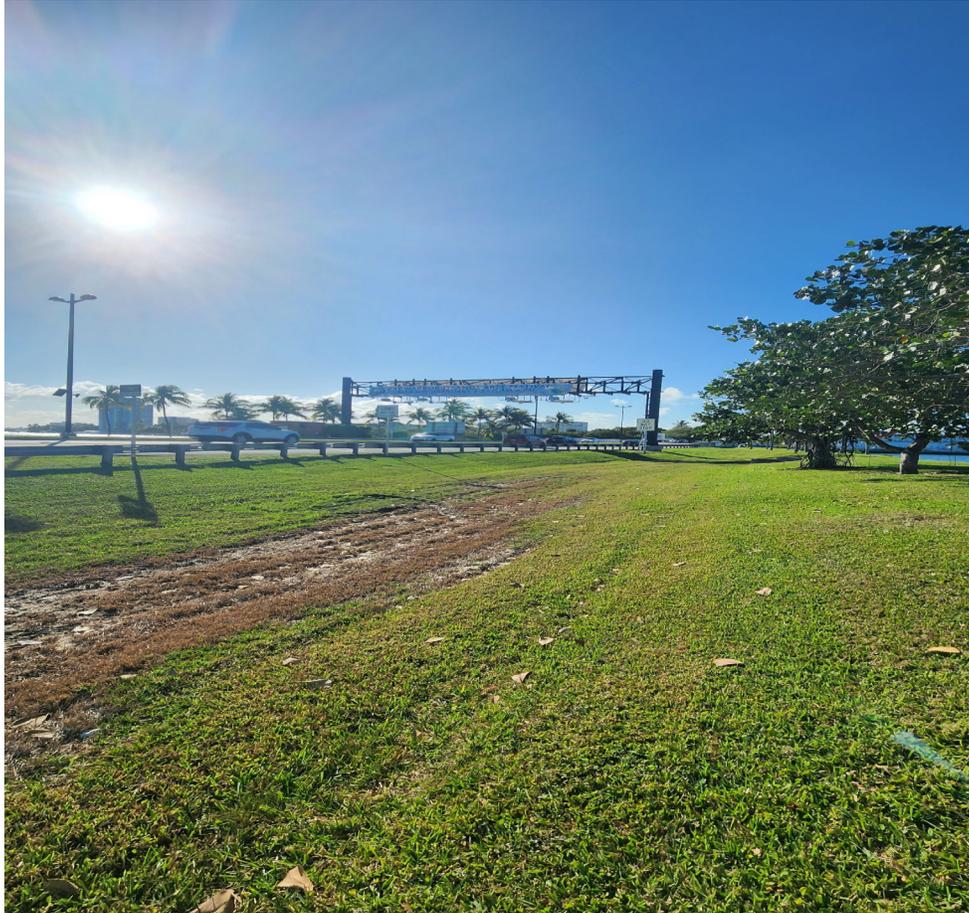
**Photo #3: Site 3- SR 922 (Broad Causeway) from the west. This site obtained a Generic NPDES construction permit and is rated No.**

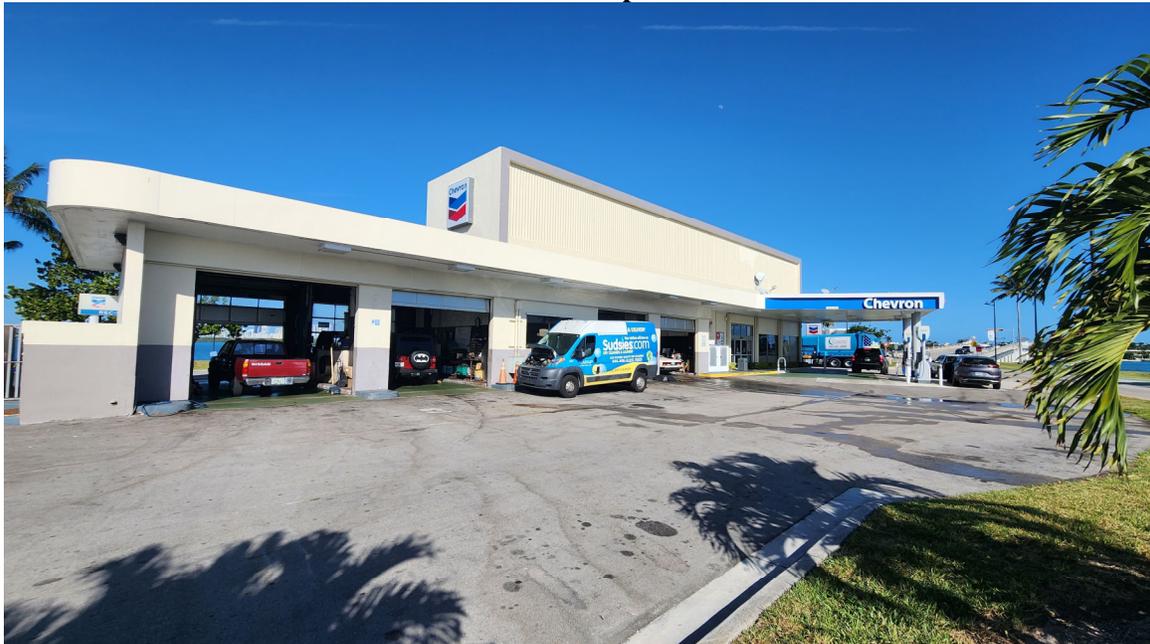
**Photo #4: Site 4 – Sunshine #8 from the southeast. This site is an active gas station that has contaminated soil and groundwater. This site is rated High.**

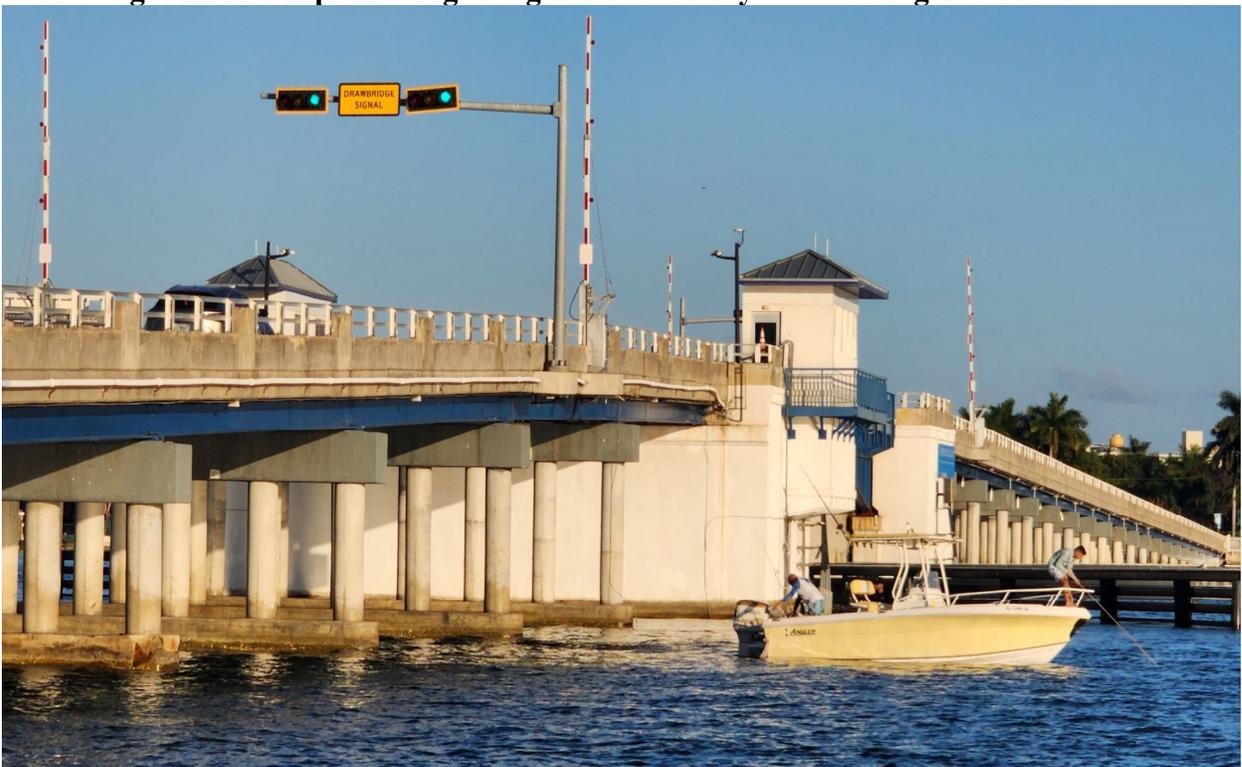
**Photo #6: Site 5 – Broad Causeway Bridge, as viewed from the east. This view shows the bascule and tender houses. The site is rated Medium.**

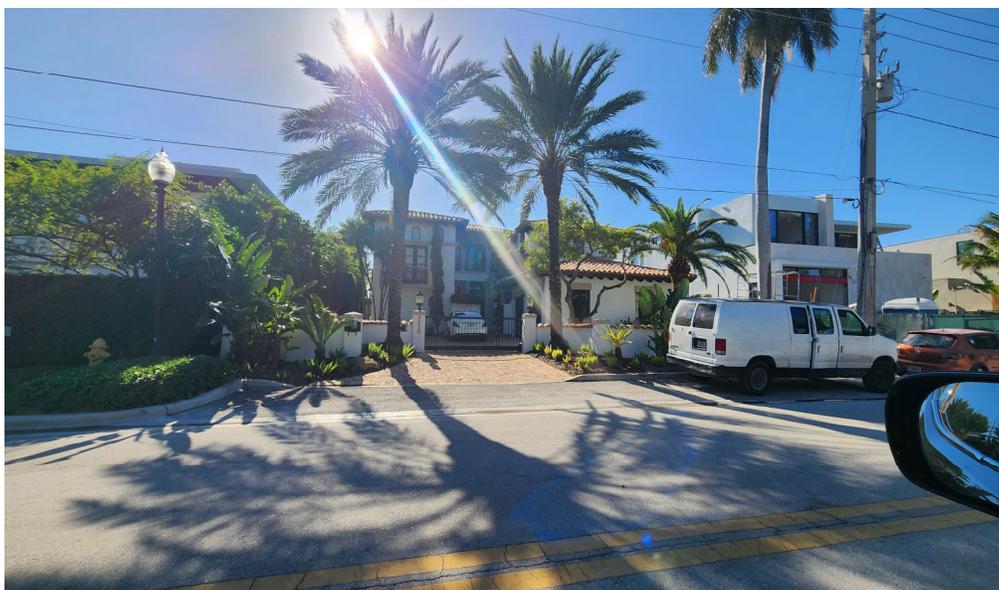
**Photo #7: Site 6- Reported Sheen. This view is from the east of the residential home. The 2019 sheen was observed on the bay side of the home and is rated Low.**

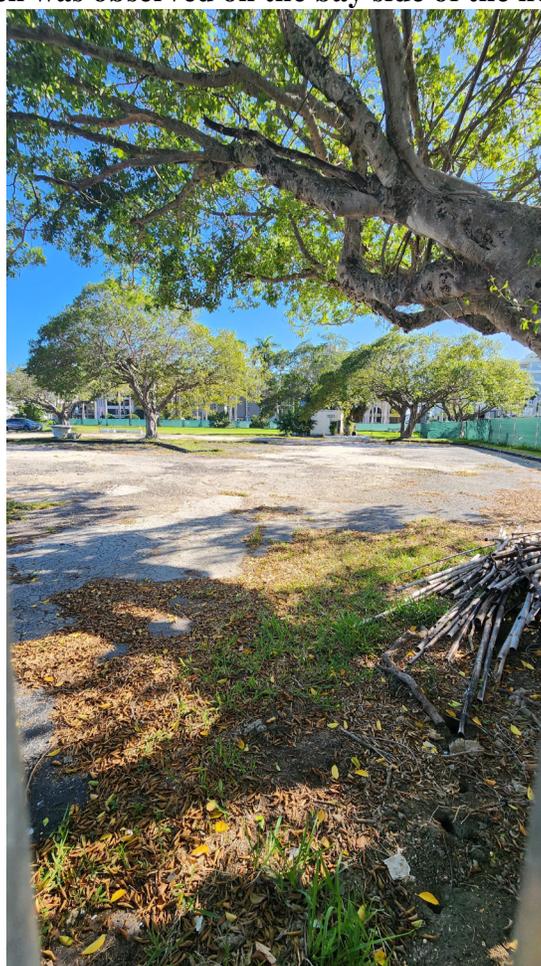
**Photo #8: Site 7 – Disaster Debris Management Site. This view is from the north side of the vacant lot. The site is rated No.**

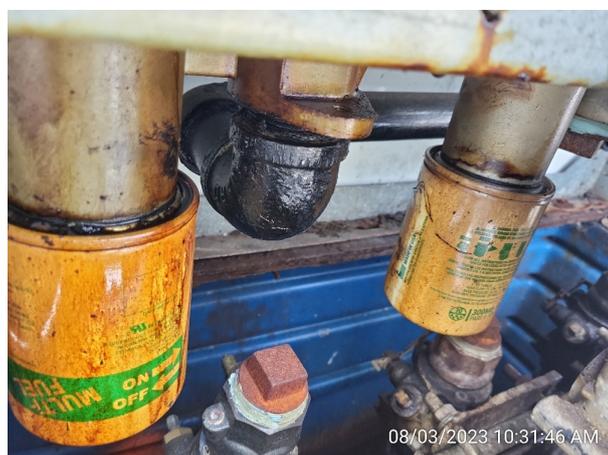
Leaking meters and filters

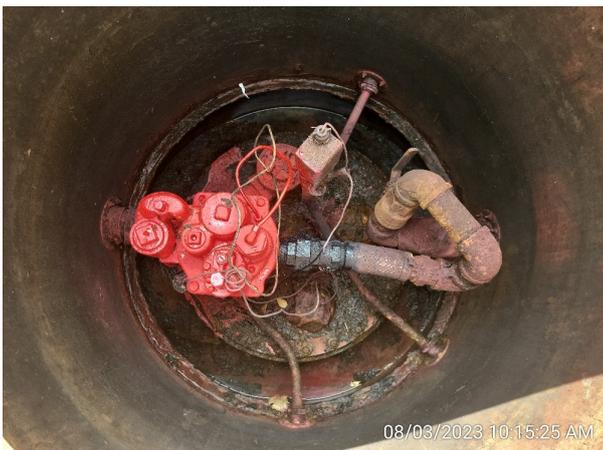
STP sump

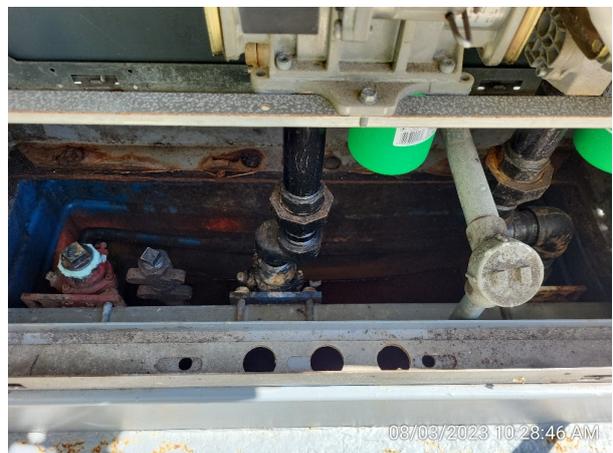
Dispenser liner

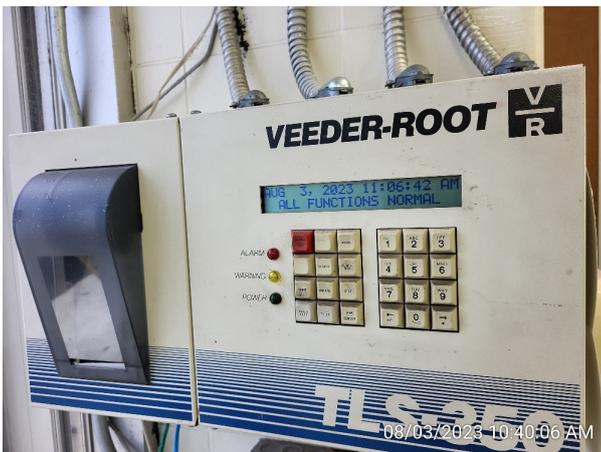
Veeder-Root TLS-350 free of alarms

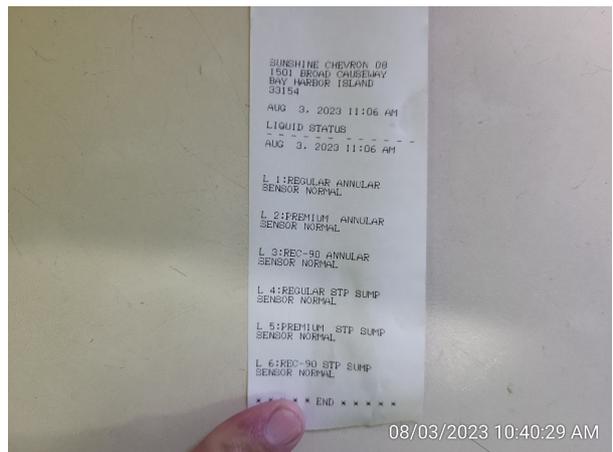
Liquid status report w/ all sensors normal

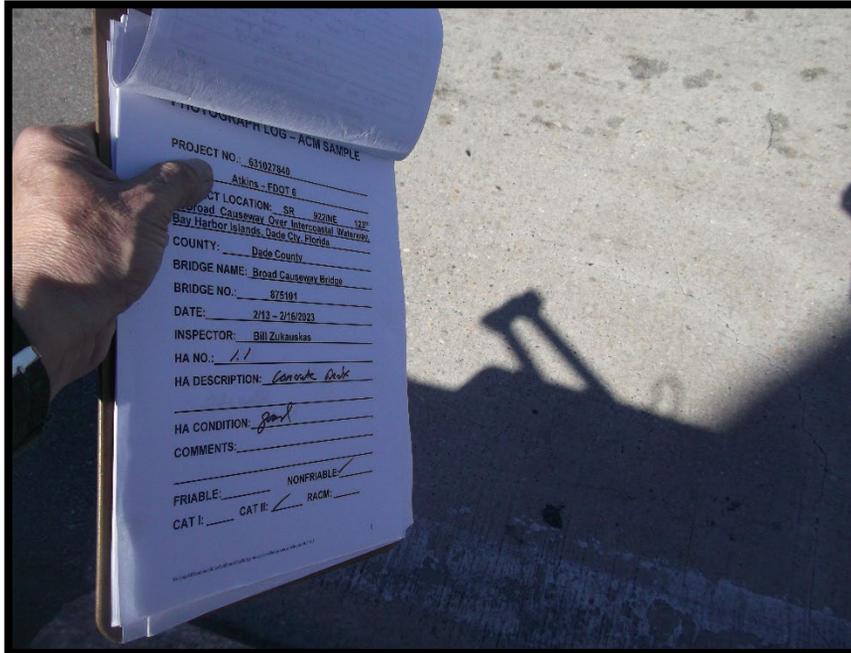
Project No: 631027840  
Photographer: William Zukauskas  
Description: Bridge 875101  
View: HA 1.1 – Bridge Deck

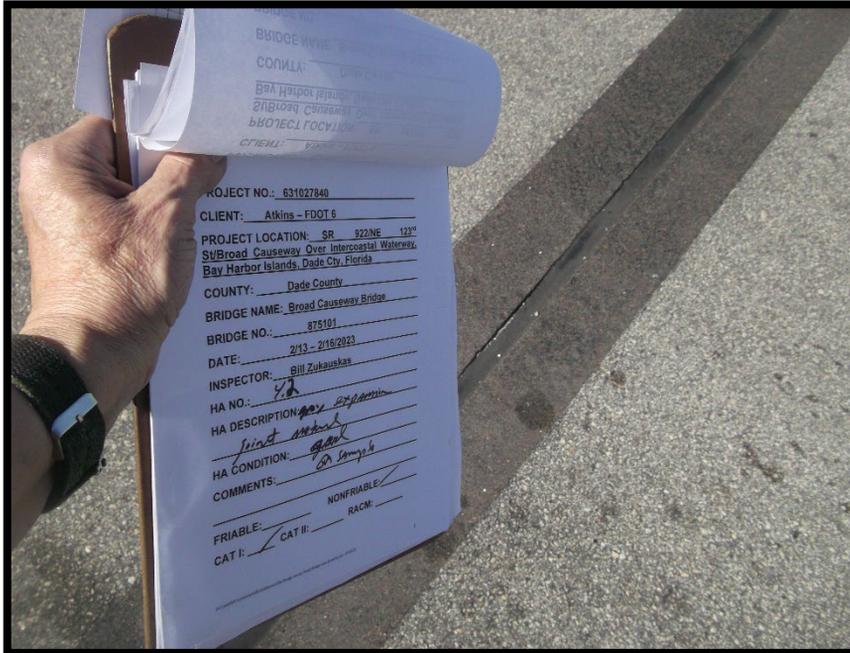
Project No: 631027840  
Photographer: William Zukauskas  
Description: Bridge 875101  
View: HA 4.2 – Gray Expansion Joint

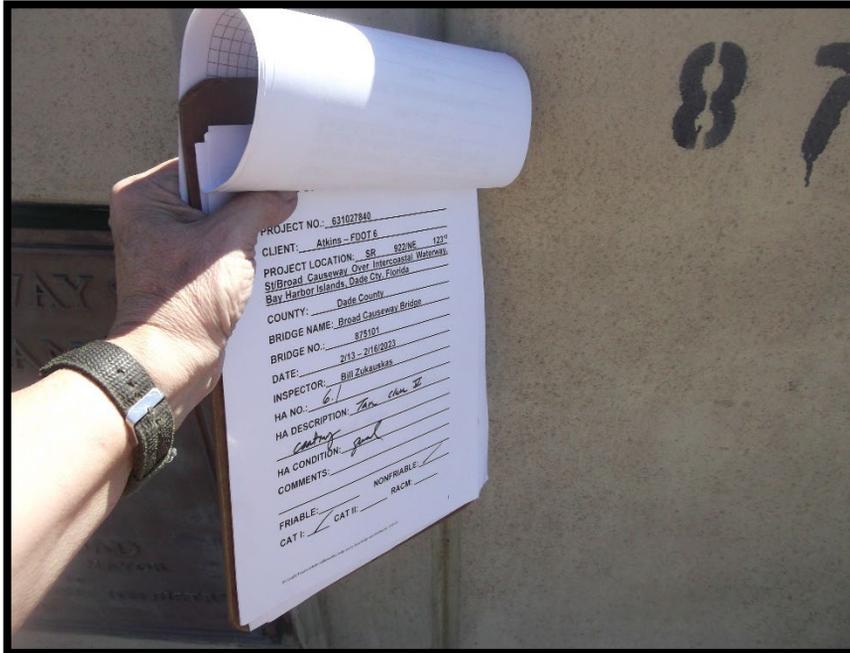
Project No: 631027840  
Photographer: William Zukauskas  
Description: Bridge 875101  
View: HA 6.1 – Tan Class V Coating On Rails

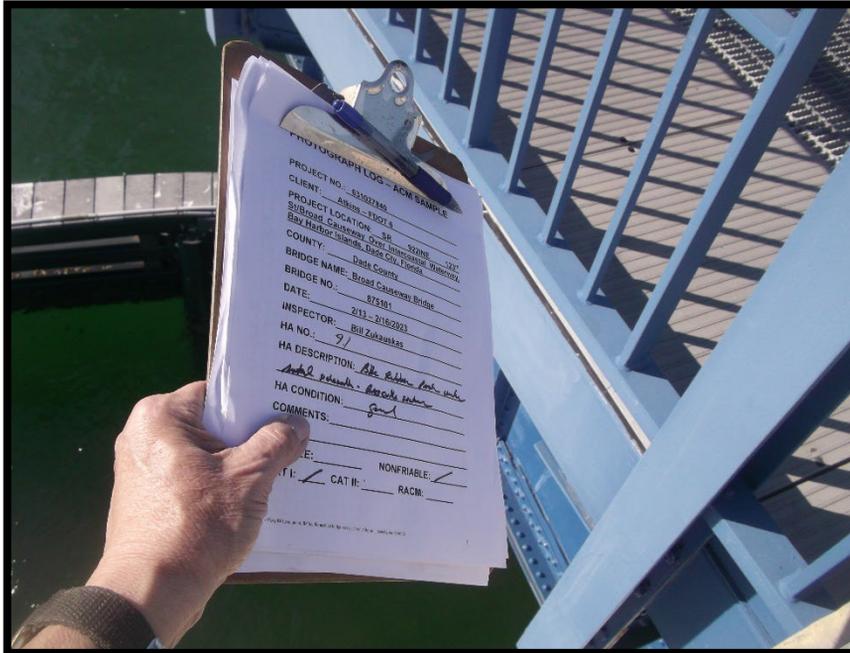
Photograph No: 31  
 Date: 2/14/2023

Project No: 631027840  
 Photographer: William Zukauskas  
 Description: Bridge 875101  
 View: HA 9.1 – Black Rubber Pads Under Metal Walkway

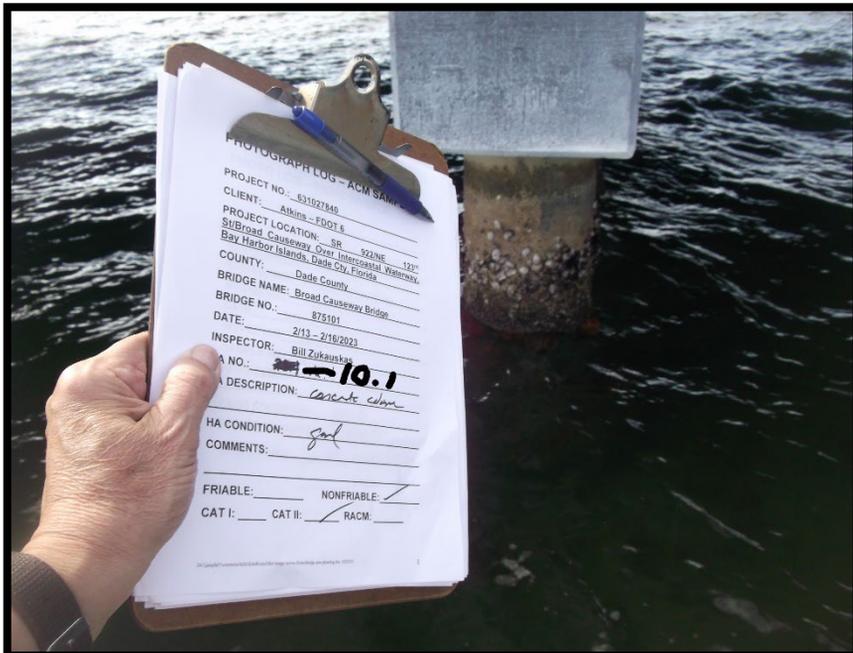
Photograph No: 34  
 Date: 2/15/2023

Project No: 631027840  
 Photographer: William Zukauskas  
 Description: Bridge 875101  
 View: HA 10.1 – Concrete Piers Under Bridge

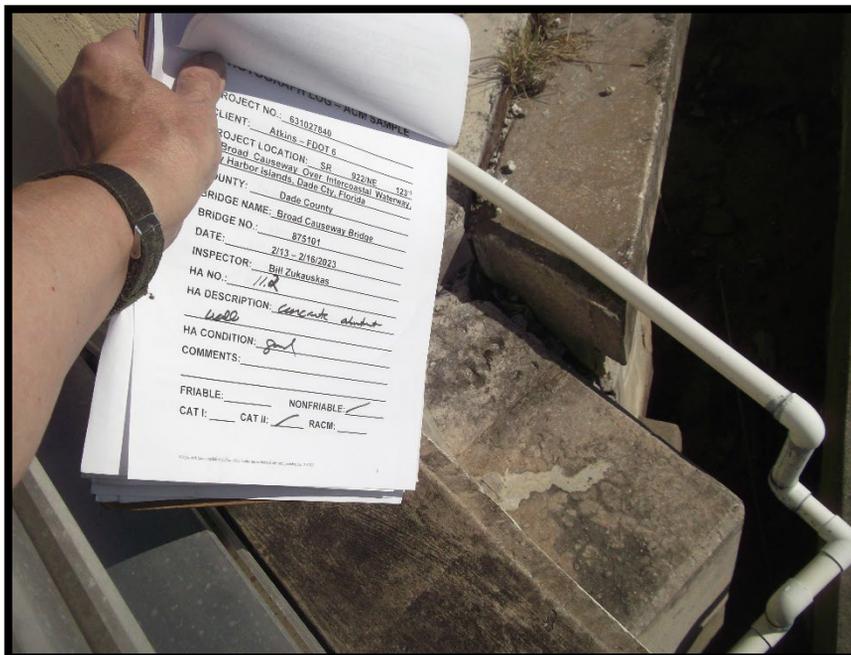
Photograph No: 38  
Date: 2/14/2023

Project No: 631027840  
Photographer: William Zukauskas  
Description: Bridge 875101  
View: HA 11.2 – Concrete Abutment Walls

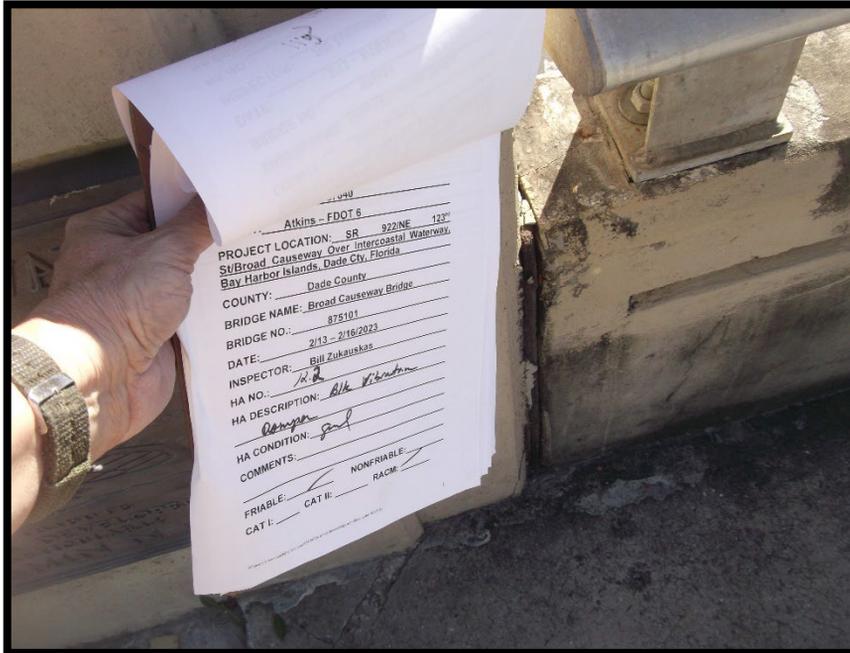
Project No: 631027840  
Photographer: William Zukauskas  
Description: Bridge 875101  
View: HA 12.2 – Black Vibration Damper

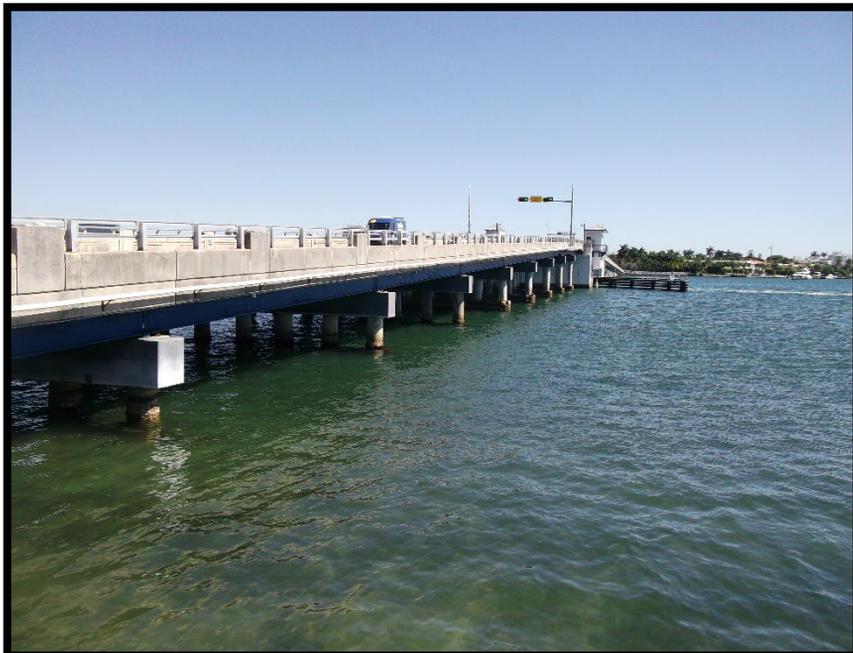
Photograph No: 2  
Date: 2/15/2023

Project No: 631027840  
Photographer: William Zukauskas  
Description: Bridge 875101  
View: Southwest End Of Bridge Looking East

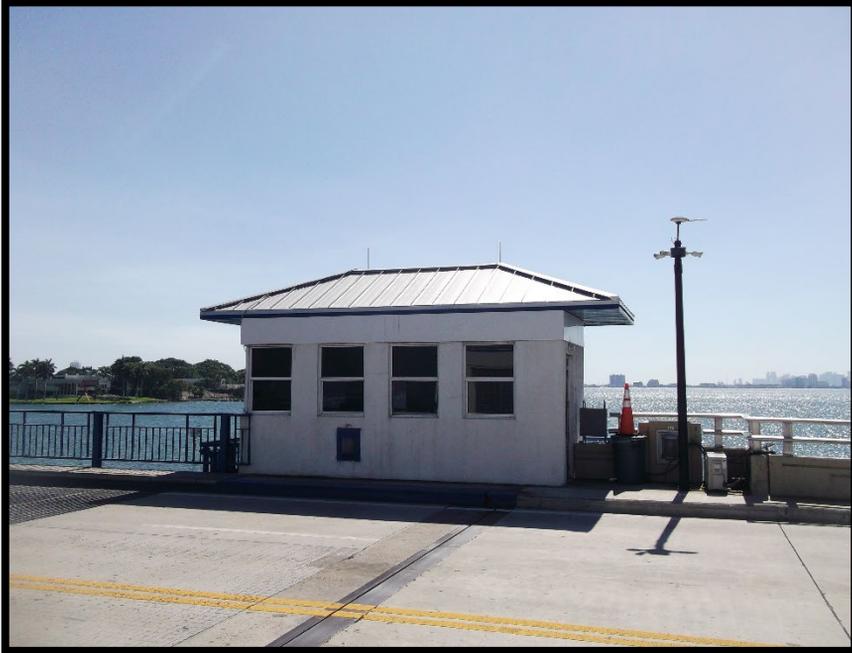
Photograph No: 3  
Date: 2/15/2023

Project No: 631027840  
Photographer: William Zukauskas  
Description: Bridge 875101  
View: Bridge Tender House

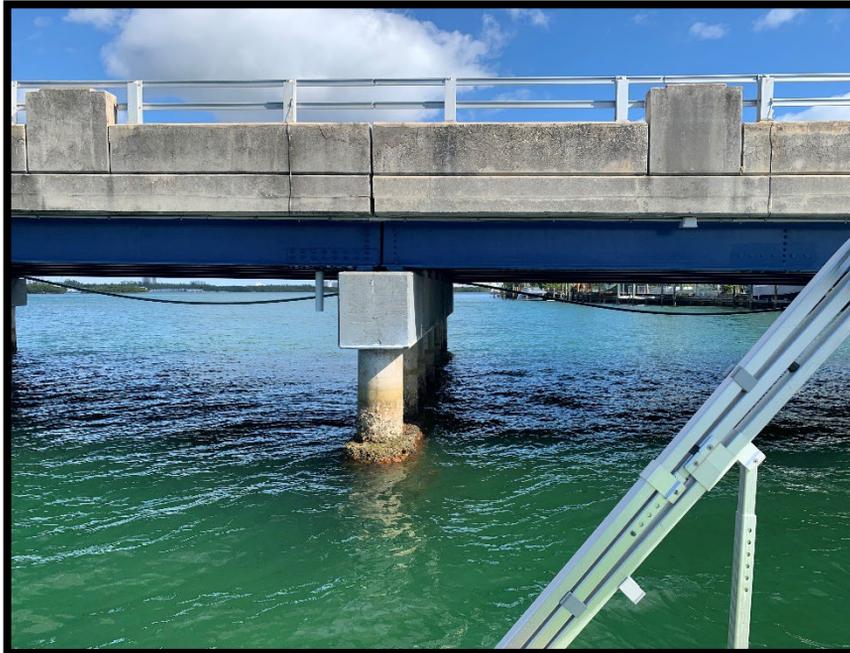
Photograph No: 5  
Date: 2/15/2023

Project No: 631027840  
Photographer: William Zukauskas  
Description: Bridge 875101  
View: Gray Paint on Pile Caps

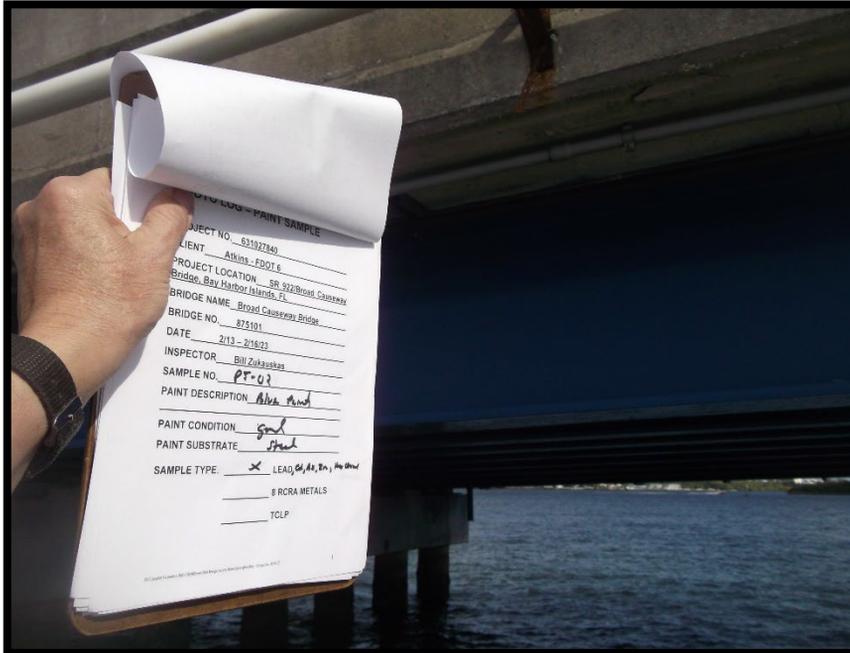
Project No: 631027840  
Photographer: William Zukauskas  
Description: Bridge 875101  
View: Sample 875101-PS-02 – Blue Paint on Steel Beams – Southwest Corner

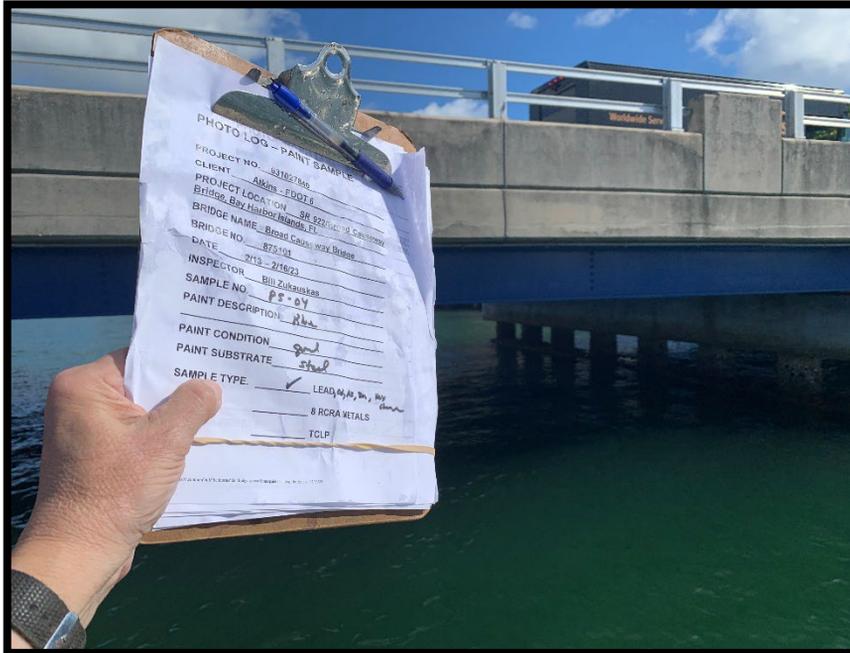
Project No: 631027840  
 Photographer: William Zukauskas  
 Description: Bridge 875101  
 View: Sample 875101-PS-04 – Blue Paint on Steel Beams – Southeast Corner

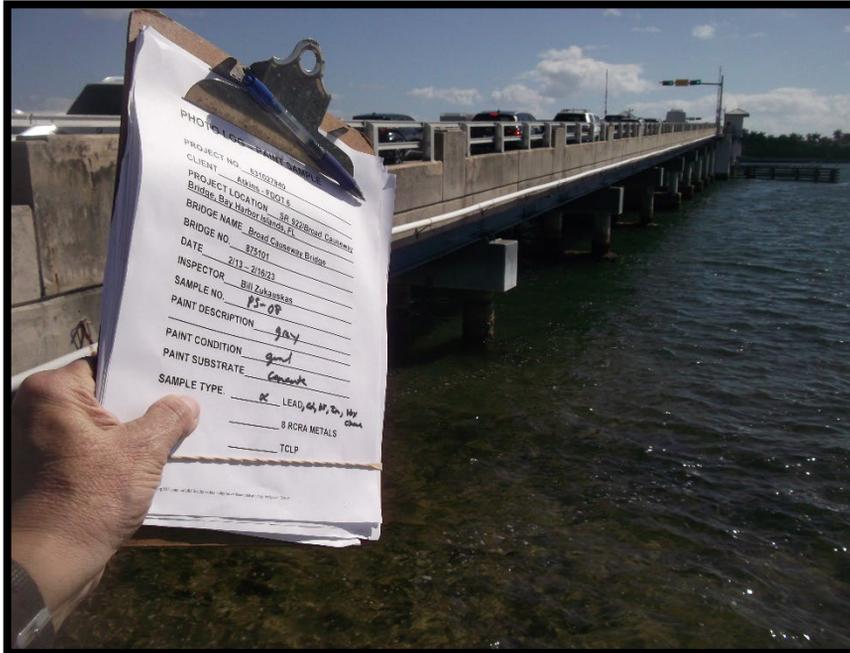
Project No: 631027840  
 Photographer: William Zukauskas  
 Description: Bridge 875101  
 View: Sample 875101-PS-08 – Gray Paint on Concrete Pile Caps
