# Seawall Condition and Resiliency Assessment Town of Bay Harbor Islands

October 2019 (Updated)

**Cummins Cederberg, Inc.**

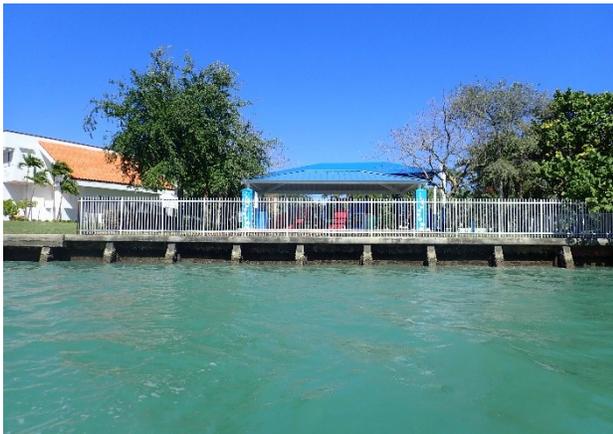
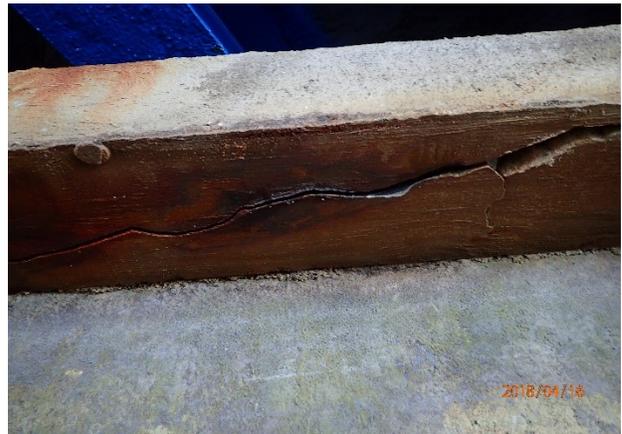
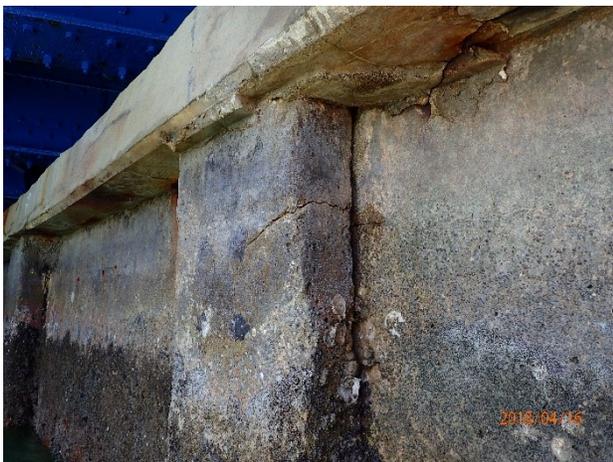
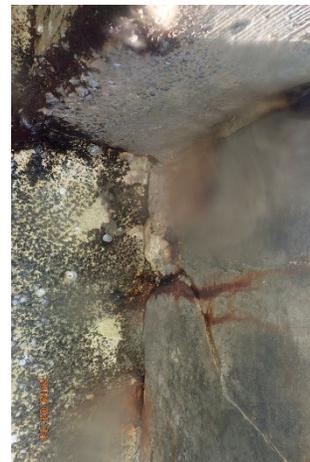
Property Address: 9640 W BROADVIEW DR  
Bay Harbor Islands, FL 33154  
Location: S-1.1 Lot#2  
Date of Inspection: 4/16/2018 @ 3:45pm

- Cap – Moderate cracking at Northern wet face and soffit
- T-Piles – Minor necking at tidal zone
- Wall Panels – Minor concrete erosion at tidal zone
- Dock – Unsecured and missing timber decking, framing
- Dock – Severe corrosion at fasteners
- Dock – Splitting at timber piles

• Seawall Rating: Fair      • Dock Rating: Critical

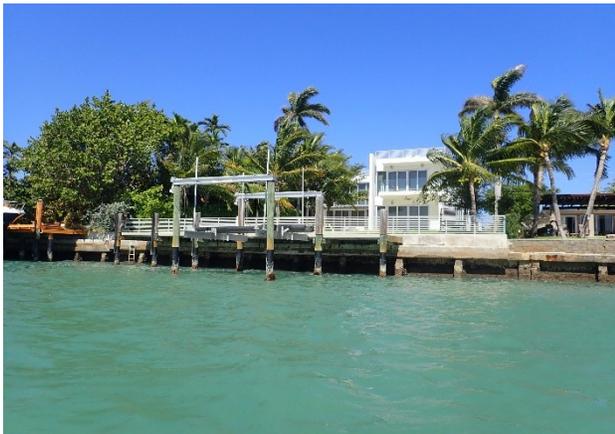
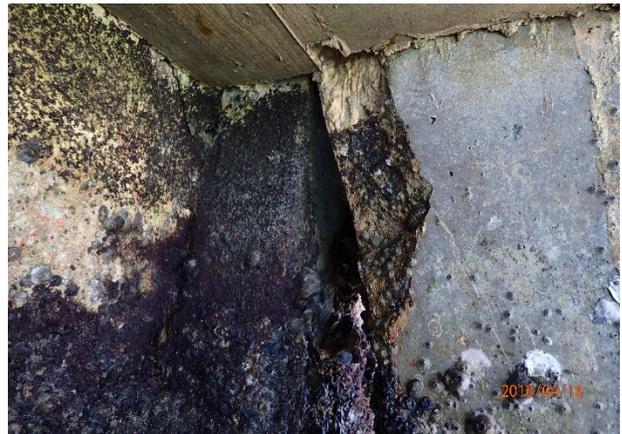
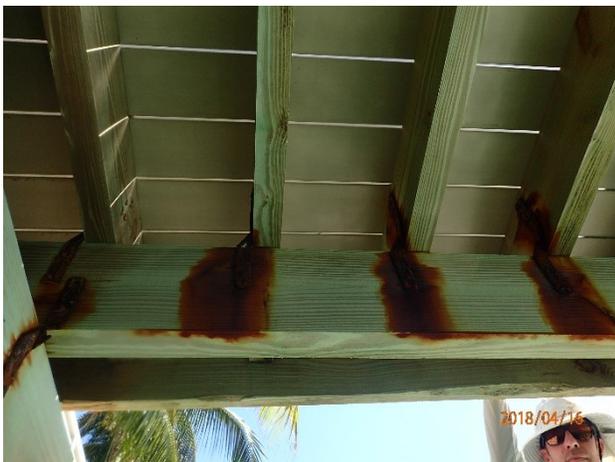
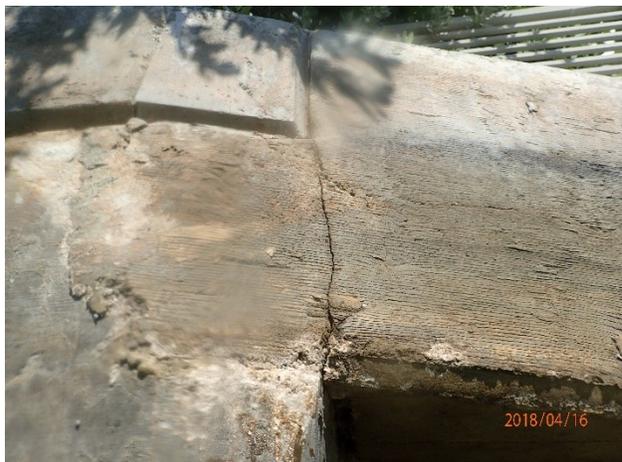
Property Address: 9720 W BROADVIEW DR  
Bay Harbor Islands, FL 33154  
Location: S-1.1 Lot#5  
Date of Inspection: 4/16/2018 @ 4:00pm

- Cap – Severe cracking and spalling at wet face with exposed steel reinforcement and corrosion staining
- Wall Panels - Moderate concrete erosion at tidal zone
- T-Piles – Separation between wall panel and t-piles
- T-Piles – Moderate necking at tidal zone
- Dock – Satisfactory Condition

• Seawall Rating: Fair      • Dock Rating: Satisfactory

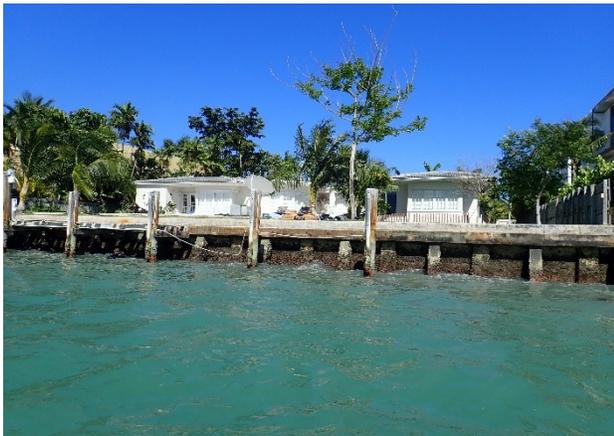
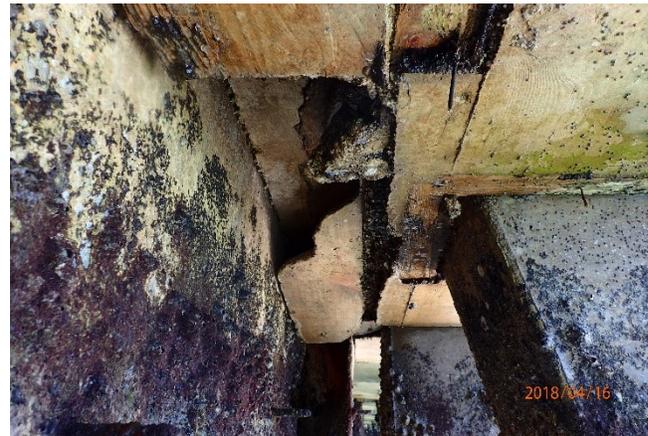
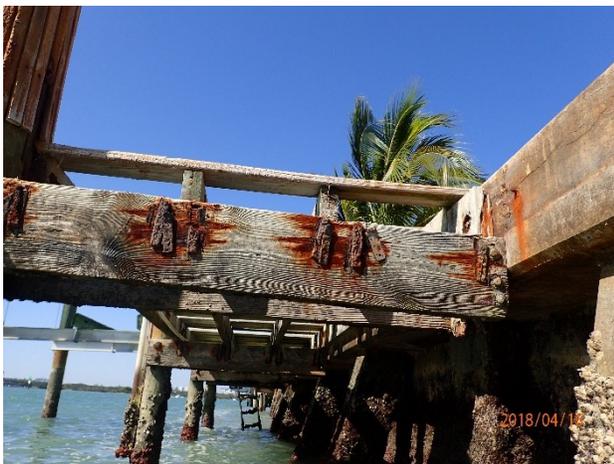
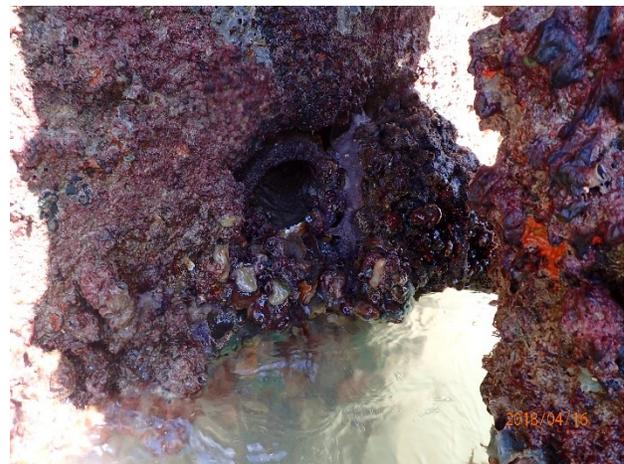
Property Address: 9814 W BROADVIEW DR  
Bay Harbor Islands, FL 33154  
Location: S-1.1 Lot#9  
Date of Inspection: 4/16/2018 @ 4:30pm

- Wall Panels – Moderate concrete cracking and spalling
- Wall Panels – Scour at mudline
- T-Piles – Separation between t-pile and wall panel
- T-Piles – Concrete spalling at heads
- Batter Piles – Cracking at heads
- Dock – Severe corrosion at fasteners/straps

• Seawall Rating: Fair      • Dock Rating: Fair

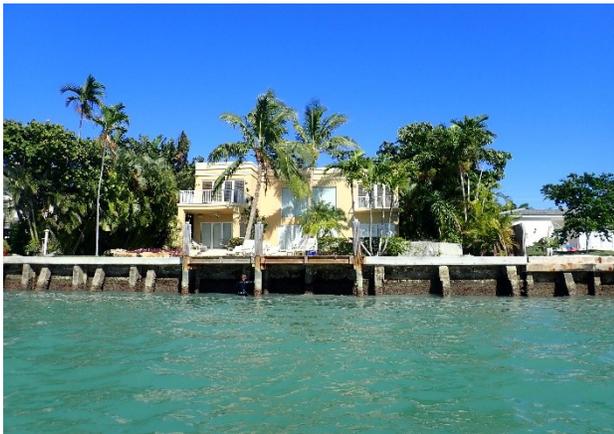
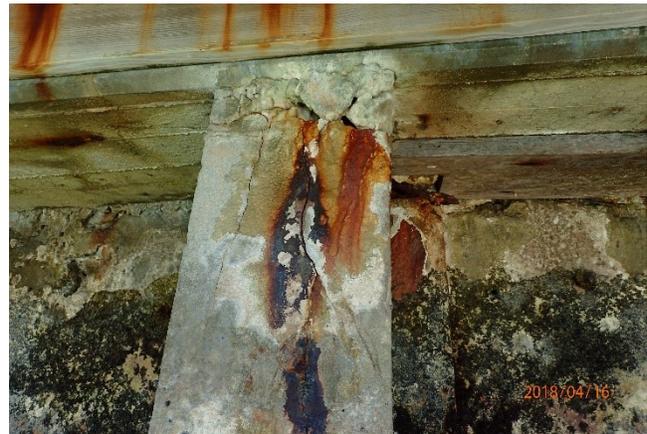
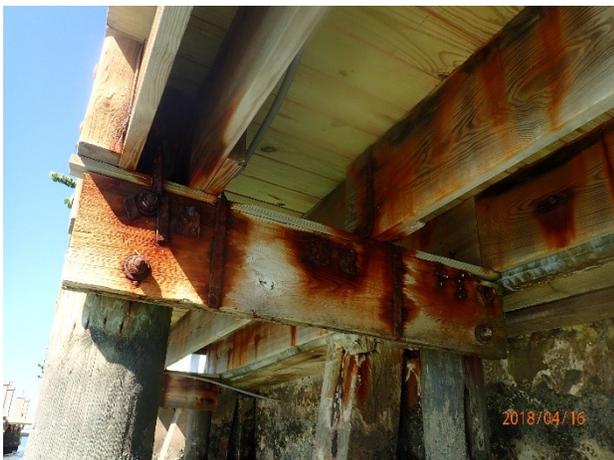
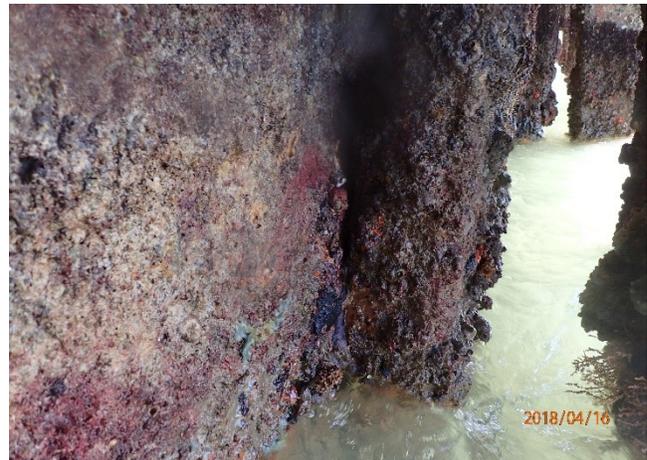
Property Address: 9826 W BROADVIEW DR  
Bay Harbor Islands, FL 33154  
Location: S-1.1 Lot#10  
Date of Inspection: 4/16/2018 @ 4:30pm

- Wall Panels – Moderate concrete erosion at splash zone
- Cap – Moderate cracking and spalling in original cap
- T-Piles – Moderate concrete erosion at splash zone
- Dock – Severe corrosion at fasteners
- Dock – Corroded straps replaced with new, bolt corrosion

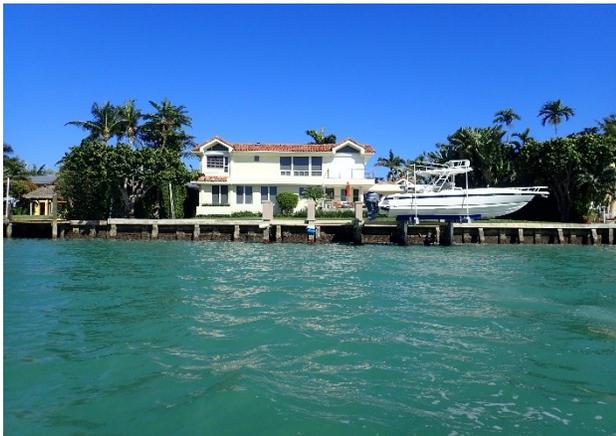
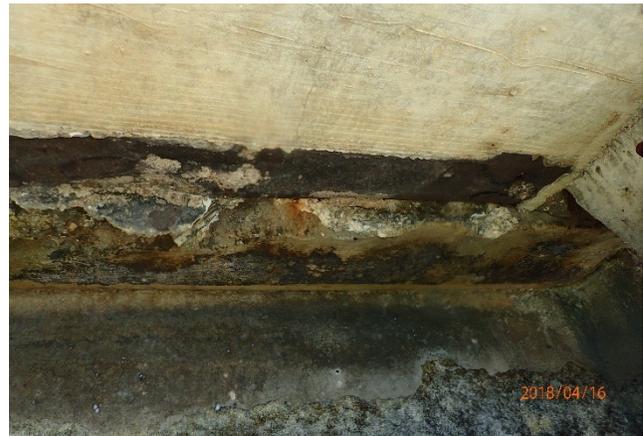
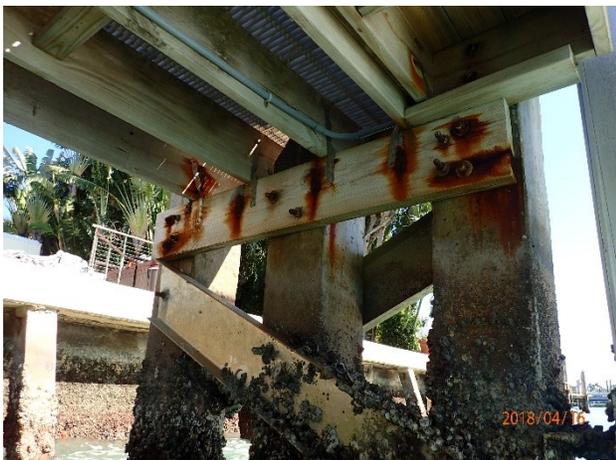
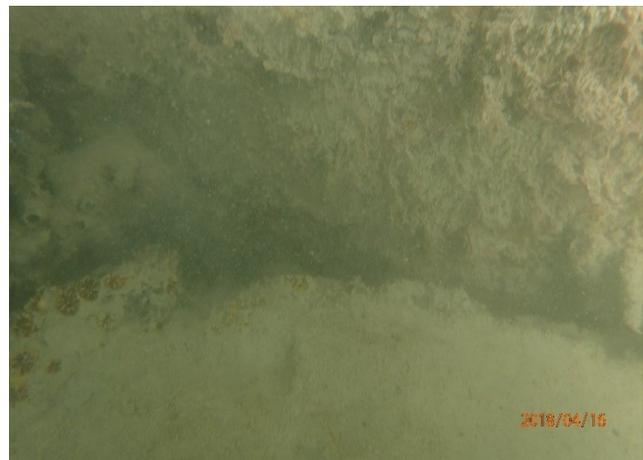
Property Address: 9900 W BROADVIEW DR  
Bay Harbor Islands, FL 33154  
Location: S-1.1 Lot#11  
Date of Inspection: 4/16/2018 @ 4:40pm

• Seawall Rating: Fair      • Dock Rating: Satisfactory

- Wall Panels – Cracking adjacent to outfall
- Wall Panels – Moderate concrete erosion at splash zone
- Cap – Moderate longitudinal cracking
- T-Piles – Moderate concrete erosion and cracking
- Batter Piles – Minor to moderate cracking
- Dock – Corrosion at fasteners/straps, wood splitting

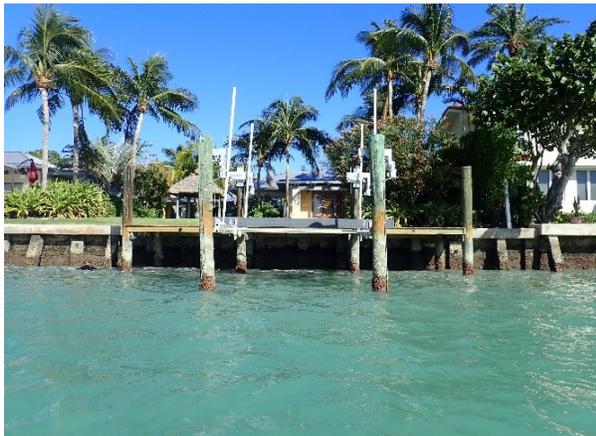
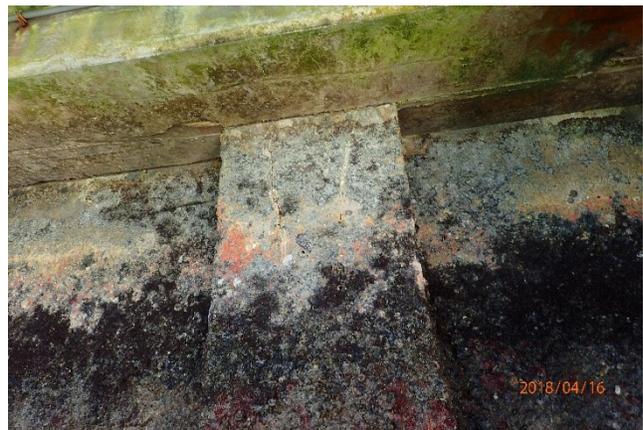
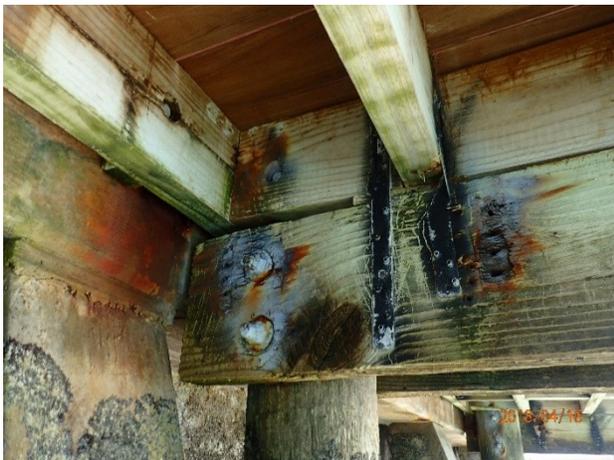
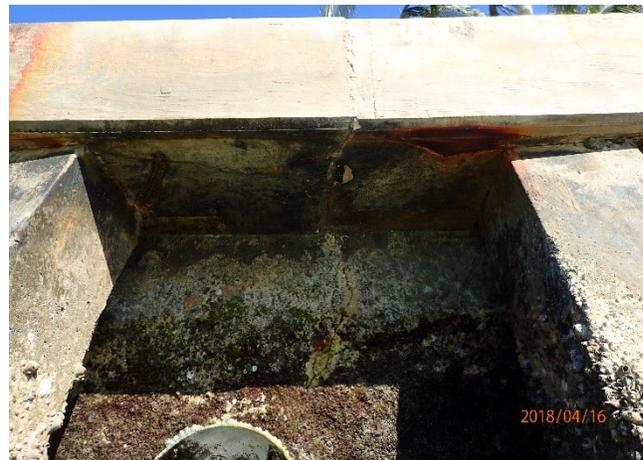
Property Address: 9920 W BROADVIEW DR  
Bay Harbor Islands, FL 33154  
Location: S-1.1 Lot#12  
Date of Inspection: 4/16/2018 @ 5:00pm

- Seawall Rating: Fair
- Dock Rating: (North) Satisfactory  
(South) Fair

- Wall Panels – Concrete erosion in splash zone
- Cap – Cracking at soffit
- T-Piles – Corrosion at t-pile anchor heads
- Dock – Moderate to severe corrosion at fasteners/straps

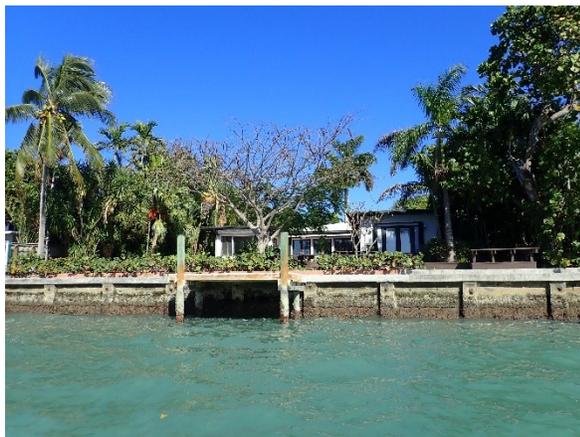
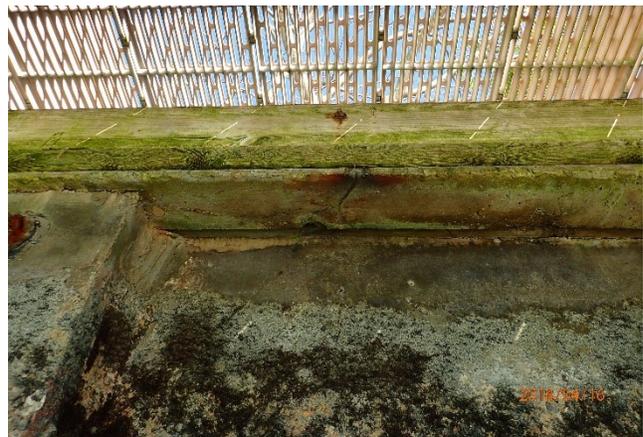
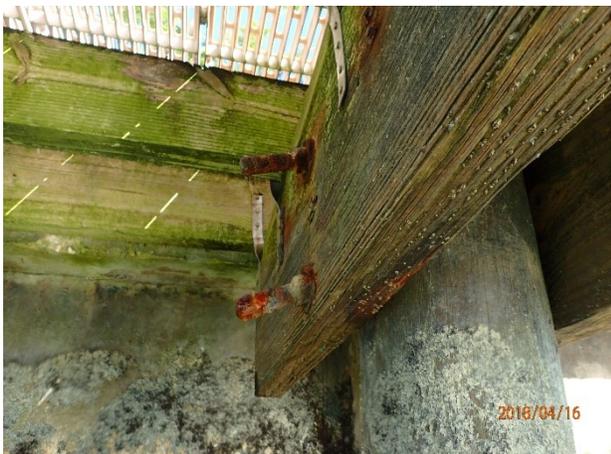
Property Address: 9930 W BROADVIEW DR  
Bay Harbor Islands, FL 33154  
Location: S-1.1 Lot#13  
Date of Inspection: 4/16/2018 @ 5:00pm

- Seawall Rating: Poor
- Dock Rating: Poor

- Cap – Spalling and cracking at North property line
- Batter Piles – Moderate impact cracking
- Dock – Corrosion at fasteners/straps

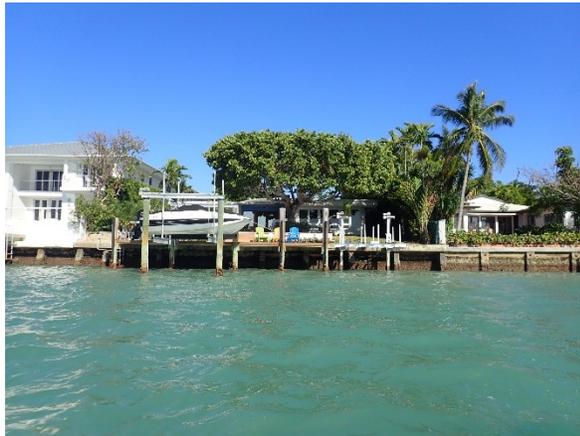
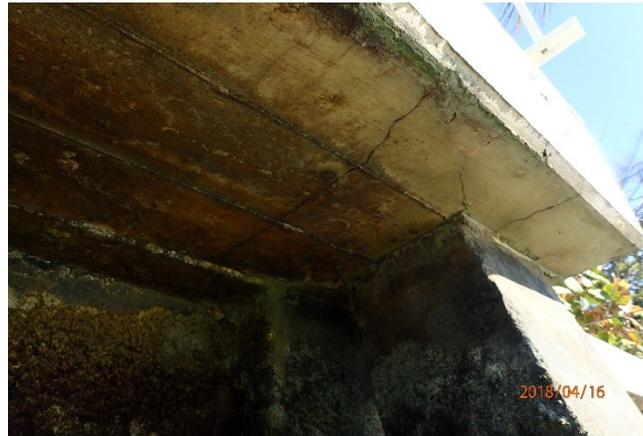
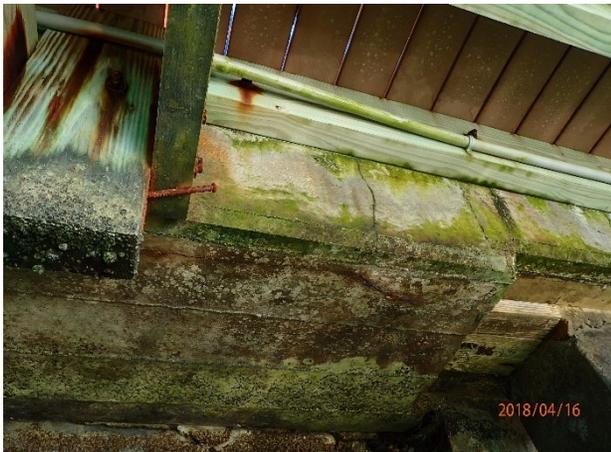
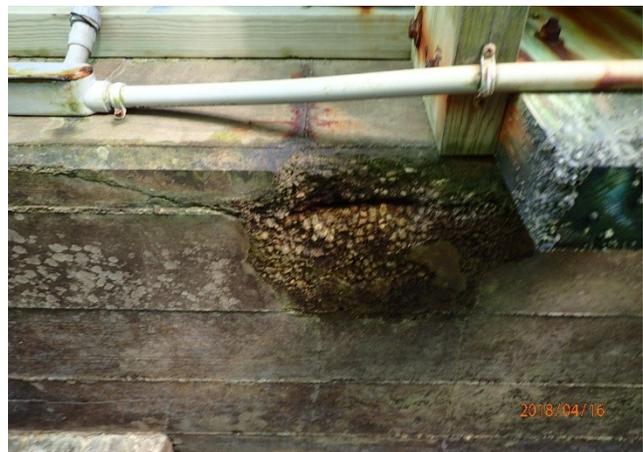
Property Address: 10000 W BROADVIEW DR  
Bay Harbor Islands, FL 33154  
Location: S-1.1 Lot#14  
Date of Inspection: 4/16/2018 @ 4:00pm

• Seawall Rating: Fair      • Dock Rating: Fair

- Cap – Minor spalling and cracking at soffit
- T-Piles – Pile/panel separation with sediment accumulation
- Batter Piles – Impact cracking at pile heads
- Dock – Moderate corrosion at fasteners/straps

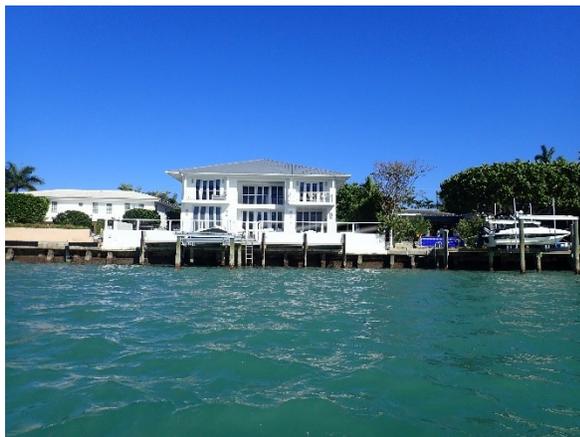
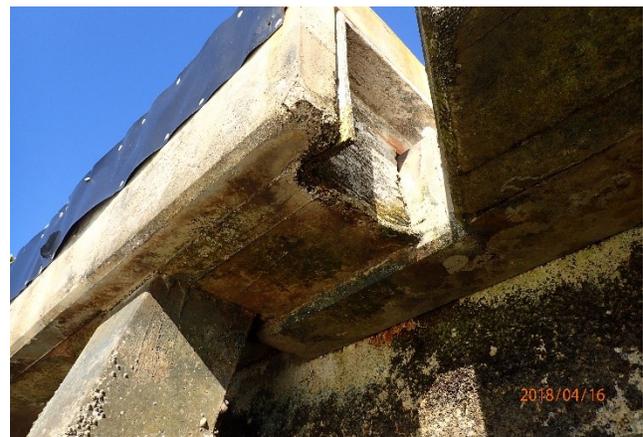
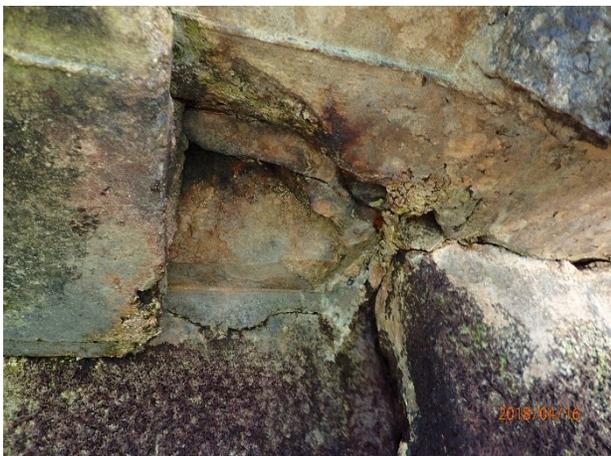
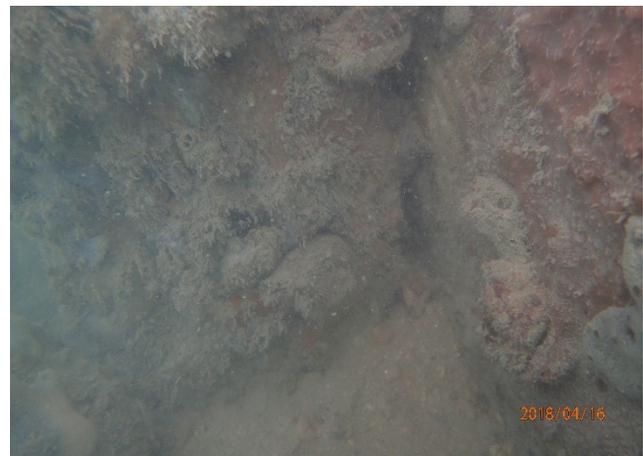
Property Address: 10006 W BROADVIEW DR  
Bay Harbor Islands, FL 33154  
Location: S-1.1 Lot#15  
Date of Inspection: 4/16/2018 @ 4:10pm

• Seawall Rating: Fair      • Dock Rating: Fair

- T-Piles – Moderate concrete erosion at splash zone
- Dock – Significant corrosion at fasteners

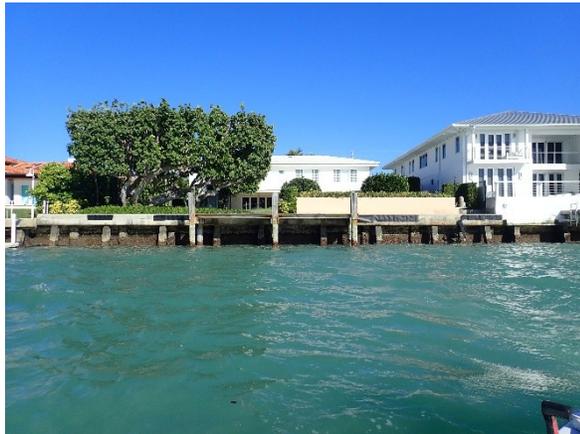
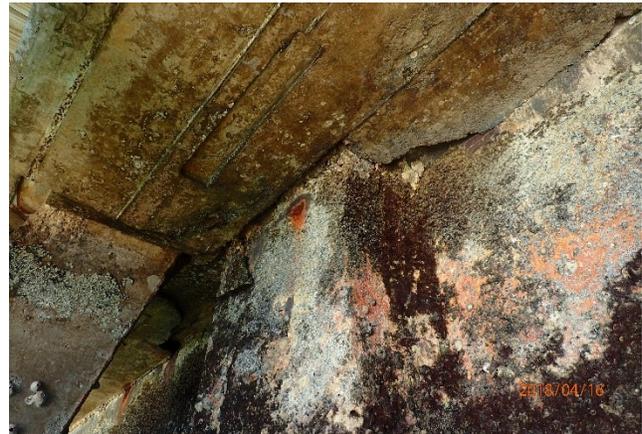
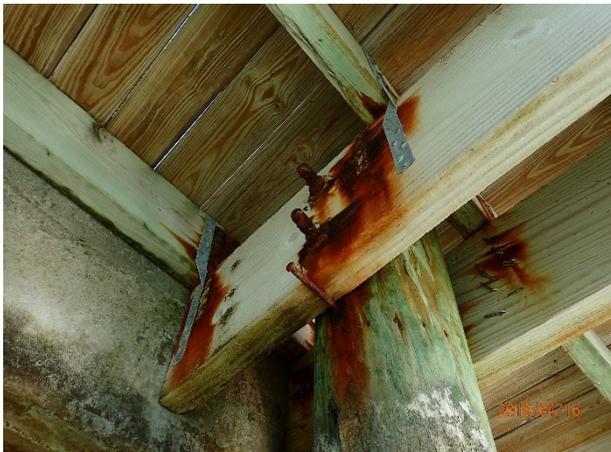
Property Address: 10010 W BROADVIEW DR  
Bay Harbor Islands, FL 33154  
Location: S-1.1 Lot#16  
Date of Inspection: 4/16/2018 @ 5:20pm

• Seawall Rating: Fair      • Dock Rating: Fair

- Wall Panels – Moderate cracking at tidal zone
- Cap – Moderate cracking with corrosion staining
- T-Piles – Pile/panel separation with sediment accumulation
- Batter Piles – Severe cracking and spalling below cap
- Dock – Joists toe nailed to beams, capacity should be verified with enhanced oil recovery

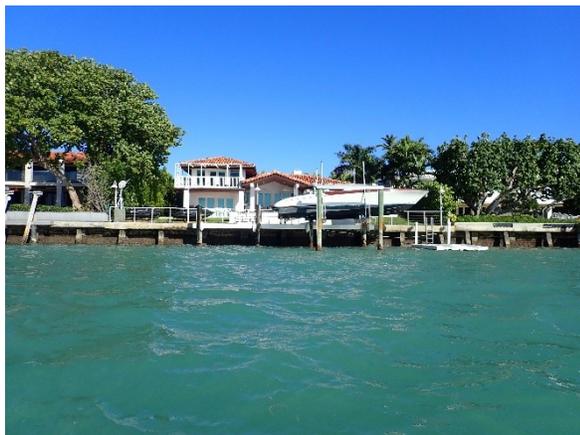
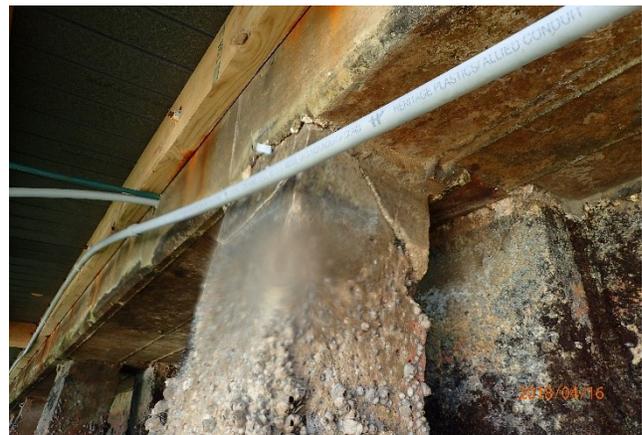
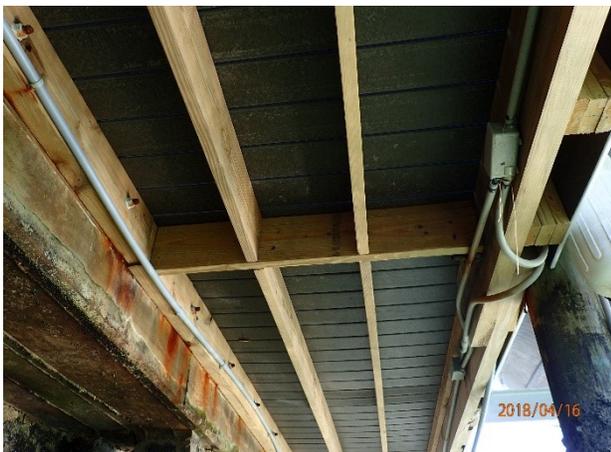
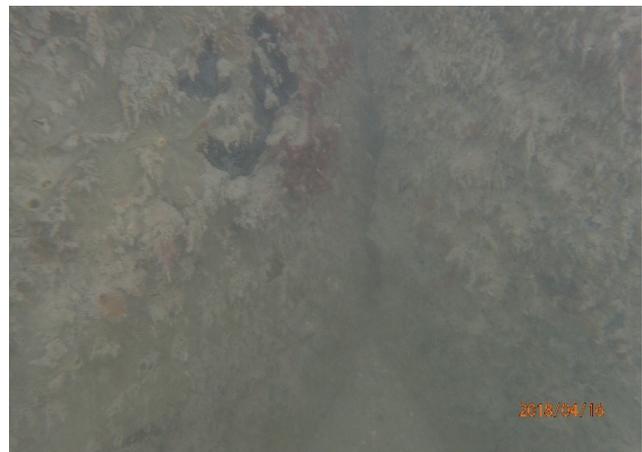
Property Address: 10020 W BROADVIEW DR  
Bay Harbor Islands, FL 33154  
Location: S-1.1 Lot#17  
Date of Inspection: 4/16/2018 @ 5:20pm

• Seawall Rating: Poor

• Dock Rating: Fair

- Wall Panels – Moderate concrete erosion and spalling
- Cap – Minor to moderate cracking
- T-Piles – Moderate concrete erosion and necking
- Dock – Minor to moderate cracking at joists/beams

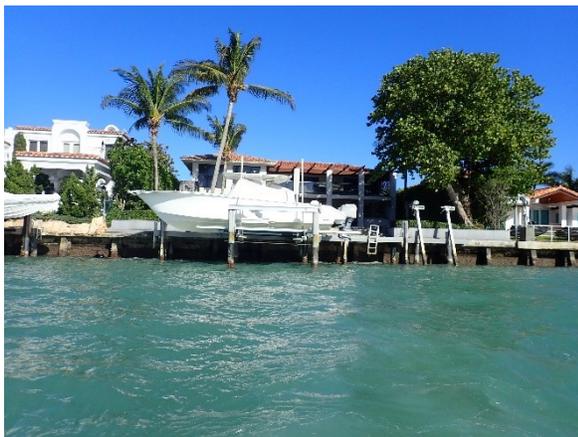
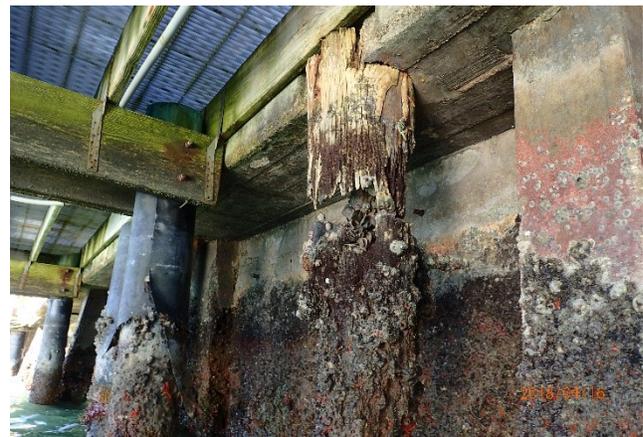
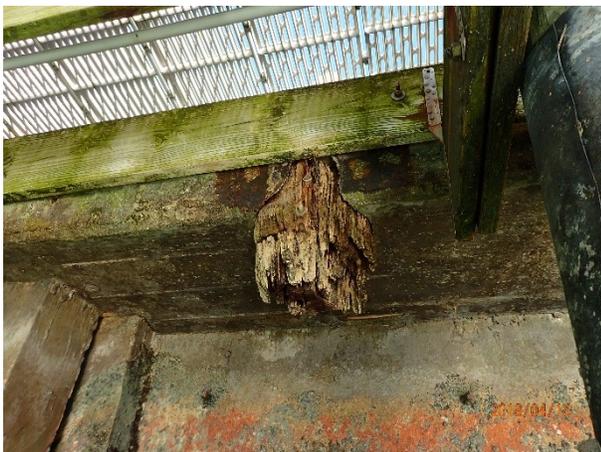
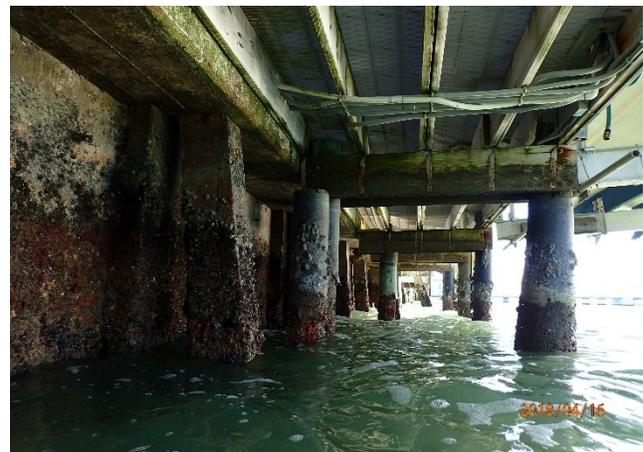
Property Address: 10050 W BROADVIEW DR  
Bay Harbor Islands, FL 33154  
Location: S-1.1 Lot#18  
Date of Inspection: 4/16/2018 @ 5:30pm

• Seawall Rating: Fair      • Dock Rating: Fair

- Cap – Minor to moderate cracking with corrosion staining
- T-Piles – Moderate concrete erosion and necking
- Batter Piles – Cracking at pile heads
- Docks – Moderate to severe corrosion at fasteners/straps

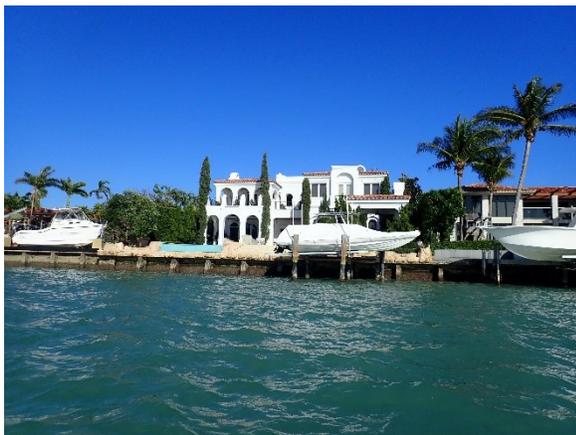
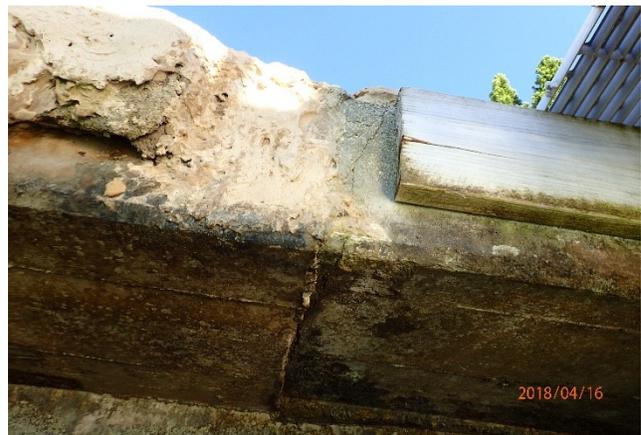
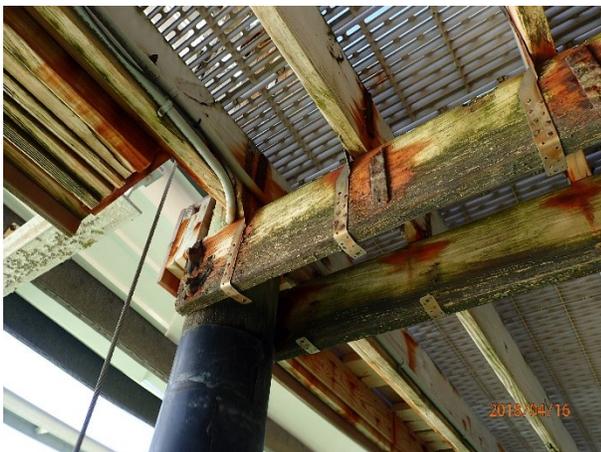
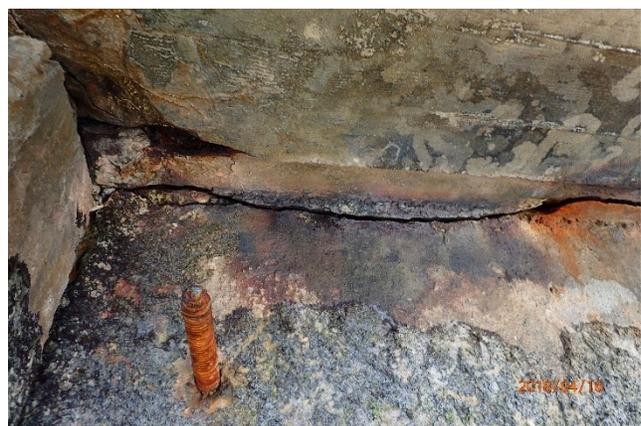
- Wall Panels – Moderate concrete erosion and cracking
- Cap – Cracking with corrosion staining at soffit and wet face
- King Piles – Cracking and concrete erosion
- Docks – Moderate to severe corrosion at fasteners/straps

• Seawall Rating: Poor      • Dock Rating: Fair

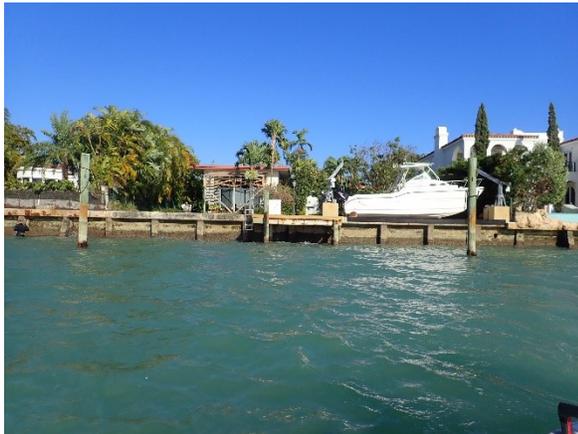
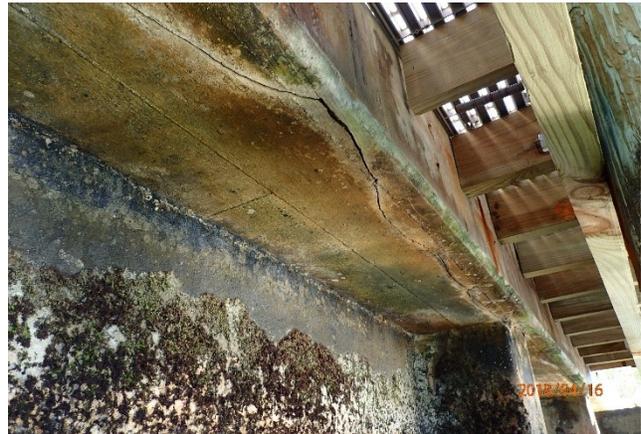
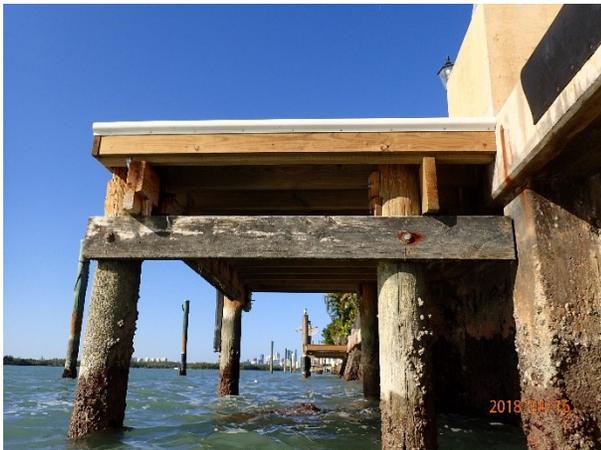
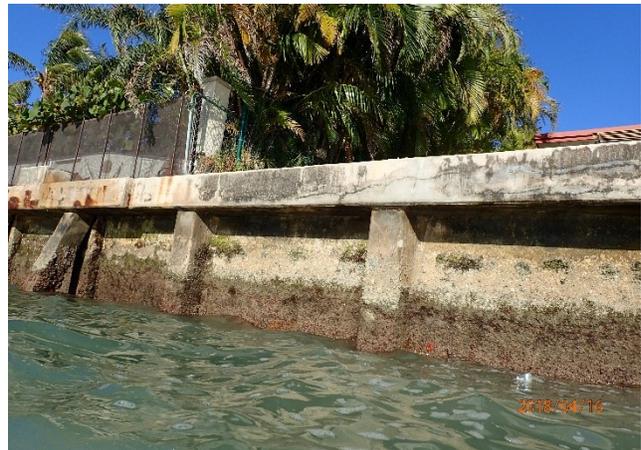
- Cap – Cracking with corrosion staining at soffit and wet face
- T Piles – Moderate cracking and Minor concrete erosion
- T Piles – Moderate concrete erosion and separation from wall panels
- Dock – Corrosion at beam and pile bolts
- Dock – Moderate deterioration of piles

• Seawall Rating: Fair      • Dock Rating: Fair

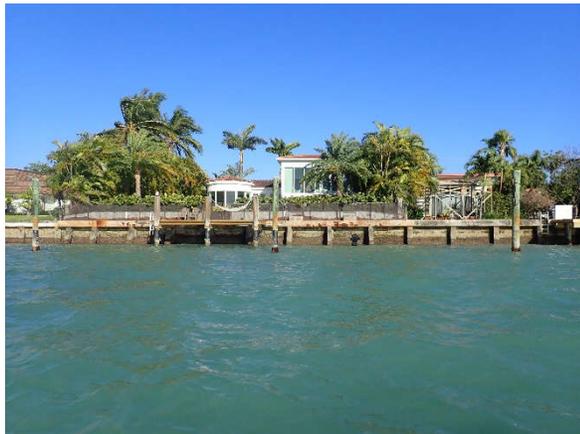
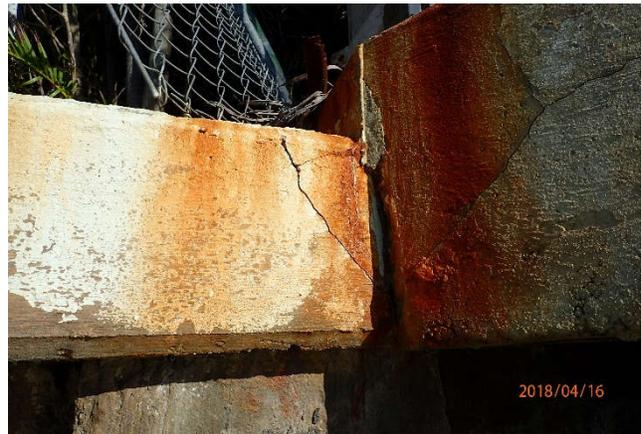
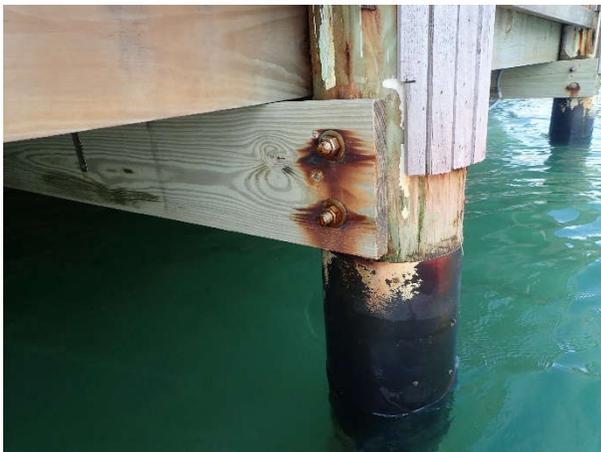
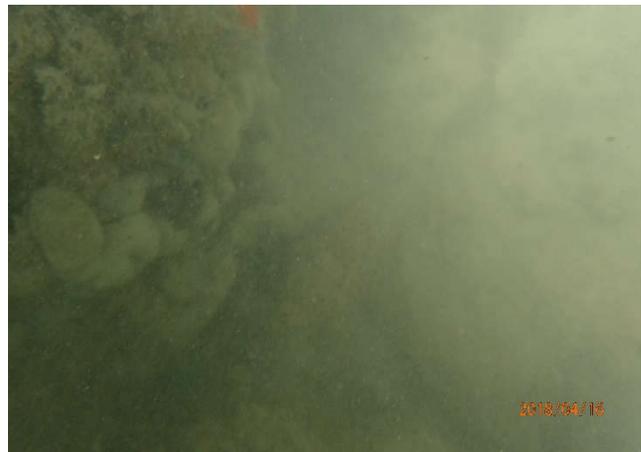
- Cap – Moderate cracking along the wet face
- Wall Panels – Moderate concrete erosion and cracking at tidal zone
- Piles – Moderate necking and concrete erosion
- Dock – Deck demolished

• Seawall Rating: Poor      • Dock Rating: N/A

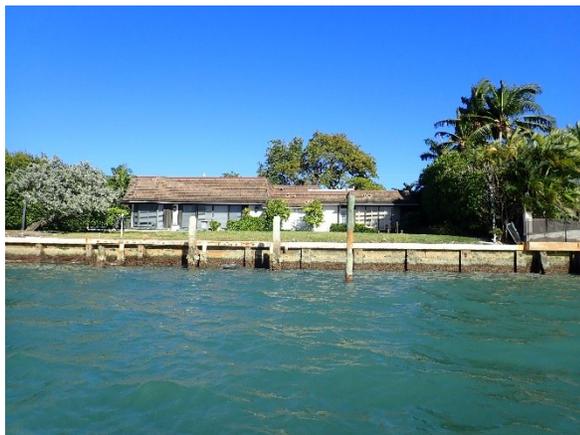
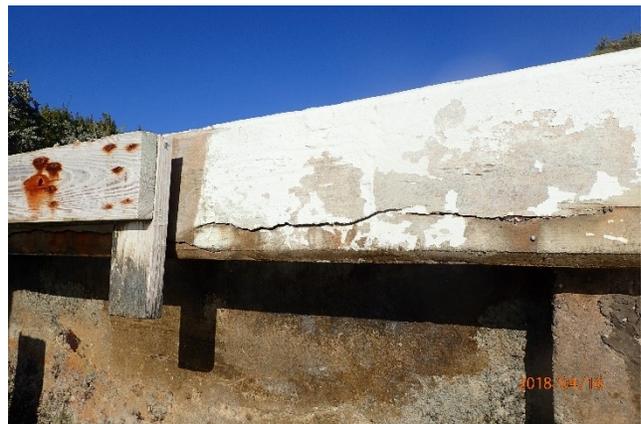
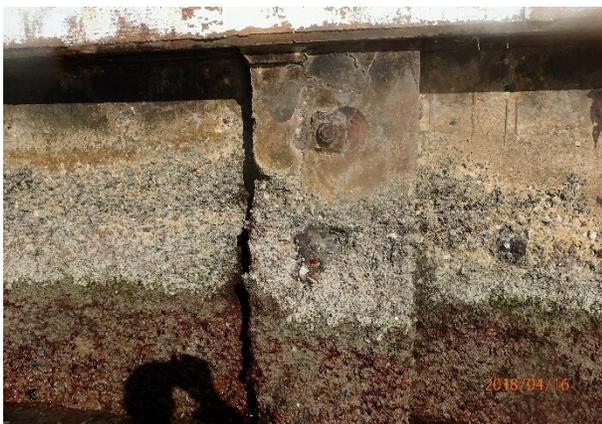
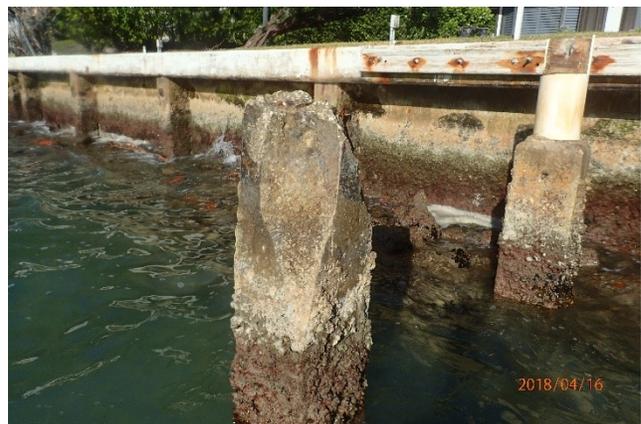
- Cap – Moderate to severe cracking with corrosion staining along the wet face
- Wall Panels – Moderate necking and concrete erosion
- Piles – Moderate necking and concrete erosion
- Dock – Moderate corrosion at dock fasteners

• Seawall Rating: Poor      • Dock Rating: Poor

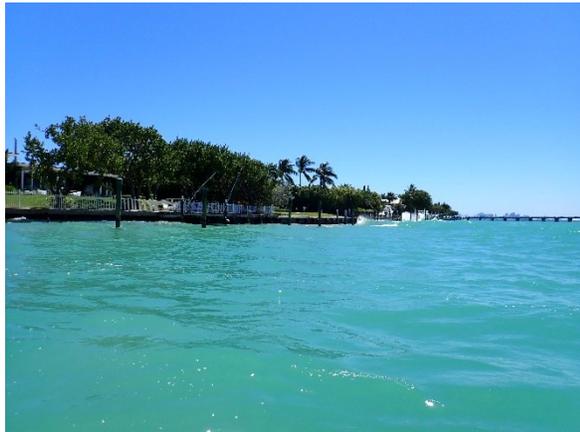
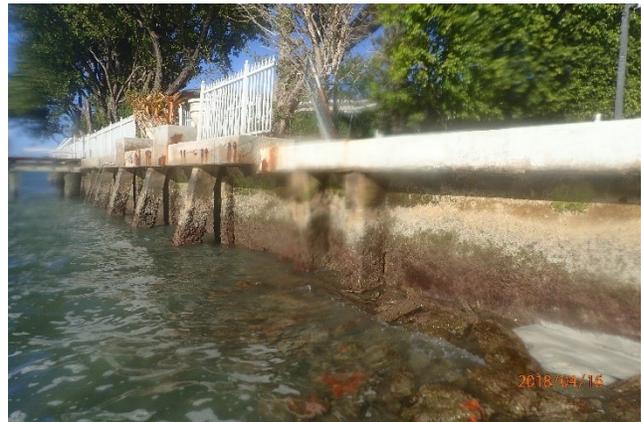
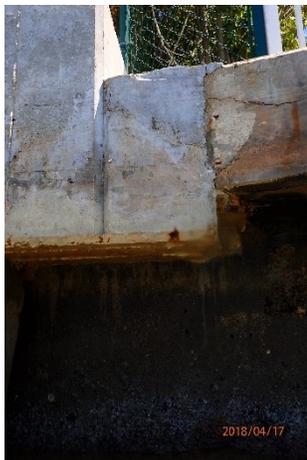
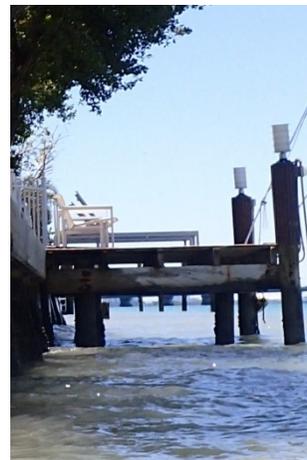
- Wall Panels - Severe spalling at top of North panels
- King Piles – Severe spalling and deterioration with exposed steel reinforcement
- T-Piles - Moderate erosion with severe cracking and an exposed bar. Deterioration at top
- Seawall experiences heavy wake

• Seawall Rating: Poor

• Dock Rating: Satisfactory

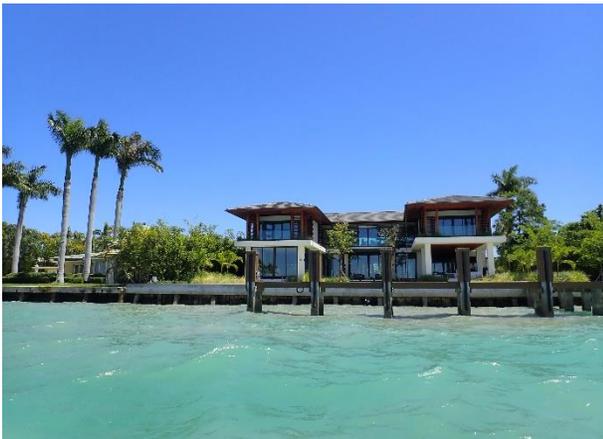
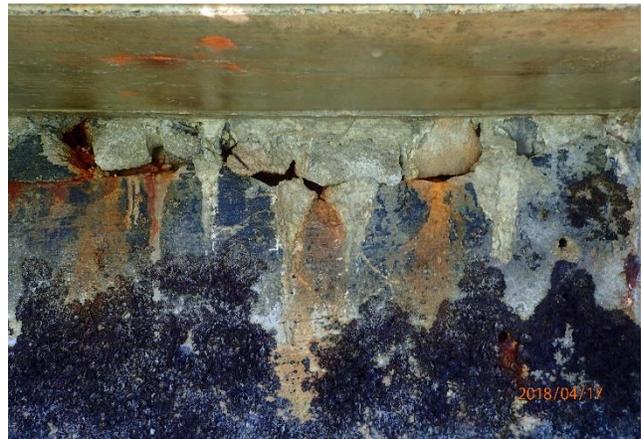
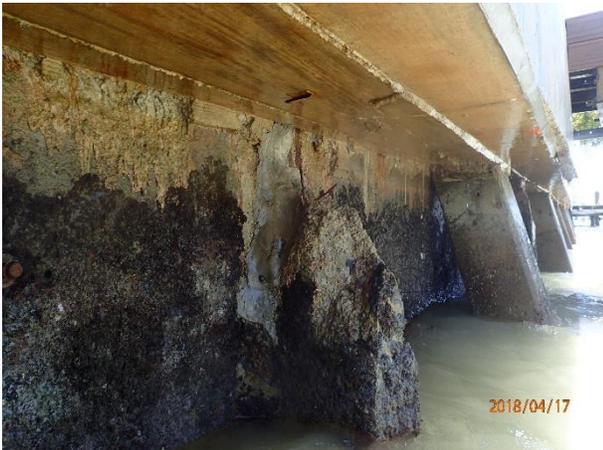
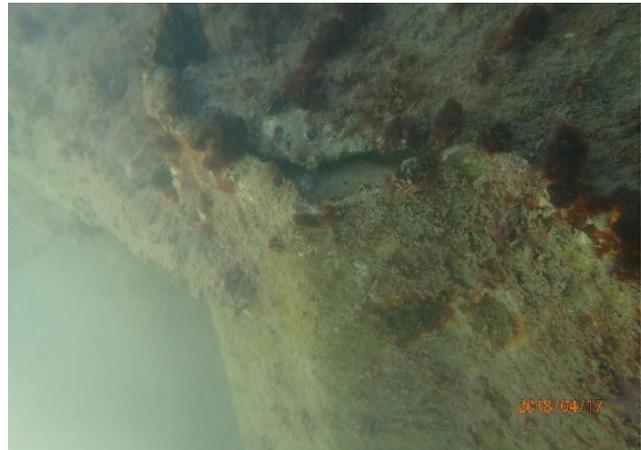
- Cap – Cracking at wet face and soffit
- Cap – Spalling and deterioration
- Batter Piles – Minor surface pitting
- Batter Piles – Moderate deterioration and cracking with corrosion staining

• Seawall Rating: Poor      • Dock Rating: Fair

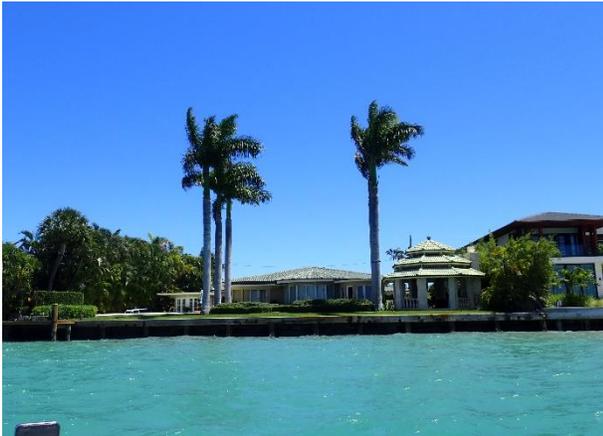
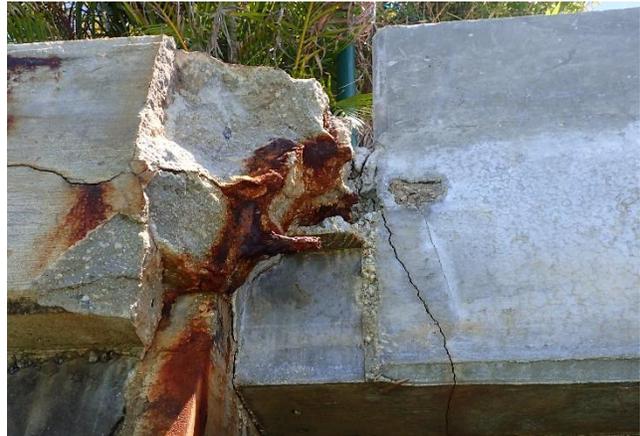
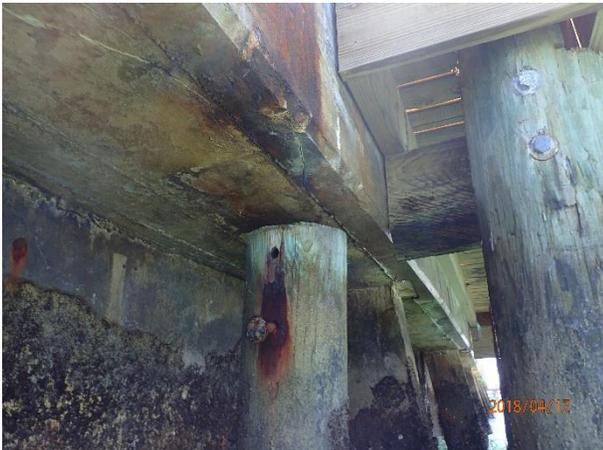
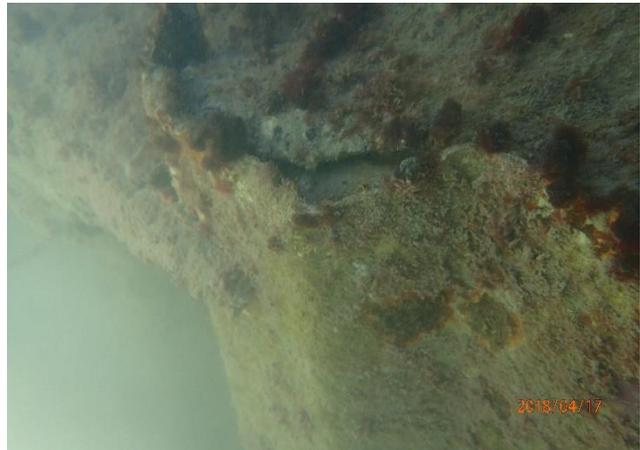
- Wall Panels – Minor erosion at tidal zone
- Cap – Severe cracking and deterioration at original cap
- Batter Piles – Minor concrete erosion
- Dock – Fastener corrosion, missing straps

• Seawall Rating: Fair      • Dock Rating: Fair

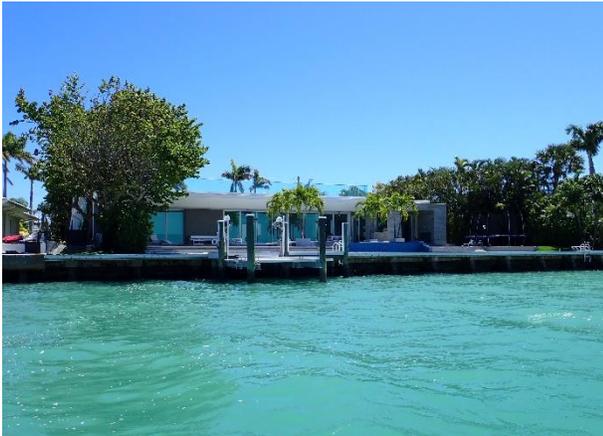
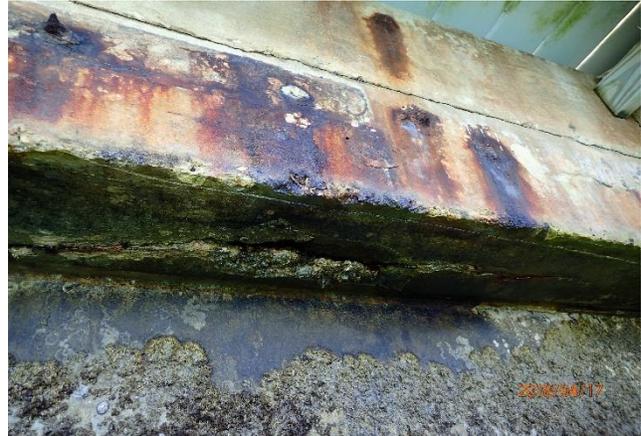
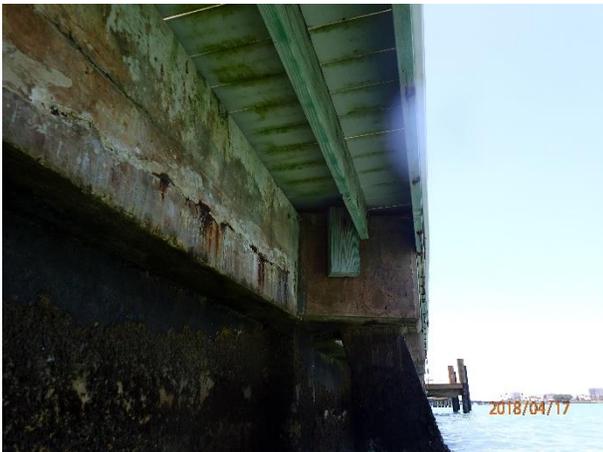
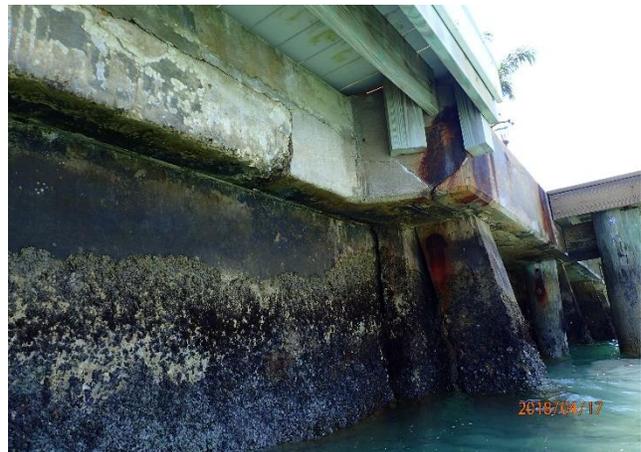
- Wall Panels – Minor concrete erosion at tidal zone
- T-Piles – Necking at tidal zone
- Dock – Corrosion at fasteners

• Seawall Rating: Fair      • Dock Rating: Fair
