# Seawall Condition and Resiliency Assessment Town of Bay Harbor Islands

October 2019 (Updated)

**Cummins Cederberg, Inc.**

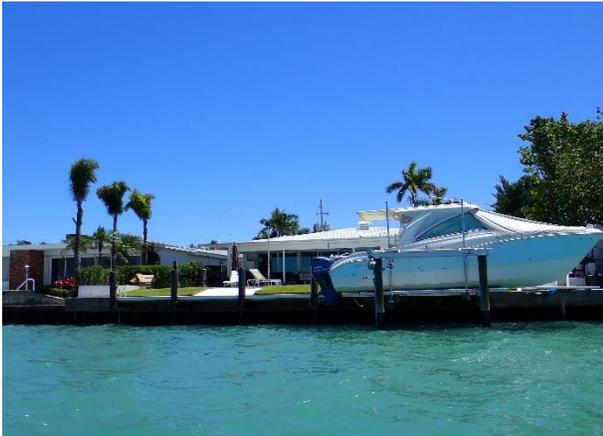
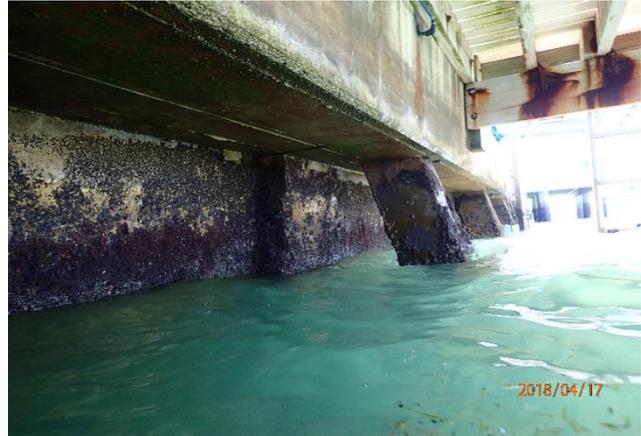
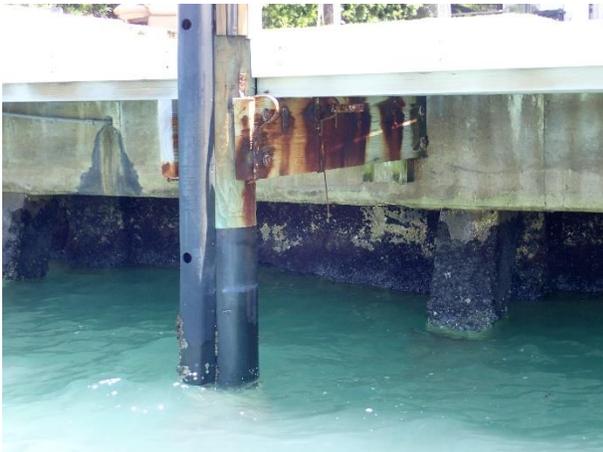
- Cap – Severe cracking along bottom and wet face
- T-Piles – Minor necking at tidal zone
- Batter Piles – Minor necking and spalling

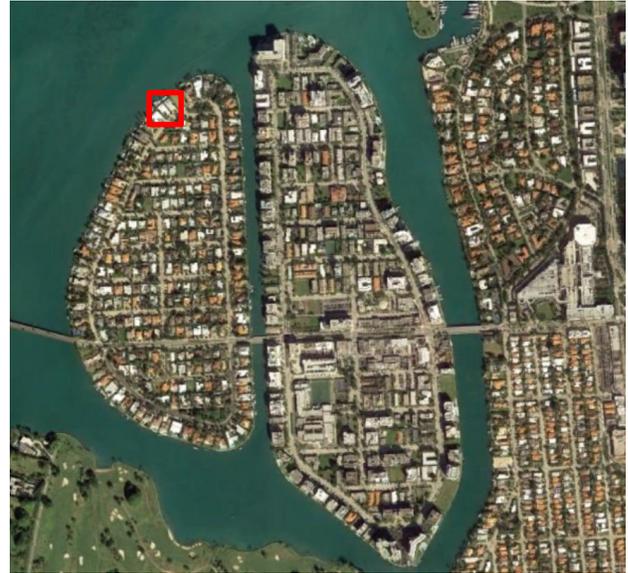
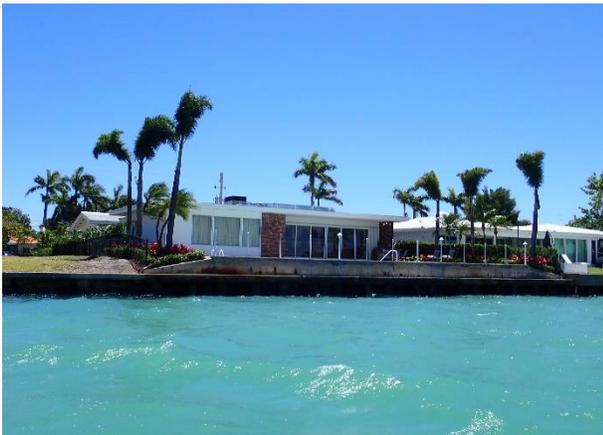
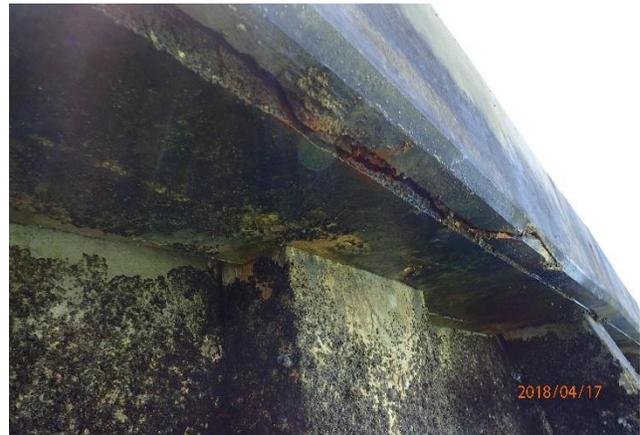
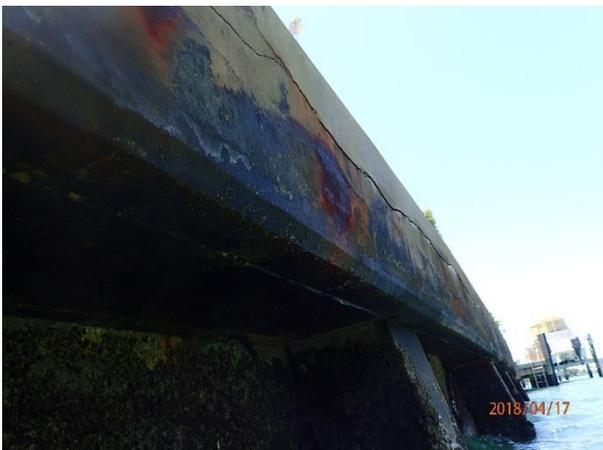
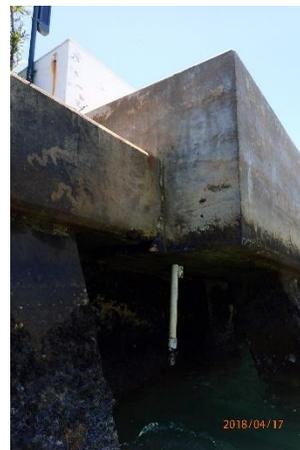
• Seawall Rating: Fair                      • Dock Rating: N/A

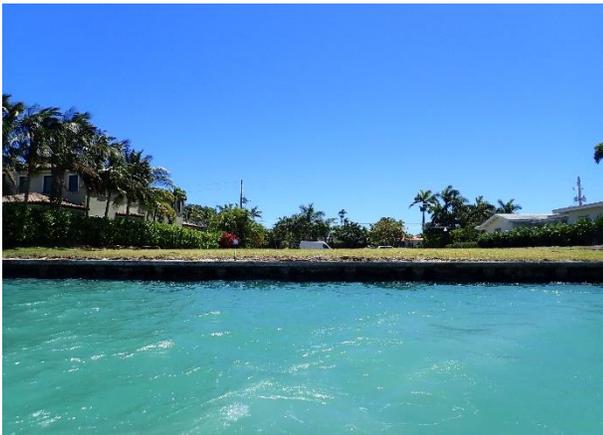
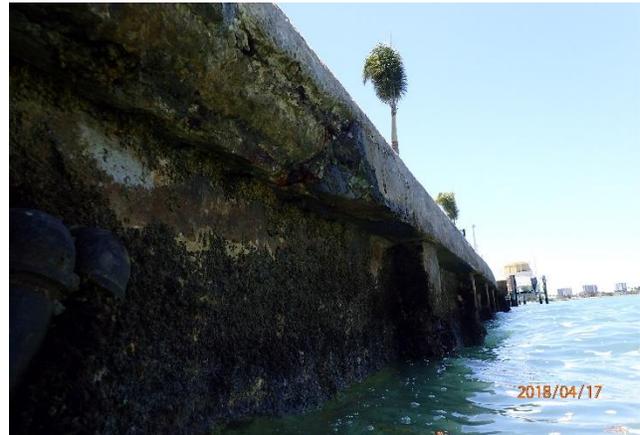
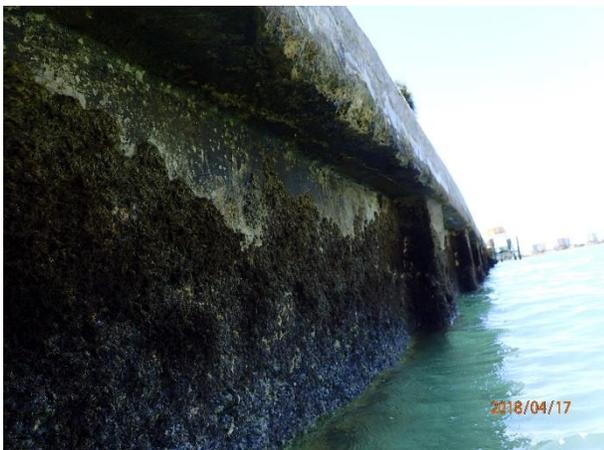
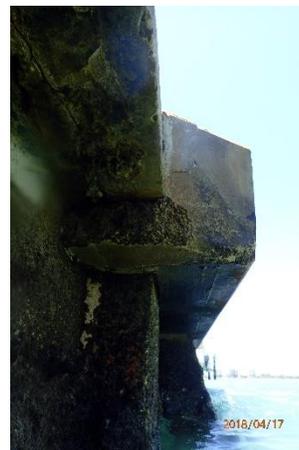
Property Address: 10312 W BROADVIEW DR  
Bay Harbor Islands, FL 33154  
Location: S-1.1 Lot#28  
Date of Inspection: 4/17/2018 @ 1:25pm

- Wall Panels – Minor cracking
- Wall Panels – Moderate to severe concrete erosion
- Cap – Moderate cracking at wet face
- Cap – Significant spalling and deterioration

• Seawall Rating: Poor

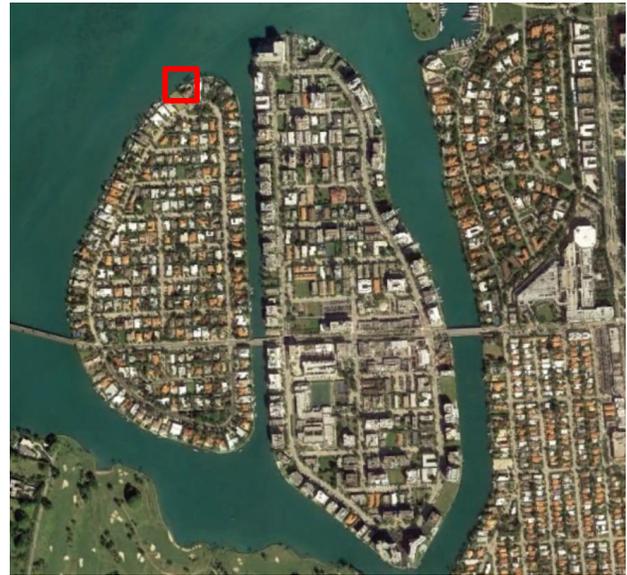
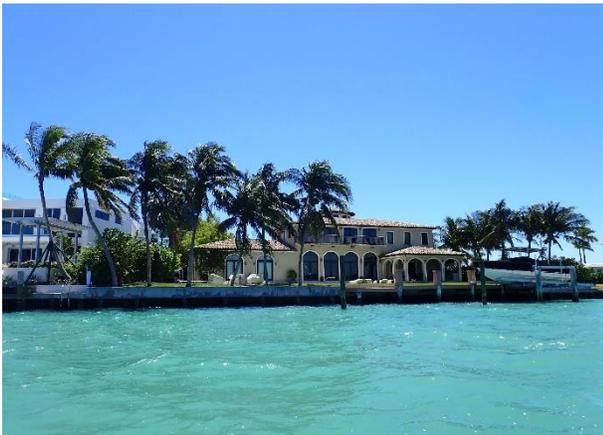
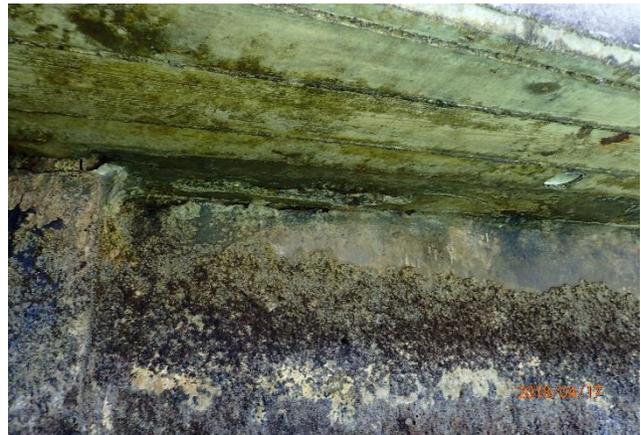
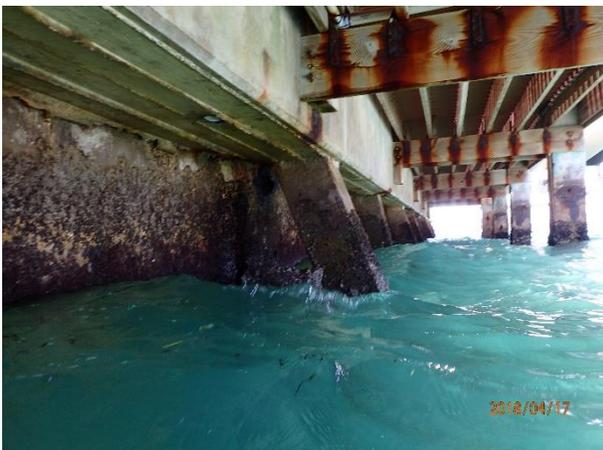
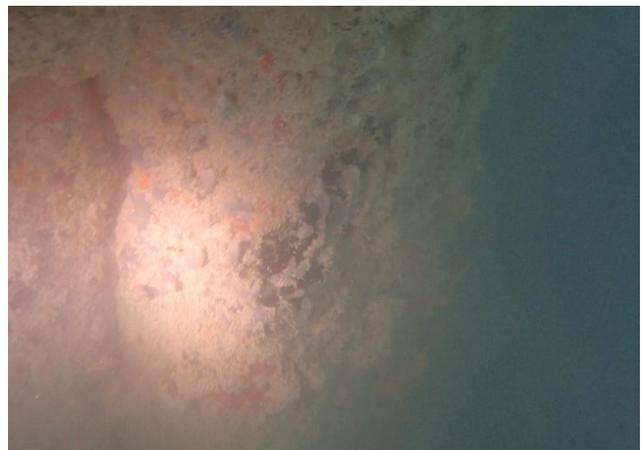
Property Address: 10330 W BROADVIEW DR  
Bay Harbor Islands, FL 33154  
Location: S-1.1 Lot#29  
Date of Inspection: 4/17/2018 @ 1:20pm

- Cap – Corrosion staining
- T-Piles – Northern pile head double anchor
- King Piles – Degradation of king piles
- Dock – Severe corrosion at straps

• Seawall Rating: Fair      • Dock Rating: Fair

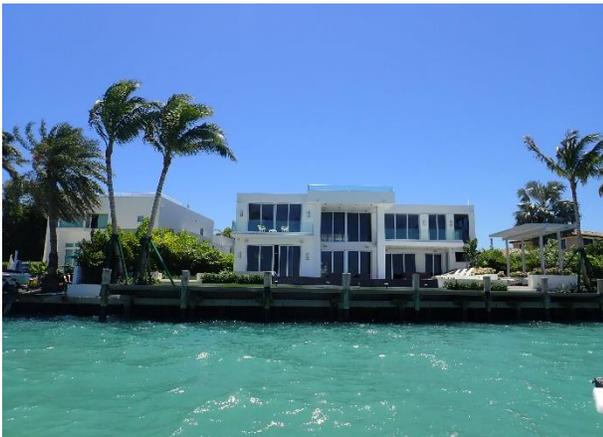
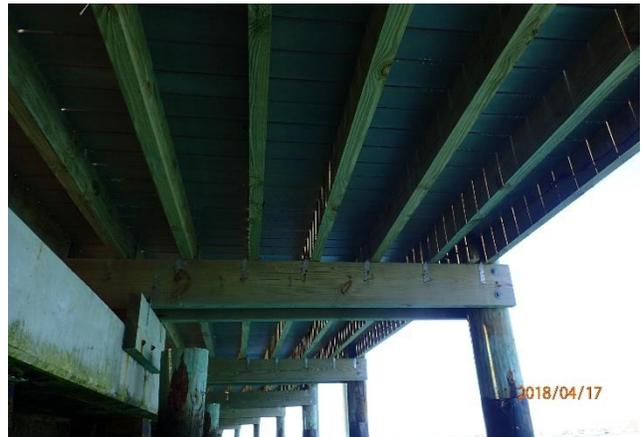
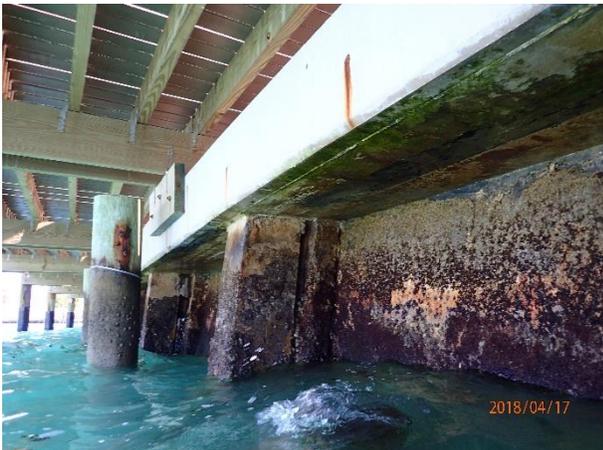
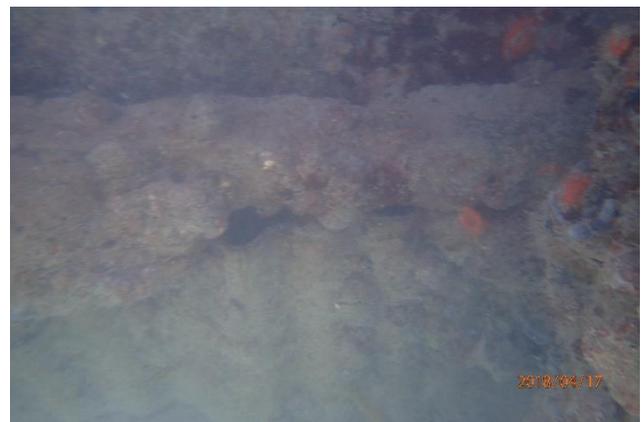
Property Address: 10340 W BROADVIEW DR  
Bay Harbor Islands, FL 33154  
Location: S-1.1 Lot#30  
Date of Inspection: 4/17/2018 @ 1:10pm

- Wall Panels – Rotation of the wall along bottom panels
- Cap – Moderate cracking at wet face and soffit
- T-Piles – Pile/panel separation
- Toe Wall – Separation from wall panels, partial collapse

• Seawall Rating: Fair      • Dock Rating: Satisfactory

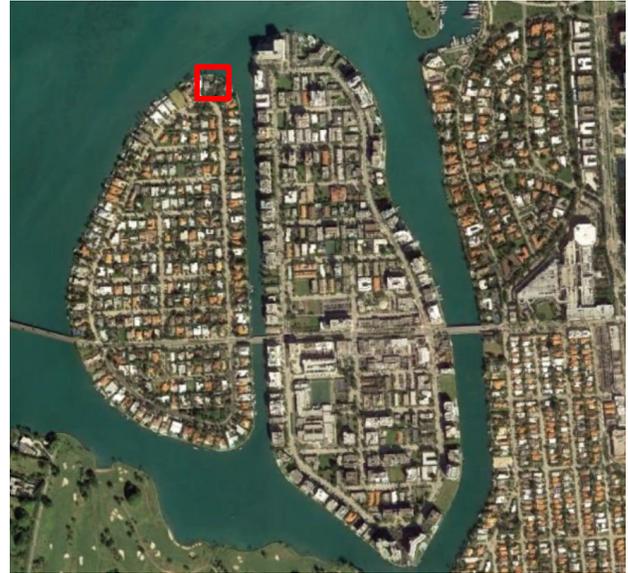
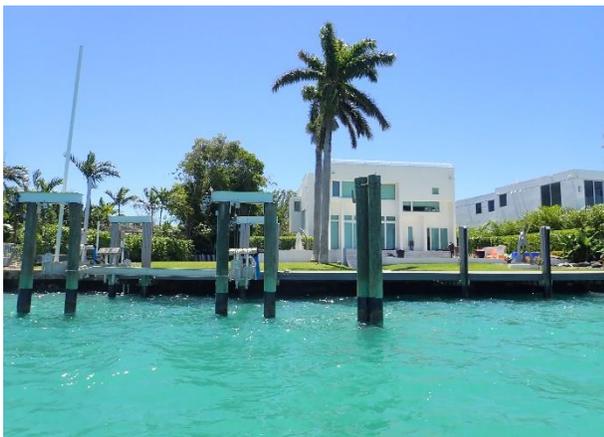
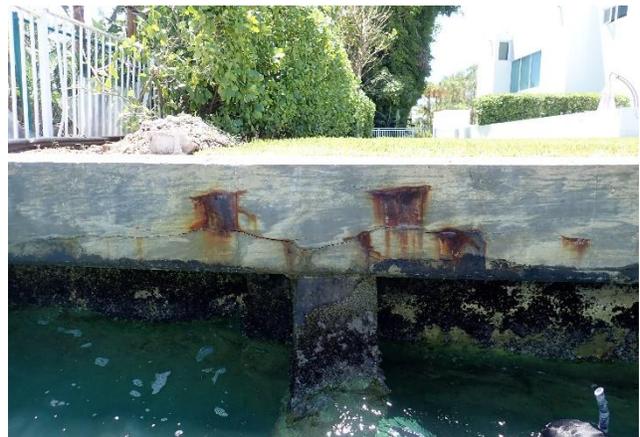
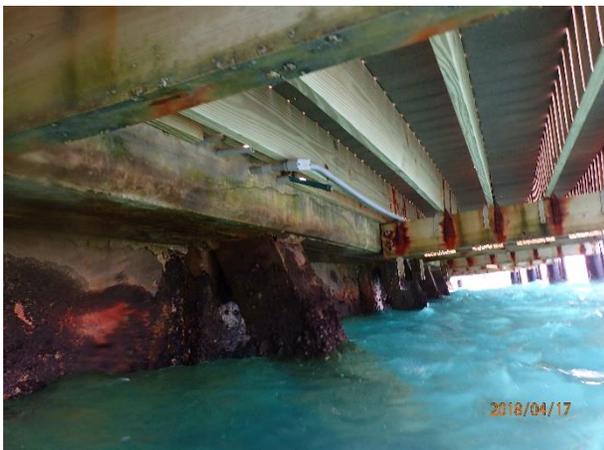
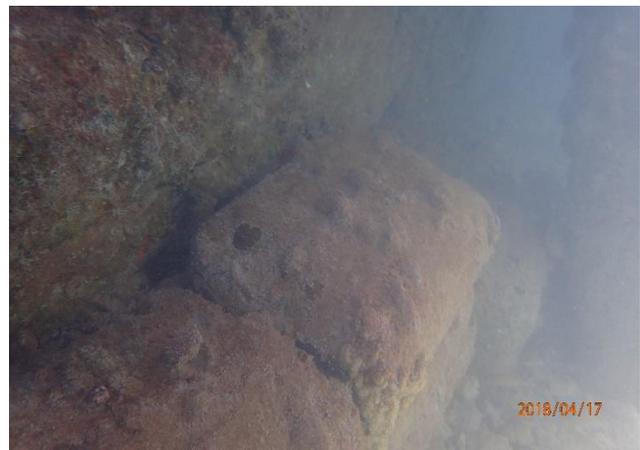
Property Address: 10337 E BROADVIEW DR  
Bay Harbor Islands, FL 33154  
Location: S-1.1 Lot#31  
Date of Inspection: 4/17/2018 @ 1:00pm

- Wall Panels – Severe undermining
- Cap – Severe cracking at wet face and soffit with corrosion staining
- Docks – Corrosion at fasteners
- Toe Wall – Voids along toe, partial collapse

• Seawall Rating: Fair                      • Dock Rating: Fair

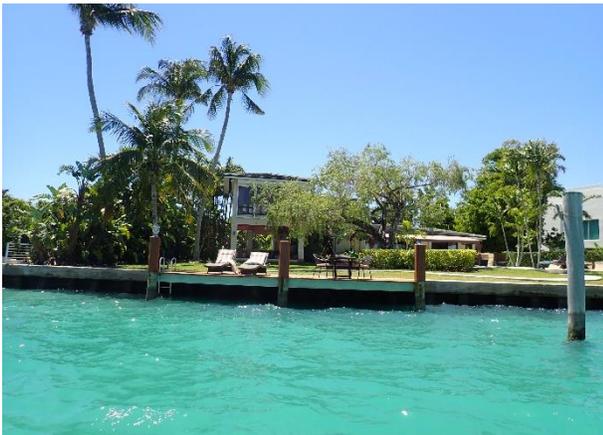
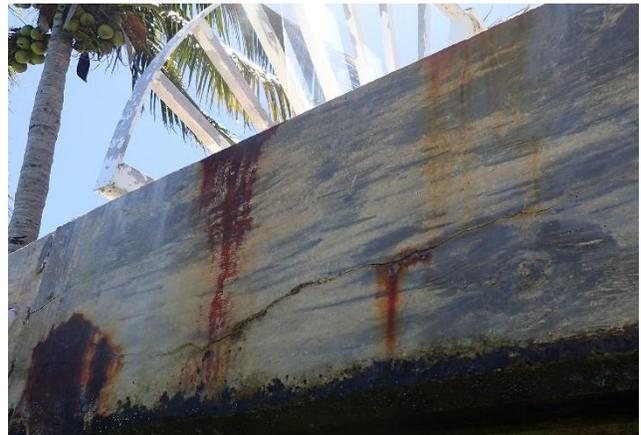
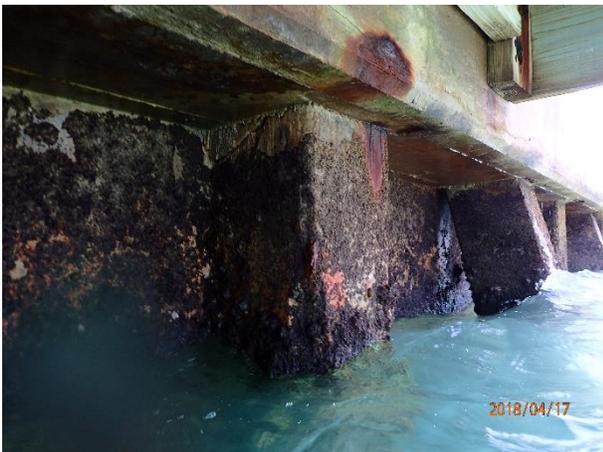
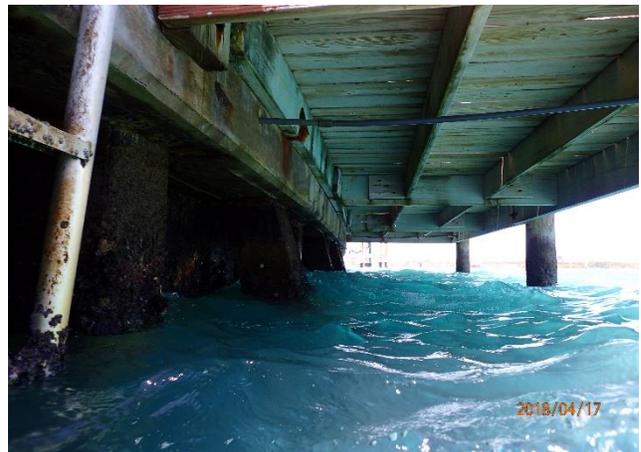
Property Address: 10331 E BROADVIEW DR  
Bay Harbor Islands, FL 33154  
Location: S-1.1 Lot#32  
Date of Inspection: 4/17/2018 @ 12:50pm

- Cap – Moderate cracking at wet face with corrosion stains
- King Piles – Moderate cracking at pile heads
- Dock – Corrosion at fasteners

• Seawall Rating: Fair    • Dock Rating: Fair

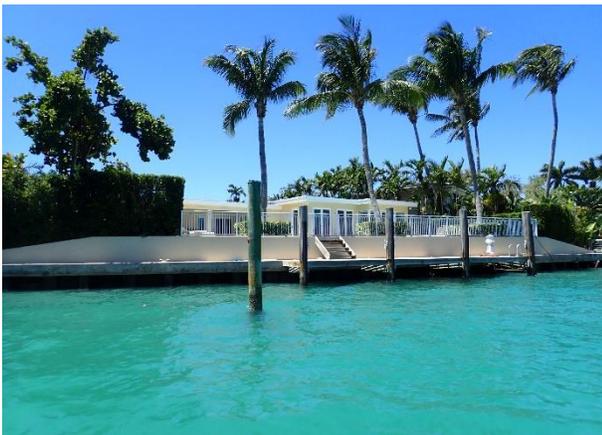
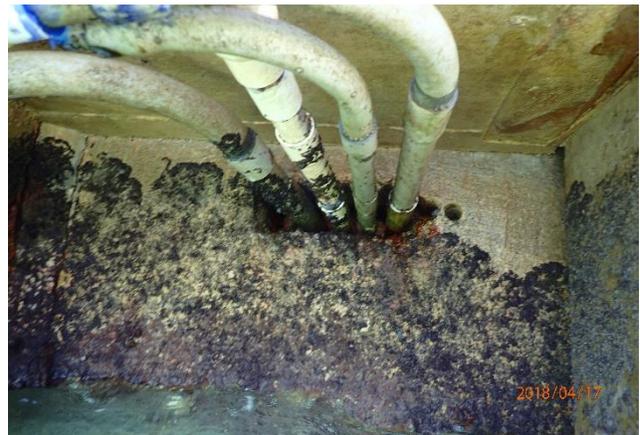
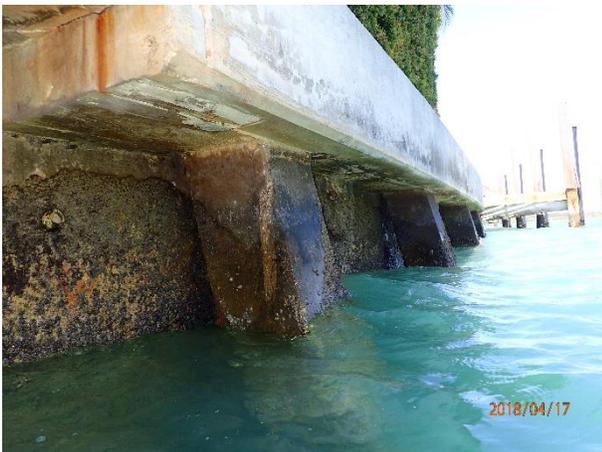
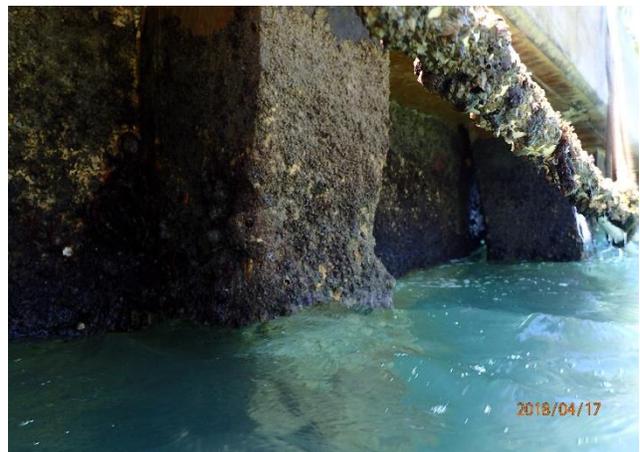
Property Address: 10321 E BROADVIEW DR  
Bay Harbor Islands, FL 33154  
Location: S-1.1 Lot#33  
Date of Inspection: 4/17/2018 @ 12:45pm

- Wall Panels – Minor concrete erosion at tidal zone
- King Piles – Moderate cracking at pile heads
- T-Piles- Moderate cracking and necking at tidal zone
- Dock – Corrosion at fasteners
- Dock Piles – Moderate “salt-kill”

• Seawall Rating: Fair    • Dock Rating: Fair

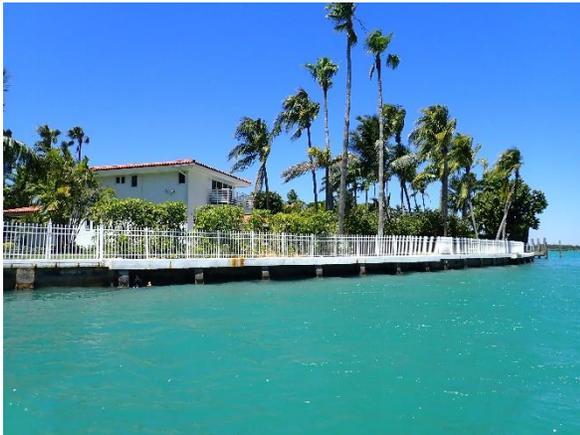
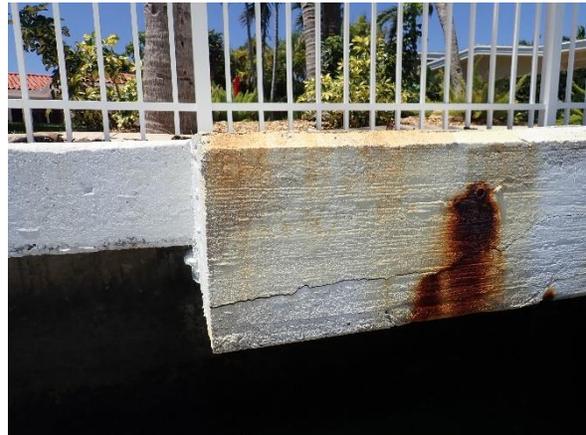
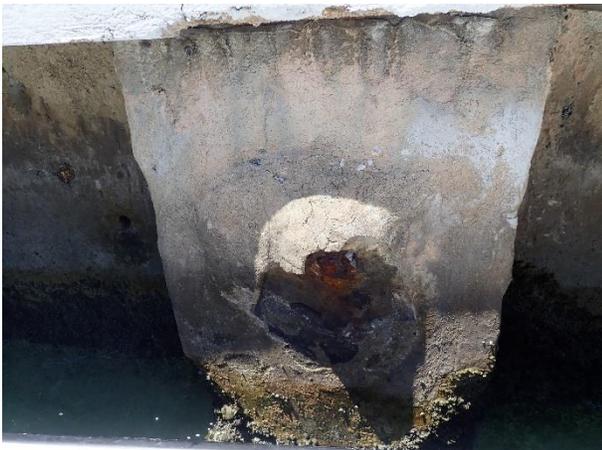
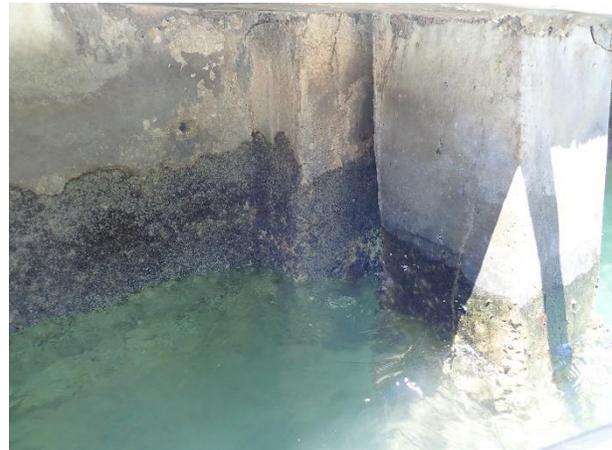
Property Address: 10301 E BROADVIEW DR  
Bay Harbor Islands, FL 33154  
Location: S-1.1 Lot#34  
Date of Inspection: 4/17/2018 @ 12:40pm

- Wall Panels – Rotation of the wall with moderate to severe cracking
- Cap – Severe cracking and concrete erosion at wet face and soffit at bump-outs
- T-Piles – Pile/panel separation through unsealed fillets
- T-Piles – Corrosion at pile anchor heads
- T-Piles – Deterioration at pile heads

• Seawall Rating: Fair                      • Dock Rating: N/A

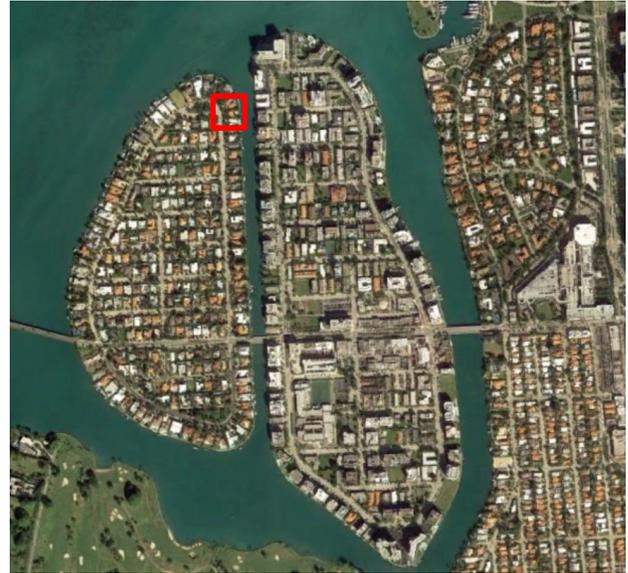
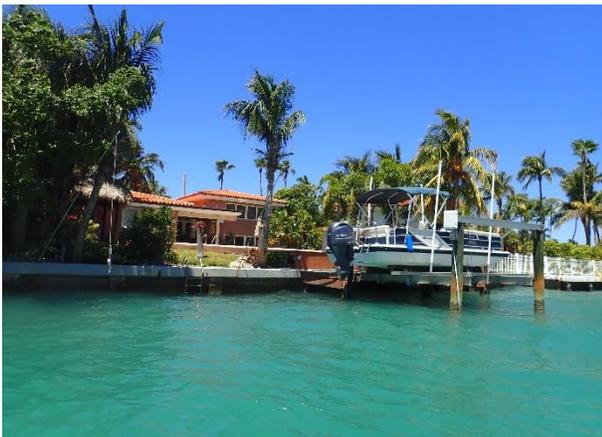
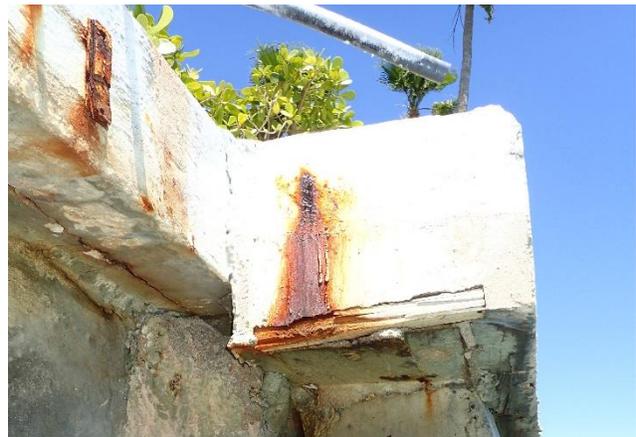
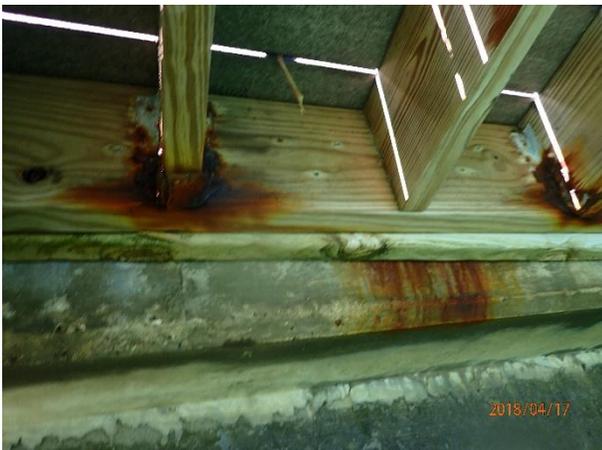
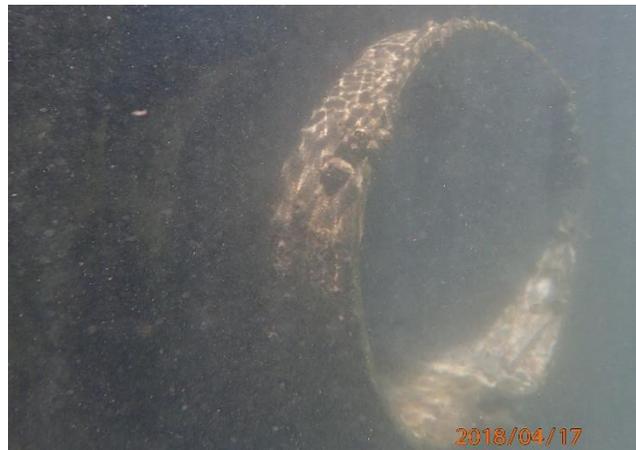
Property Address: 10261 E BROADVIEW DR  
Bay Harbor Islands, FL 33154  
Location: S-1.1 Lot#35  
Date of Inspection: 4/17/2018 @ 12:35pm

- Cap – Moderate cracking corrosion staining at wet face
- Cap – Minor to moderate concrete erosion
- Wall Panels – Minor rotation of the wall
- T-Piles- Moderate concrete erosion and cracking
- Dock – Severe corrosion at fasteners and straps
- Dock – Loose/unsecured timber joists

• Seawall Rating: Fair      • Dock Rating: Serious

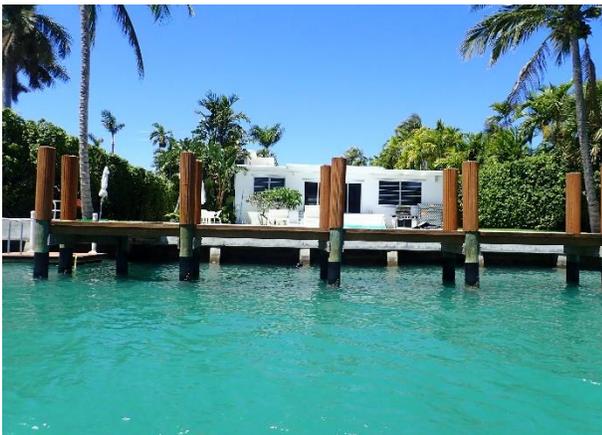
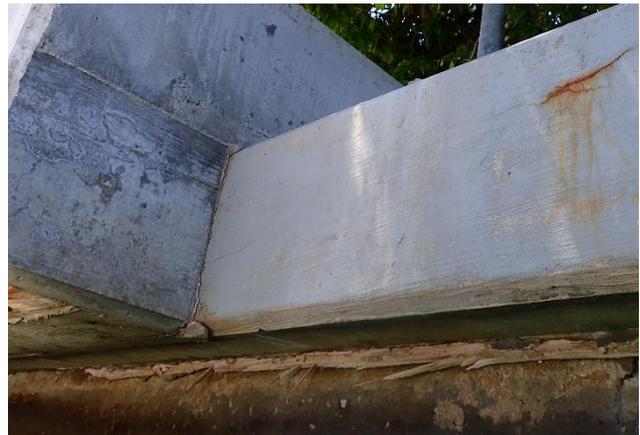
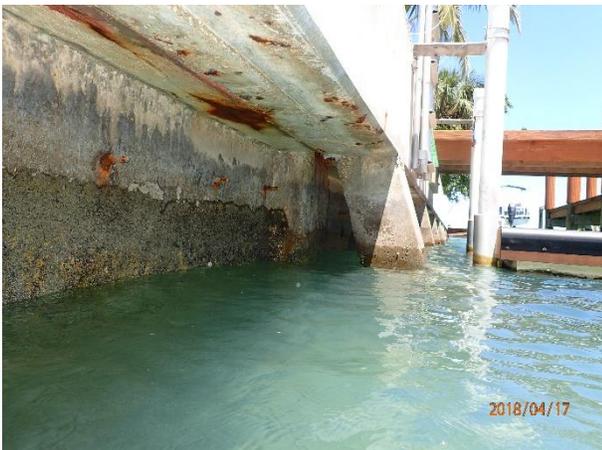
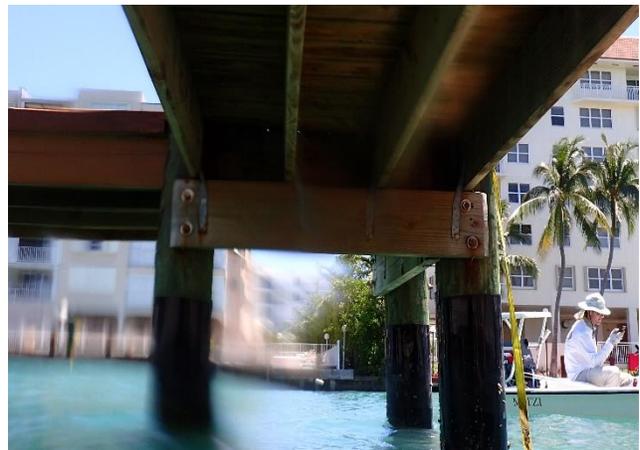
- Cap – Moderate cracking with corrosion staining at soffit
- Cap – Poured new cap topping original cap
- Wall Panels – Minor to moderate concrete erosion at tidal zone
- Dock – Minimal size at threaded rod fasteners

• Seawall Rating: Fair    • Dock Rating: Satisfactory

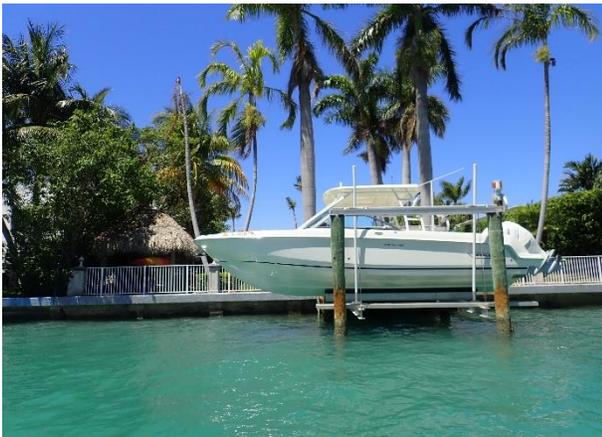
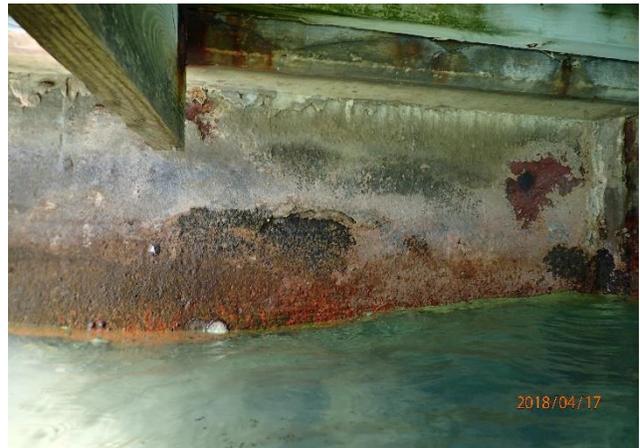
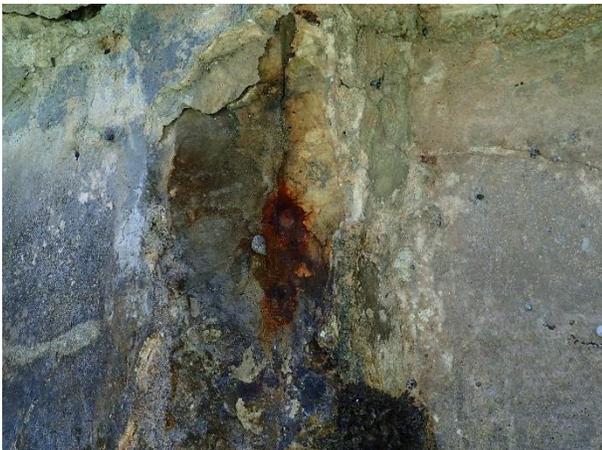
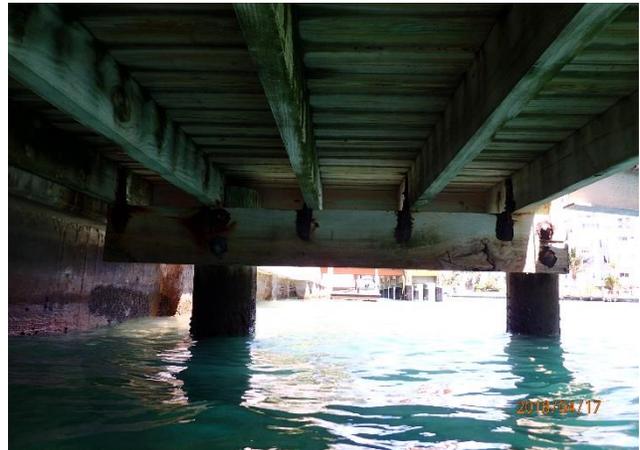
Property Address: 10201 E BROADVIEW DR  
Bay Harbor Islands, FL 33154  
Location: S-1.1 Lot#38  
Date of Inspection: 4/17/2018 @ 12:20pm

- \*Cap – Moderate cracking at soffit with corrosion staining
- \*Wall Panels – Moderate cracking
- \*T-Piles – Moderate necking and cracking at tidal zone
- \*Dock – Moderate to severe corrosion at fasteners
- \*Dock – Timber pile bearing on rock with no embedment
- \*Dock – Rotation at Northern pile

• Seawall Rating: Fair      • Dock Rating: Critical

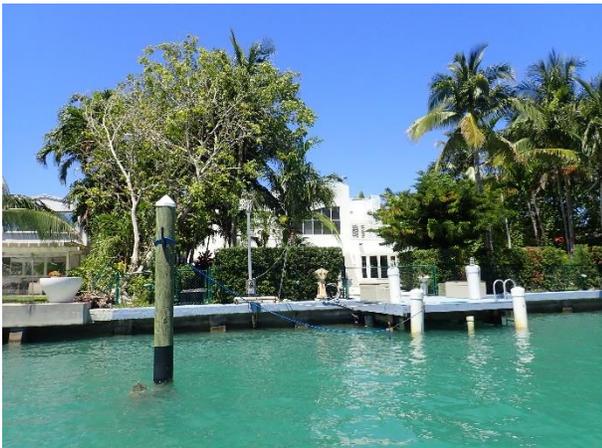
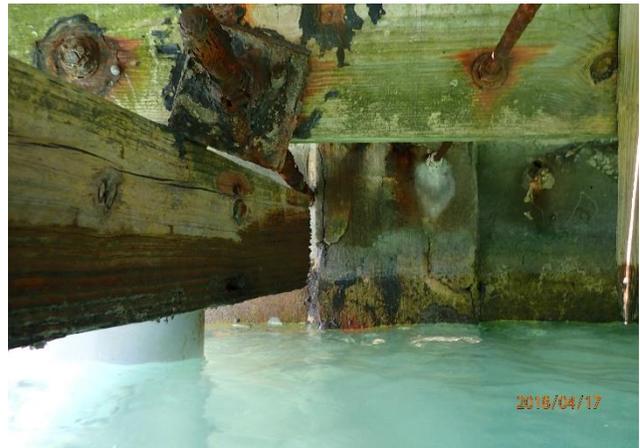
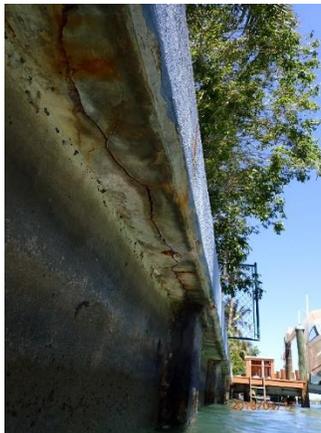
Property Address: 10161 E BROADVIEW DR  
Bay Harbor Islands, FL 33154  
Location: S-1.1 Lot#39  
Date of Inspection: 4/17/2018 @ 12:10am

- Wall Panels – Moderate cracking
- Wall Panels – Moderate concrete erosion at tidal zone
- T-Piles – Moderate cracking at tidal zone
- Dock – Corrosion at fasteners

• Seawall Rating: Fair      • Dock Rating: Fair

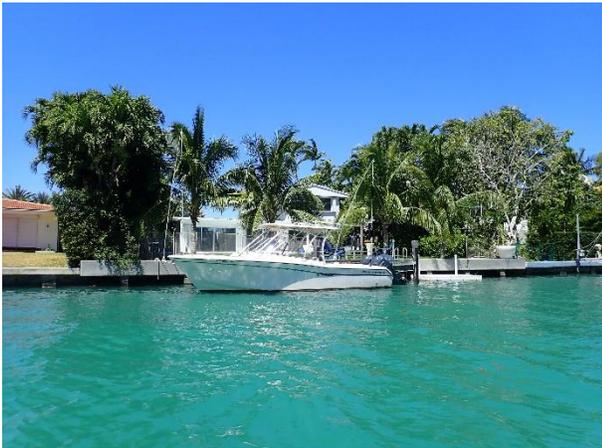
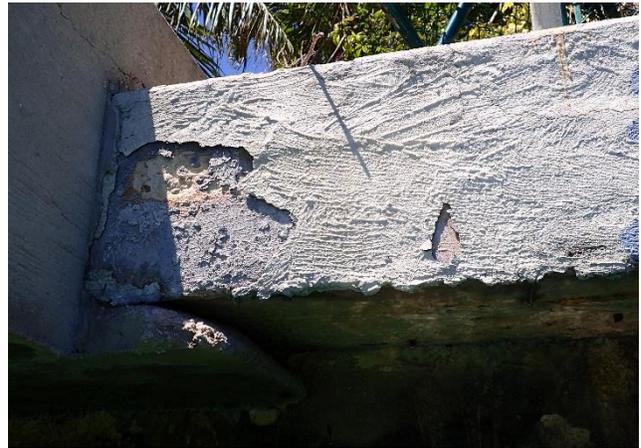
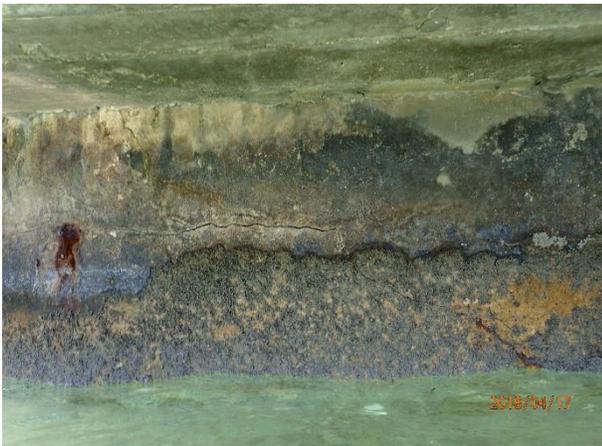
Property Address: 10141 E BROADVIEW DR  
Bay Harbor Islands, FL 33154  
Location: S-1.1 Lot#40  
Date of Inspection: 4/17/2018 @ 11:10am

- \*Cap – Minor cracking at soffit
- \*Wall Panels – Minor to moderate cracking
- \*Wall Panels – Minor to moderate concrete erosion
- \*Dock – Galvanized fasteners and channels

• Seawall Rating: Fair                      • Dock Rating: Satisfactory

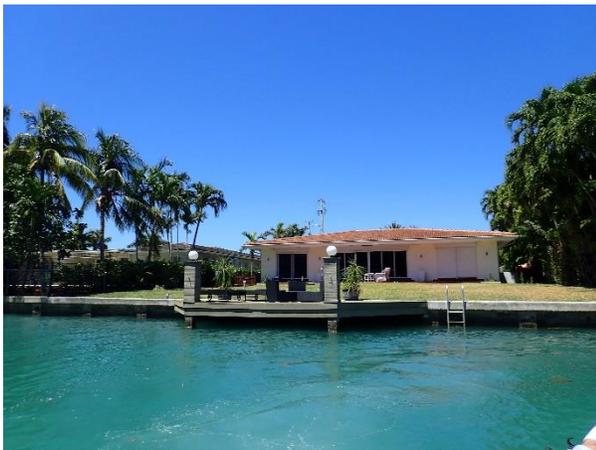
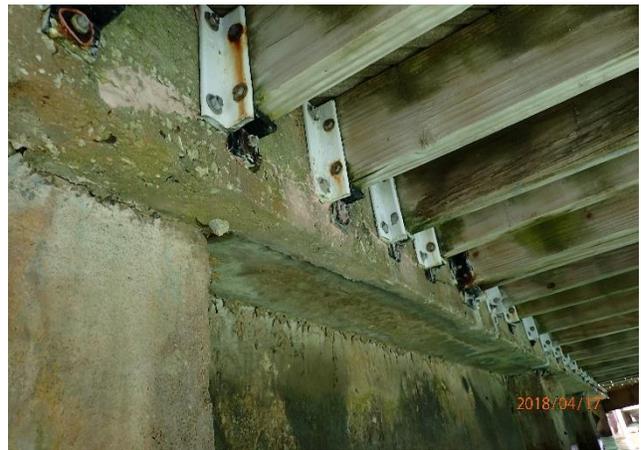
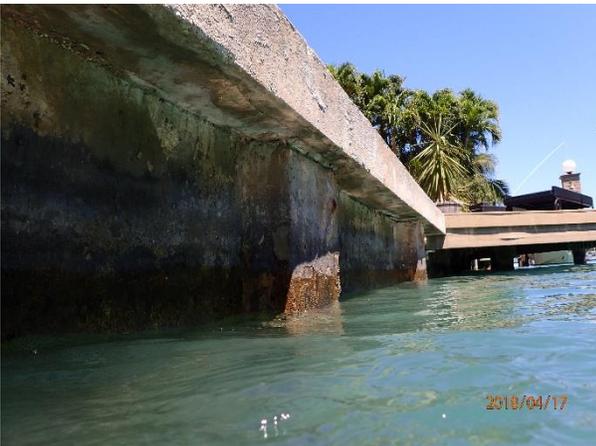
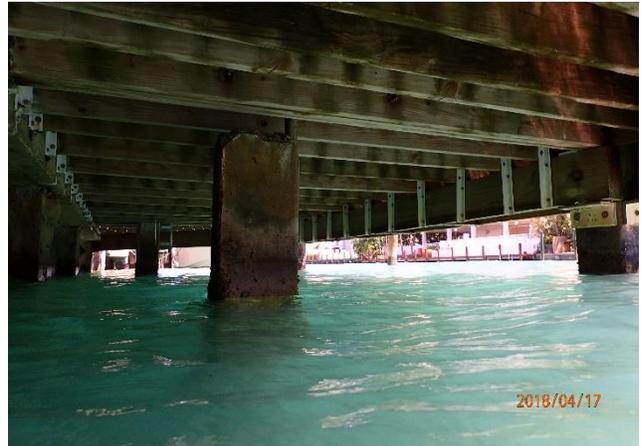
Property Address: 10121 E BROADVIEW DR  
Bay Harbor Islands, FL 33154  
Location: S-1.1 Lot#41  
Date of Inspection: 4/17/2018 @ 12:05pm

- Cap – Minor cracking of the wet face and soffit
- Cap – Moderate spalling and honeycombing
- King Pile – Anchor head corrosion
- Dock – Mooring piles deteriorating
- Dock – Fastener corrosion

• Seawall Rating: Fair                      • Dock Rating: Fair

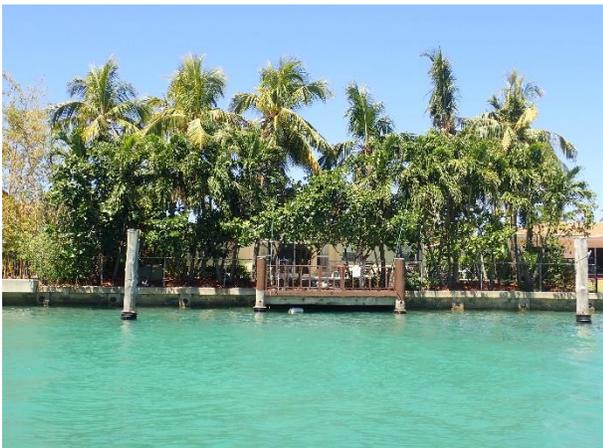
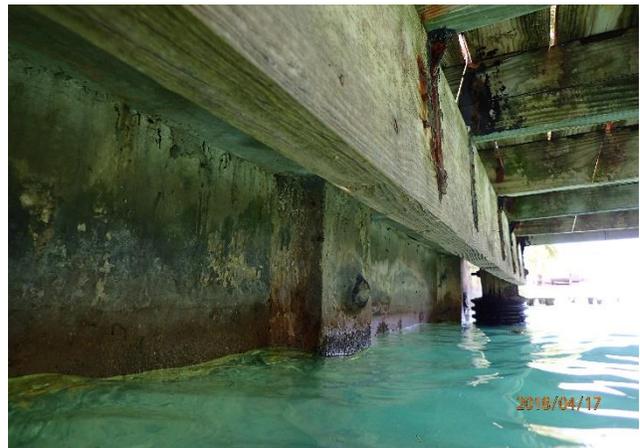
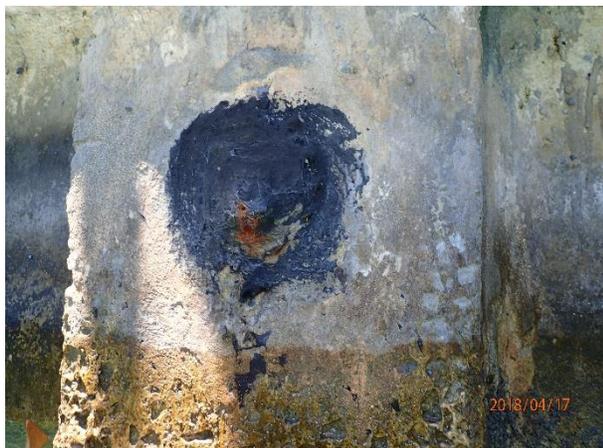
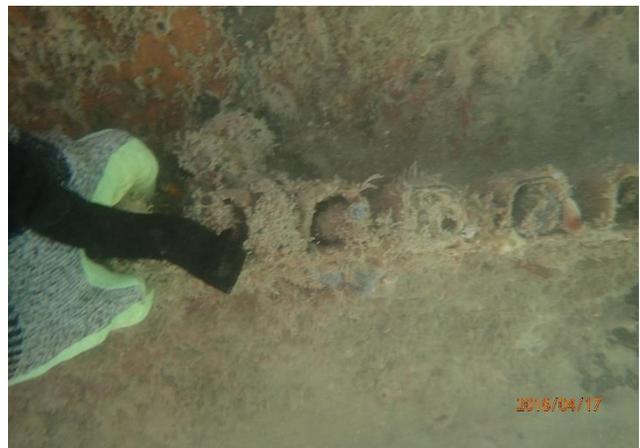
Property Address: 10061 to 10101 E BROADVIEW DR  
Bay Harbor Islands, FL 33154  
Location: S-1.1 Lot#42  
Date of Inspection: 4/17/2018 @ 12:00pm

- Cap – Construction of two different caps at North and South ends of the property
- Cap – Moderate cracking at wet face at Northern seawall
- Wall Panels – Minor cracking at transition to caps
- Wall Panels – Exposed bar, spalling at outfall with rotation
- T-Piles – Moderate cracking
- King-Piles – Moderate cracking
- Dock – Fastener corrosion, pile splitting

• Seawall Rating: Fair                      • Dock Rating: Fair

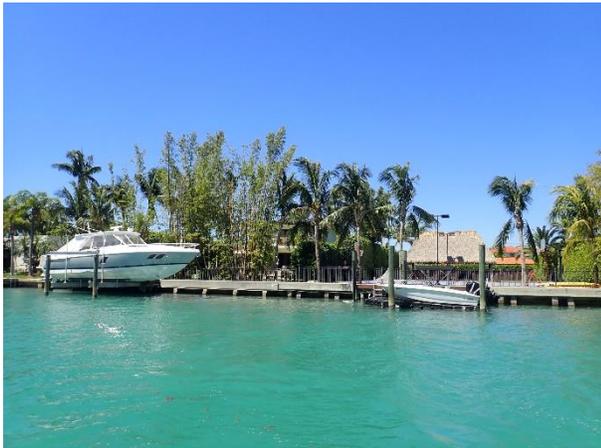
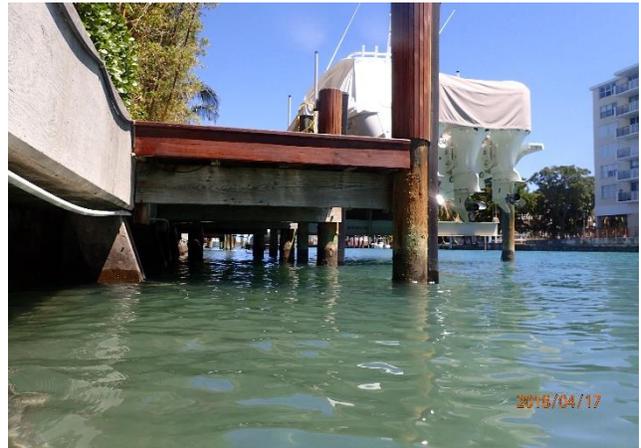
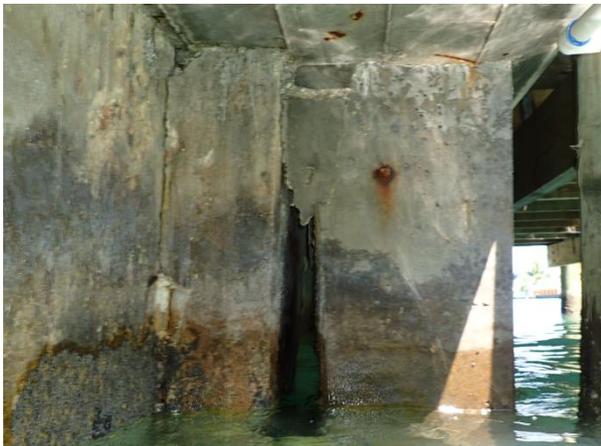
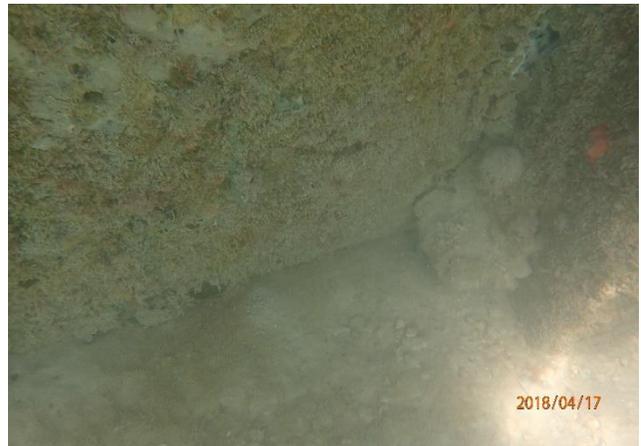
Property Address: 10043 E BROADVIEW DR  
Bay Harbor Islands, FL 33154  
Location: S-1.1 Lot#43  
Date of Inspection: 4/17/2018 @ 11:50am

- Cap – Minor cracking with corrosion staining at wet face
- T-Piles – Exposed anchor heads with moderate corrosion
- Wall Panels – Moderate concrete erosion at tidal zone with moderate rotation
- Dock – Moderate corrosion at fasteners and straps
- Dock – Piles exhibit salt kill

• Seawall Rating: Fair      • Dock Rating: Fair

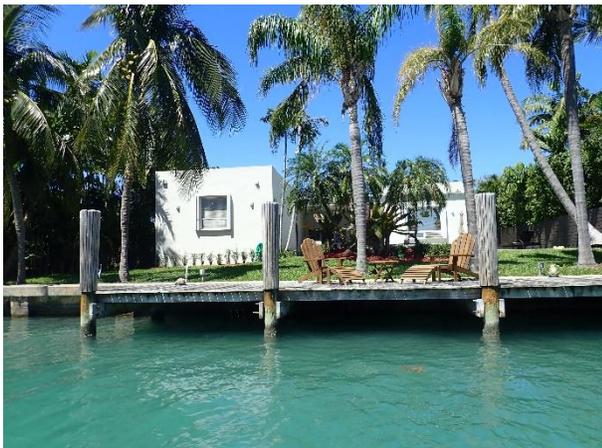
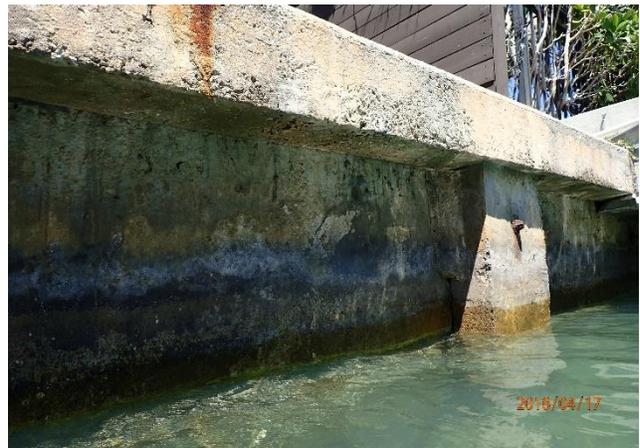
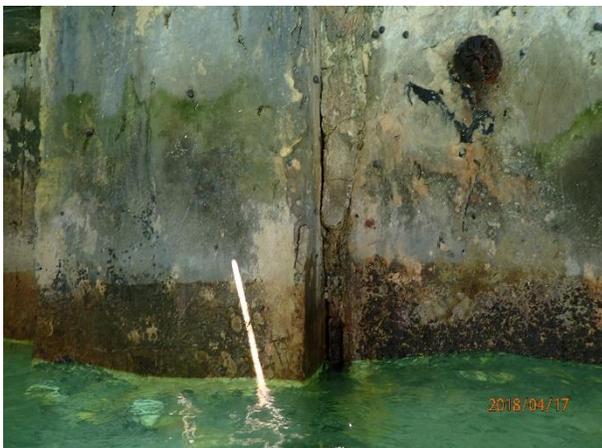
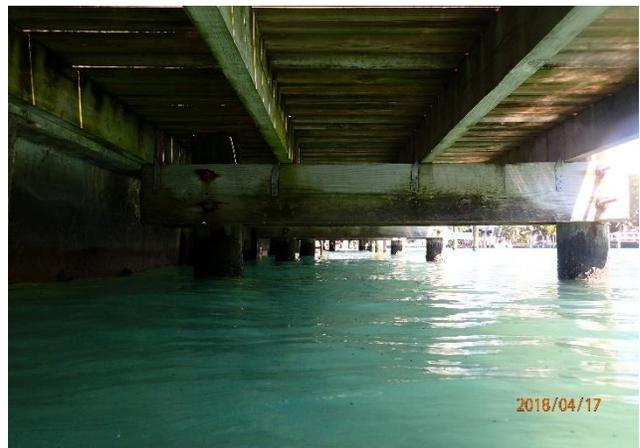
Property Address: 10021 E BROADVIEW DR  
Bay Harbor Islands, FL 33154  
Location: S-1.1 Lot#44  
Date of Inspection: 4/17/2018 @ 11:50am

- Cap – Minor to moderate cracking with corrosion staining at retrofit batter pile caps
- T-Piles – Moderate corrosion at anchors
- Batter Pile –Cracking/ spalling
- Wall Panels – Minor concrete erosion of older panels
- Dock – Moderate corrosion at fasteners
- Dock – Minor to moderate splitting of joists, pile deterioration

• Seawall Rating: Fair                      • Dock Rating: Fair

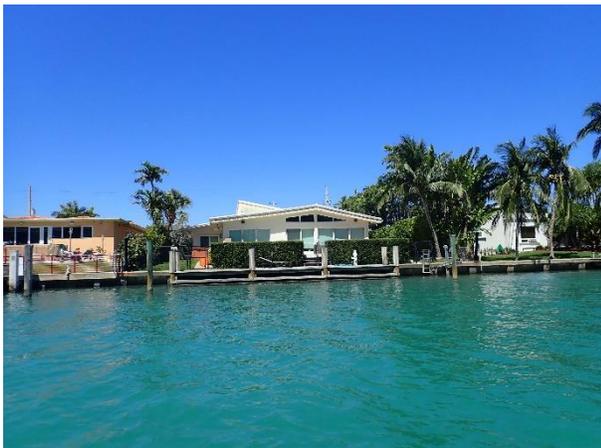
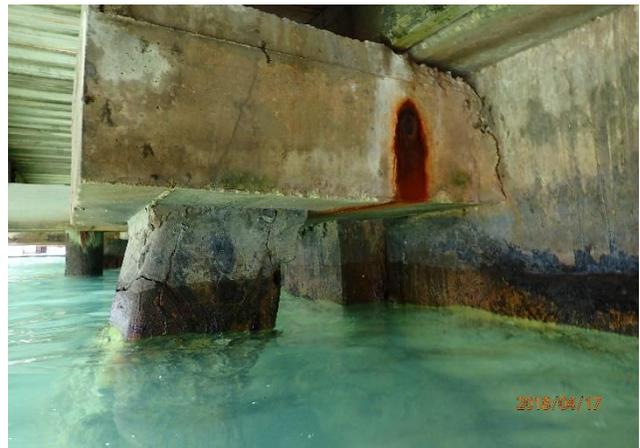
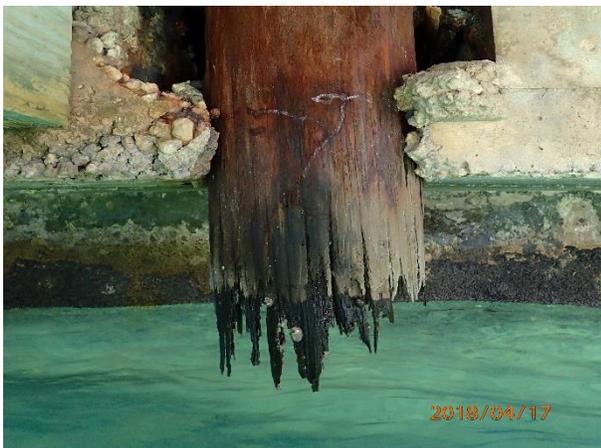
Property Address: 10001 E BROADVIEW DR  
Bay Harbor Islands, FL 33154  
Location: S-1.1 Lot#45  
Date of Inspection: 4/17/2018 @ 11:45am

- \*Cap – Minor cracking along wet face
- \*T-Piles – Moderate necking at tidal zone
- \*T-Piles – Moderate corrosion at anchor heads
- \*Wall Panels – Rotation of the wall
- \*Dock – Heavy corrosion at fasteners
- \*Dock – Wood splitting

• Seawall Rating: Fair      • Dock Rating: Poor
