# Seawall Condition and Resiliency Assessment Town of Bay Harbor Islands

October 2019 (Updated)

**Cummins Cederberg, Inc.**

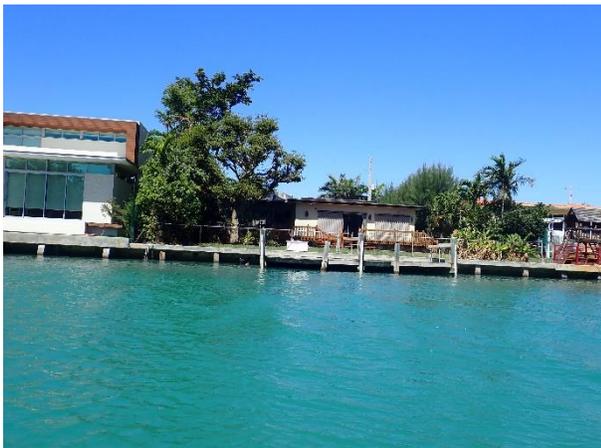
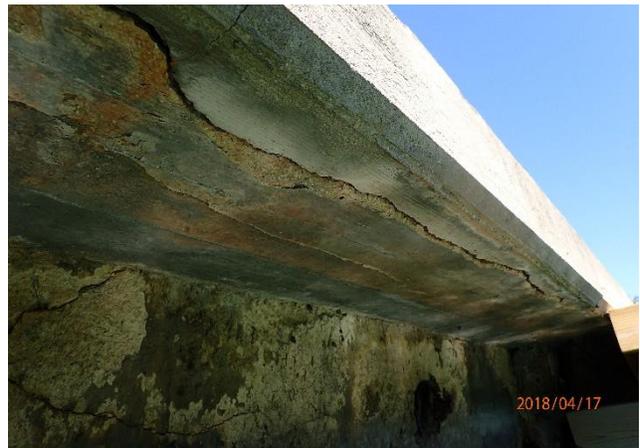
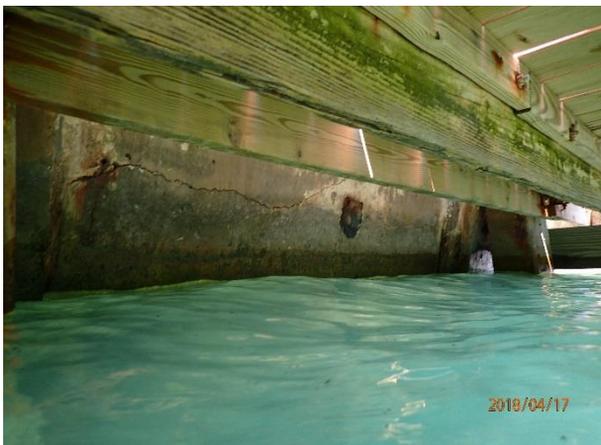
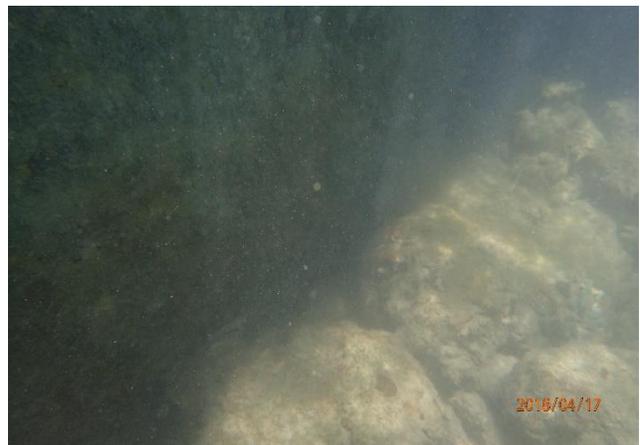
Property Address: 9961 E BROADVIEW DR  
Bay Harbor Islands, FL 33154  
Location: S-1.1 Lot#46  
Date of Inspection: 4/17/2018 @ 11:45am

- Cap – Moderate cracking at wet face and soffit
- Wall Panels – Moderate to severe cracking along panels
- Wall Panels – Moderate concrete erosion at tidal zone
- Batter Piles – Moderate cracking
- Dock – Stringers unsecured
- Dock – Wood rotting, corroded fasteners

• Seawall Rating: Fair      • Dock Rating: Poor

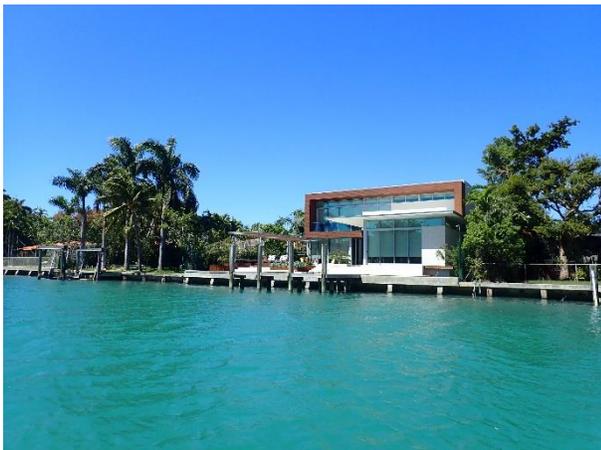
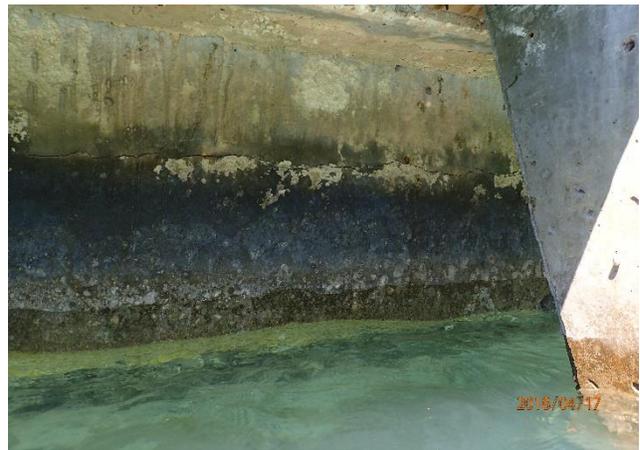
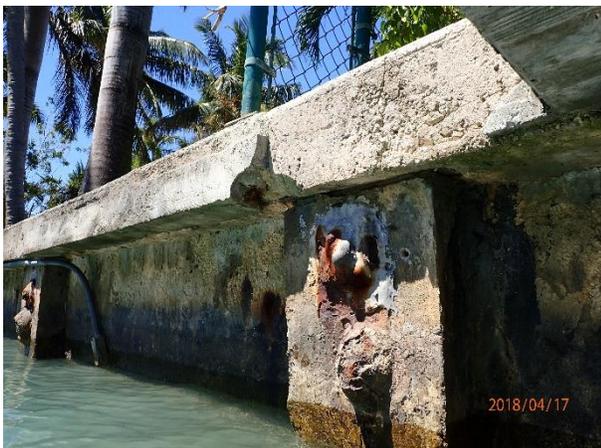
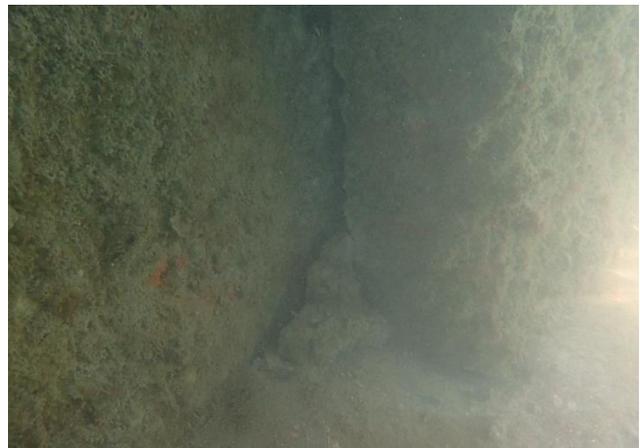
Property Address: 9933 E BROADVIEW DR  
Bay Harbor Islands, FL 33154  
Location: S-1.1 Lot#47  
Date of Inspection: 4/17/2018 @ 11:30am

- Wall Panels – Minor spalling at outfall
- Wall Panels – Concrete erosion at tidal zone
- Wall Panels – Minor to moderate horizontal cracking
- Cap – Spalling
- T-Piles – Moderate vertical cracking and sediment loss through fillets, anchor head corrosion

• Seawall Rating: Fair      • Dock Rating: Satisfactory

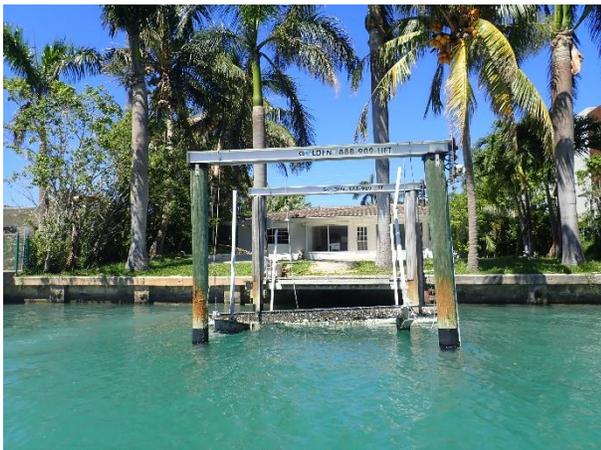
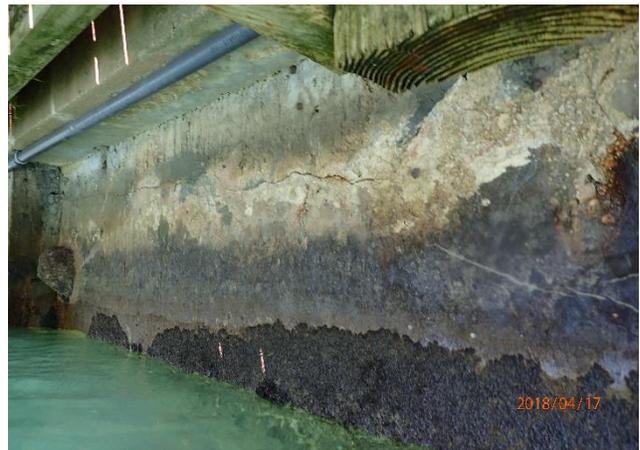
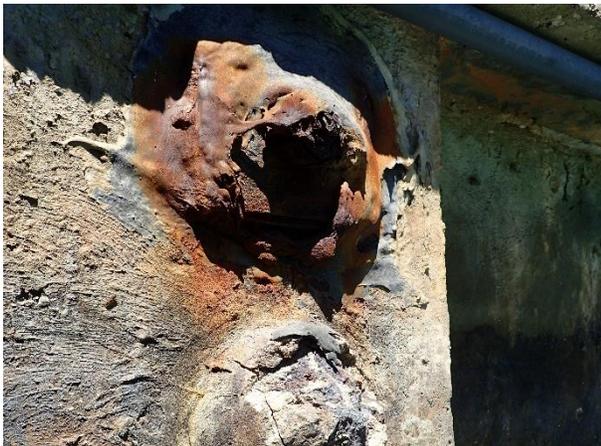
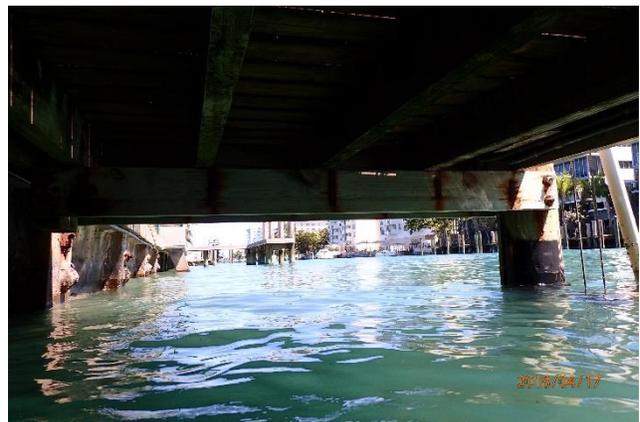
Property Address: 9921 E BROADVIEW DR  
Bay Harbor Islands, FL 33154  
Location: S-1.1 Lot#48  
Date of Inspection: 4/17/2018 @ 11:30am

- Cap – Minor spalling with longitudinal and vertical cracking
- T-Piles – Minor to moderate erosion at anchors
- T-Piles – Double anchors with moderate corrosion at heads
- T-Piles – Pitting at piles below dock
- Wall Panels – Minor concrete erosion and cracking
- Dock – Moderate corrosion at fasteners

• Seawall Rating: Fair      • Dock Rating: Fair

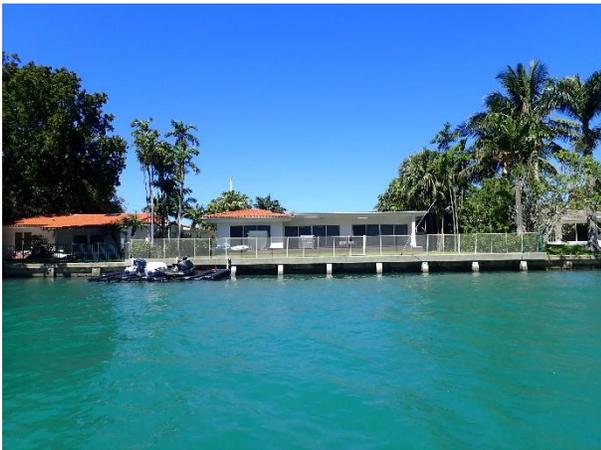
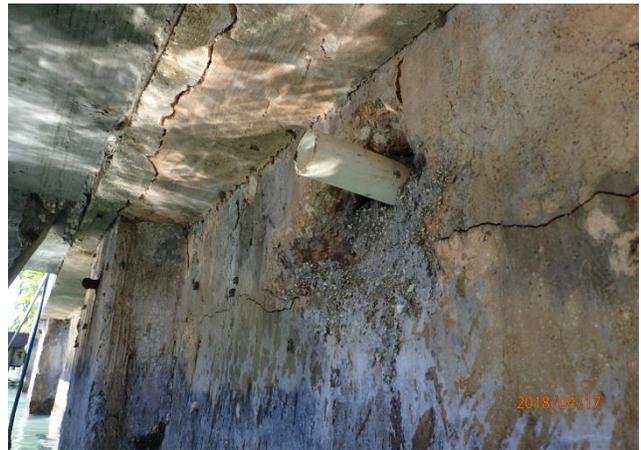
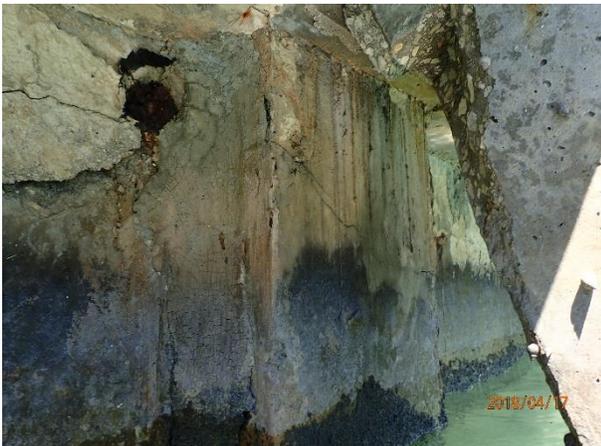
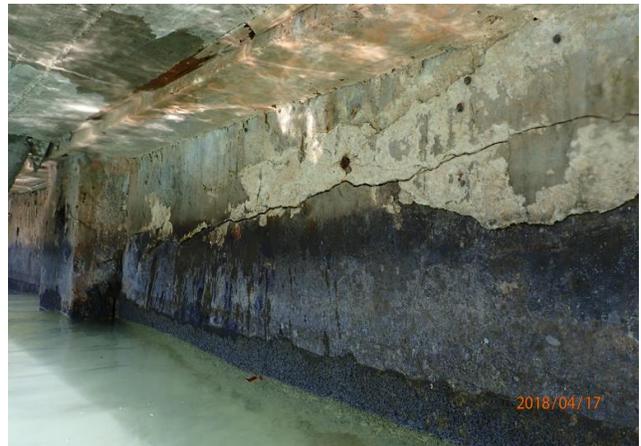
Property Address: 9901 E BROADVIEW DR  
Bay Harbor Islands, FL 33154  
Location: S-1.1 Lot#49  
Date of Inspection: 4/17/2018 @ 11:30am

- Cap – Minor cracking at soffit
- Wall Panels – Minor spalling adjacent to outfall
- Wall Panels – Minor to moderate horizontal cracking
- T-Piles – Minor concrete erosion at splash zone
- T-Piles – corrosion of the anchors

• Seawall Rating: Fair      • Dock Rating: Satisfactory

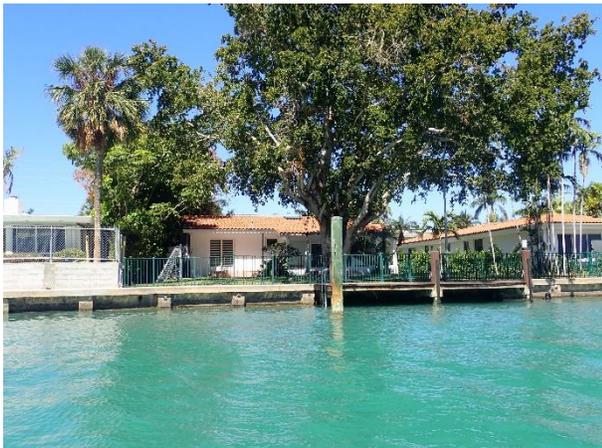
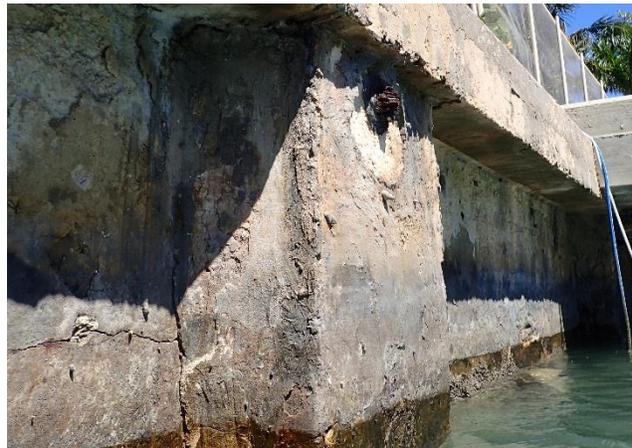
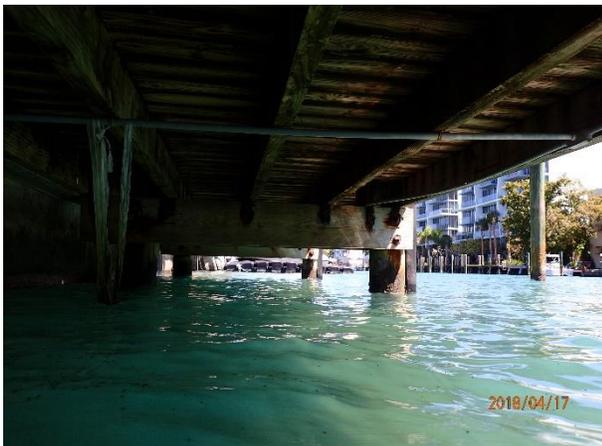
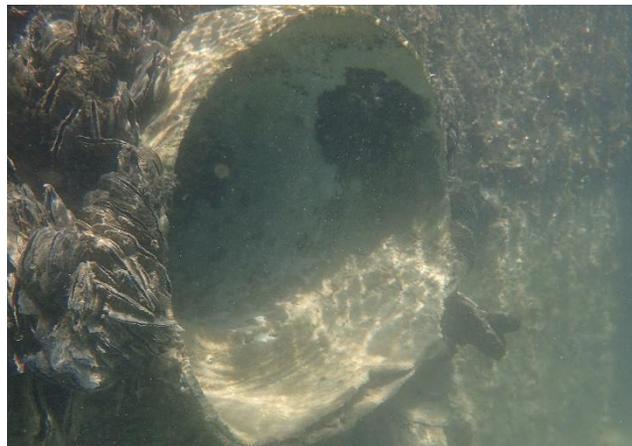
Property Address: 9881 E BROADVIEW DR  
Bay Harbor Islands, FL 33154  
Location: S-1.1 Lot#50  
Date of Inspection: 4/17/2018 @ 11:25am

- \*Cap – Minor cracking at wet face
- \*Wall Panels – Minor spalling and cracking along panels
- \*T-Piles – Moderate to severe corrosion of the anchors
- \*Dock – Corrosion at fasteners

• Seawall Rating: Poor                      • Dock Rating: Fair

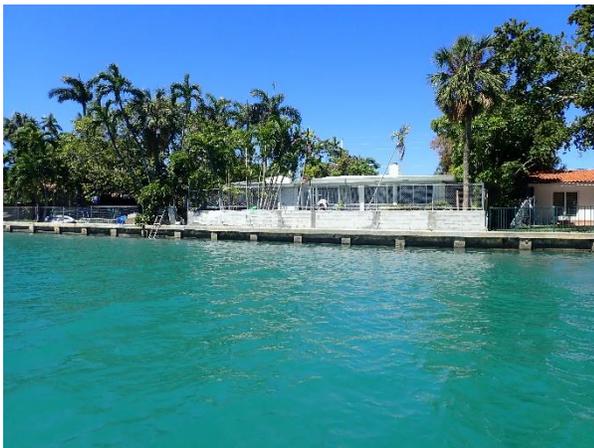
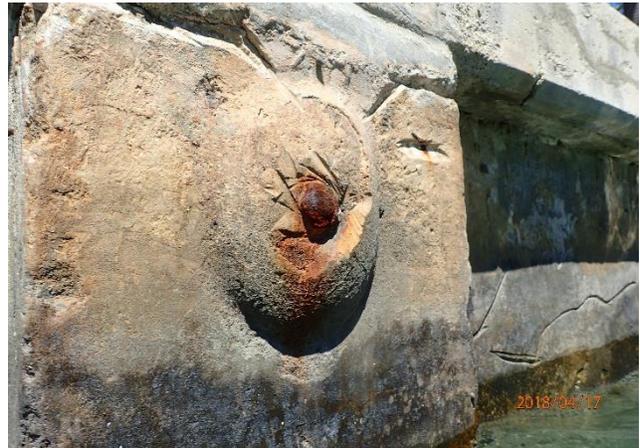
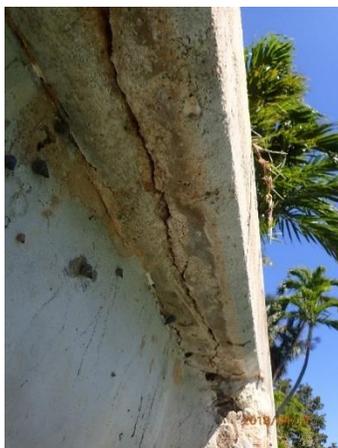
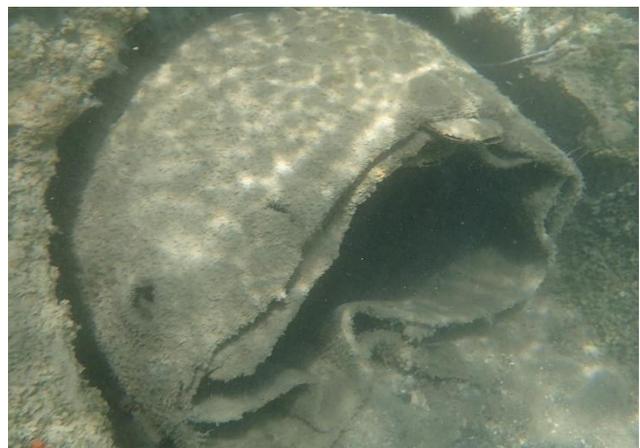
Property Address: 9861 E BROADVIEW DR  
Bay Harbor Islands, FL 33154  
Location: S-1.1 Lot#51  
Date of Inspection: 4/17/2018 @ 11:20am

- \*Cap– Moderate cracking at the soffit
- \*Wall Panels – Moderate rotation of the wall
- \*T-Piles – Moderate corrosion at anchor heads
- \*T-Piles – Pile/panel separation with sediment loss at fillets
- \*Previous cracks repairs inadequate

• Seawall Rating: Fair                      • Dock Rating: N/A

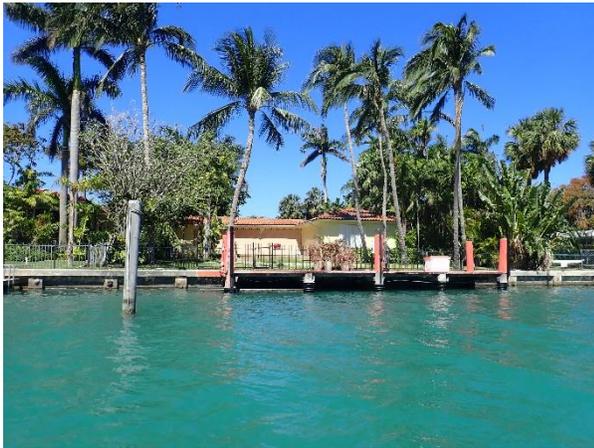
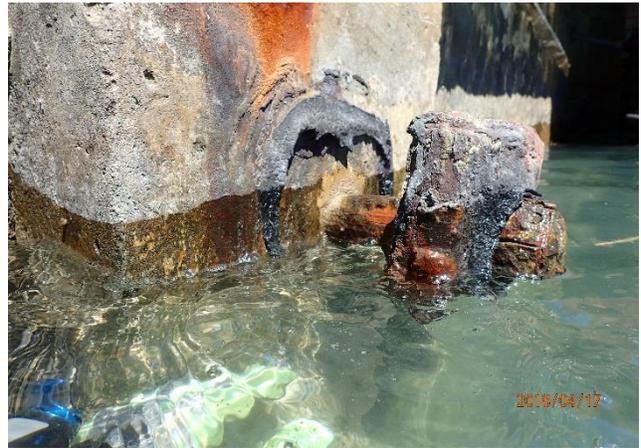
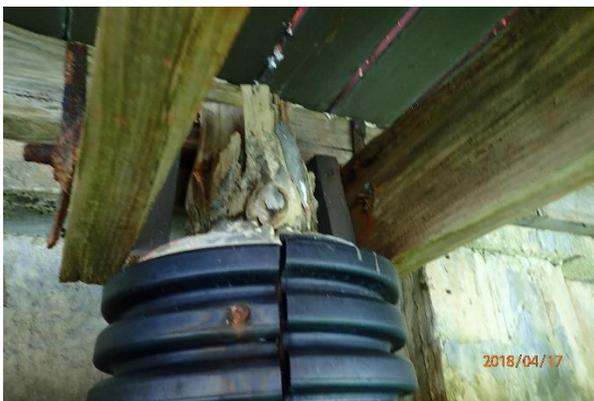
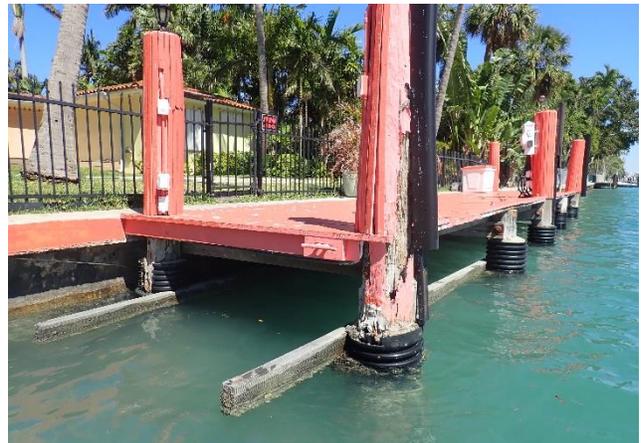
Property Address: 9821 E BROADVIEW DR  
Bay Harbor Islands, FL 33154  
Location: S-1.1 Lot#52  
Date of Inspection: 4/17/2018 @ 11:20am

- T-Piles – Moderate corrosion at anchors
- T-Piles – Anchor corroded and pulled waterward
- Wall Panels – Rotation and chipping at splash zone
- Dock – Severe corrosion at fasteners
- Dock – Severe deterioration at timber piles above sleeves

• Seawall Rating: Poor      • Dock Rating: Critical

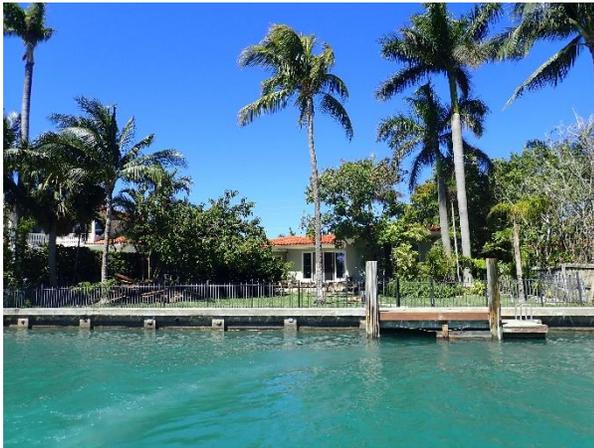
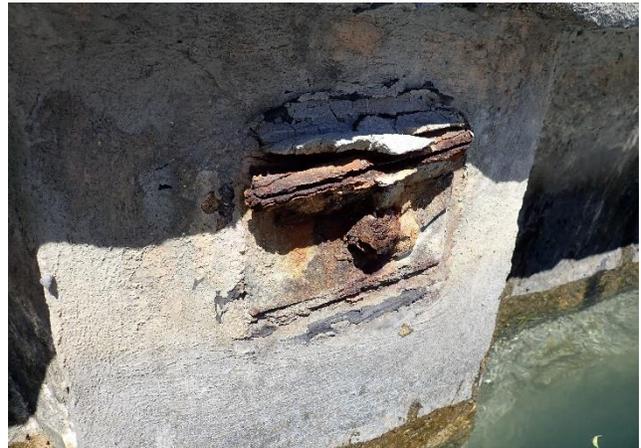
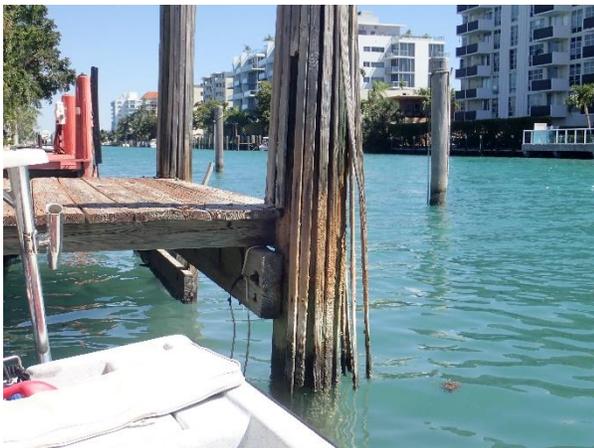
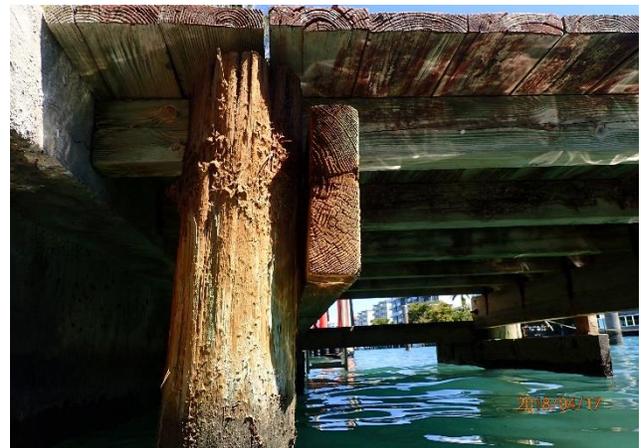
Property Address: 9801 E BROADVIEW DR  
Bay Harbor Islands, FL 33154  
Location: S-1.1 Lot#53  
Date of Inspection: 4/17/2018 @ 11:15am

- Cap – Minor to moderate cracking at wet face
- T-Piles – Moderate to severe corrosion at anchor heads
- Dock – Severe corrosion at bolts and straps
- Dock – Moderate salt kill at timber piles

• Seawall Rating: Fair                  • Dock Rating: Poor

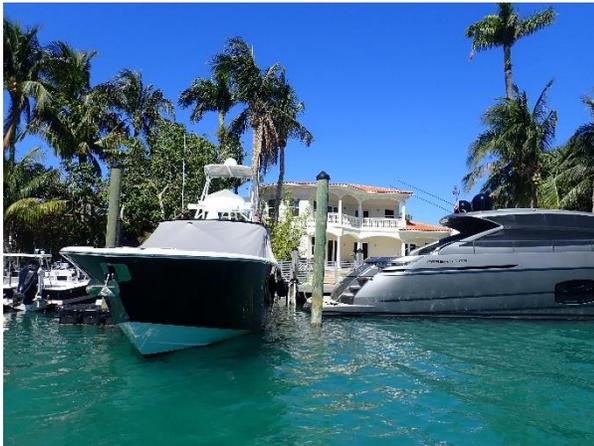
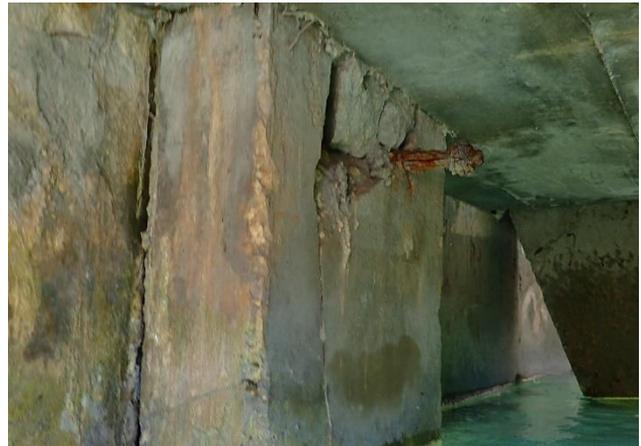
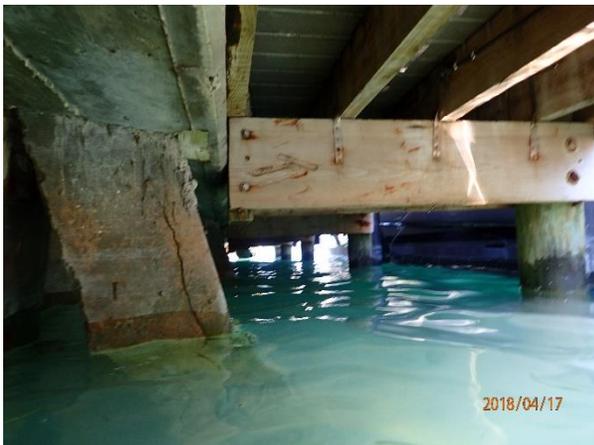
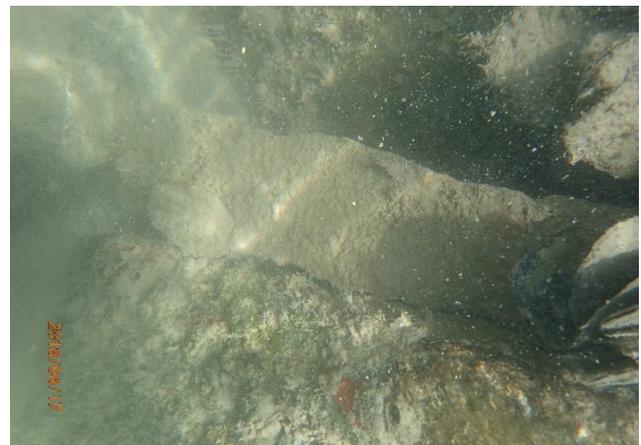
Property Address: 9721 E BROADVIEW DR  
Bay Harbor Islands, FL 33154  
Location: S-1.1 Lot#55  
Date of Inspection: 4/17/2018 @ 11:00am

- \*Cap – Moderate cracking at the soffit
- \*Wall Panels – Soil loss through fillets
- \*Wall Panels – Moderate cracking along panels
- \*Wall Panels – Moderate rotation of wall
- \*Dock – Fastener corrosion
- \*Dock – Wood decay/splitting

• Seawall Rating: Fair      • Dock Rating: Fair

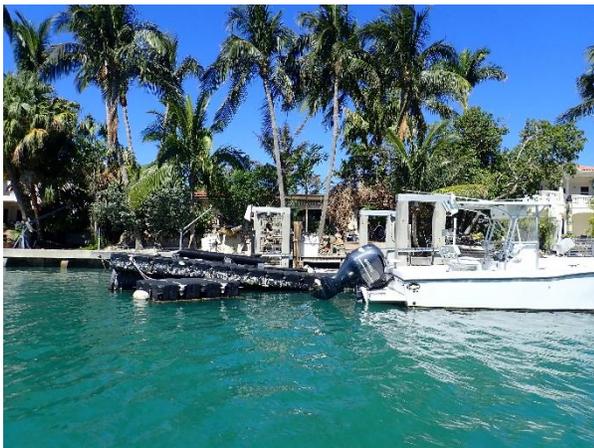
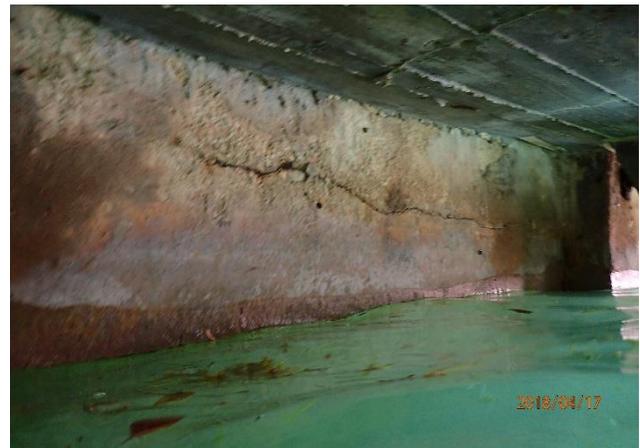
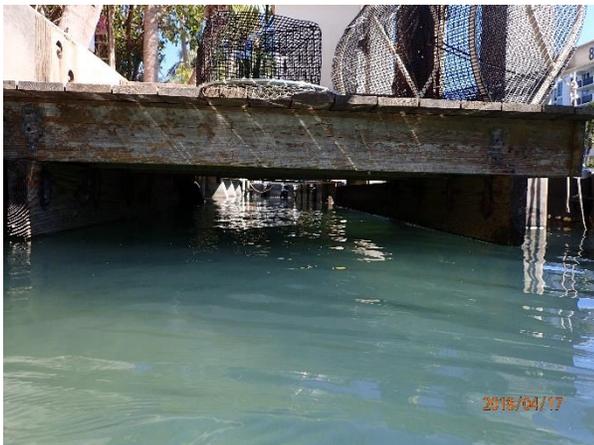
Property Address: 9705 E BROADVIEW DR  
Bay Harbor Islands, FL 33154  
Location: S-1.1 Lot#56  
Date of Inspection: 4/17/2018 @ 10:55am

- Wall Panels – Moderate cracking throughout panels, spalling
- T-Piles – Moderate cracking, spalling
- Dock – Moderate to severe corrosion at fasteners
- Dock – Wood decay

• Seawall Rating: Fair      • Dock Rating: Fair

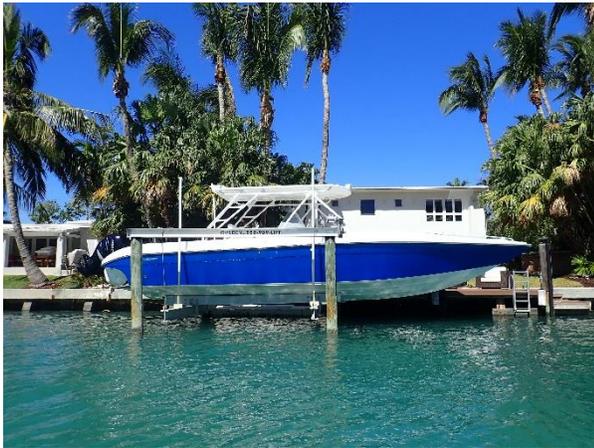
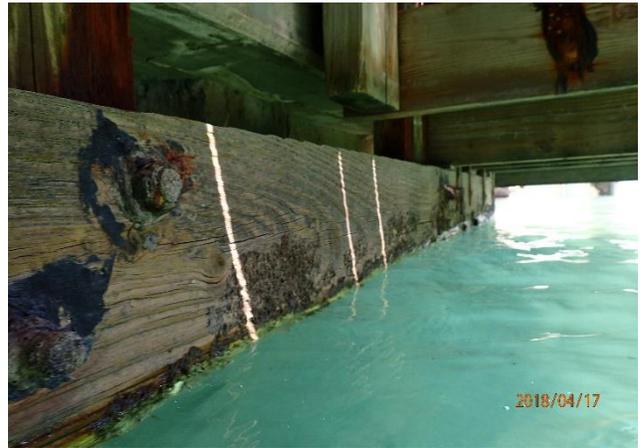
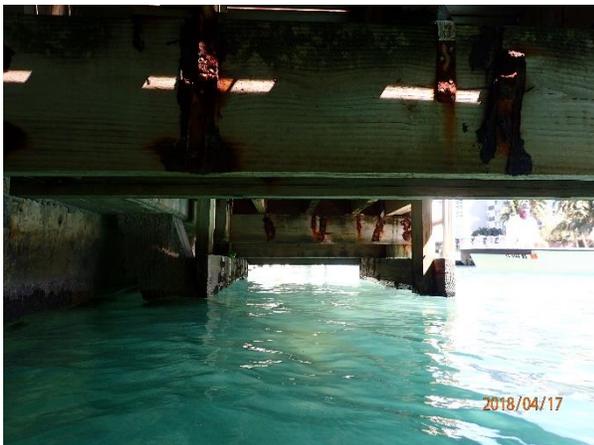
Property Address: 9661 E BROADVIEW DR  
Bay Harbor Islands, FL 33154  
Location: S-1.1 Lot#57  
Date of Inspection: 4/17/2018 @ 10:50am

- Wall Panels – Minor rotation of wall
- Batter Piles – Moderate cracking at spot locations
- T-Piles – Moderate cracking at spot locations
- Dock – Moderate corrosion at fasteners
- Dock – Remanence of demolished dock

• Seawall Rating: Fair                      • Dock Rating: Poor

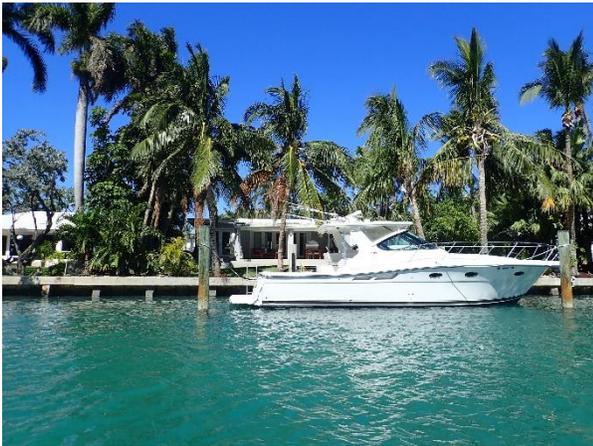
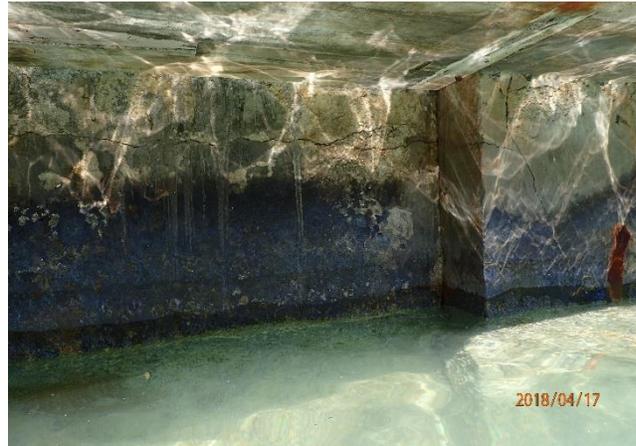
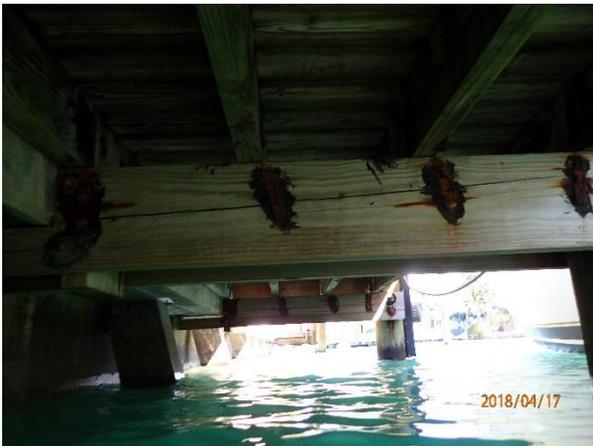
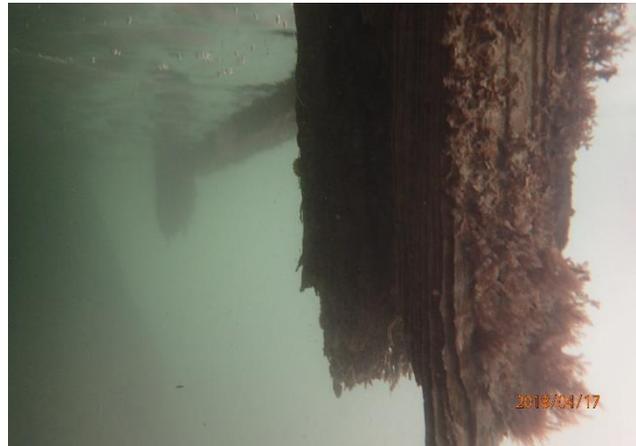
Property Address: 9623 E BROADVIEW DR  
Bay Harbor Islands, FL 33154  
Location: S-1.1 Lot#58  
Date of Inspection: 4/17/2018 @ 10:50am

- \*Cap – Moderate cracking at wet face
- \*Wall Panels – Rotation of wall
- \*Wall Panels – Severe cracking throughout panels
- \*T-Piles – Severe deterioration
- \*Batter Piles – Moderate cracking and unsound concrete (pre-spall) at pile heads
- \*Dock – Warped decking with salt kill at piles

\* Seawall Rating: Poor                  \* Dock Rating: Poor

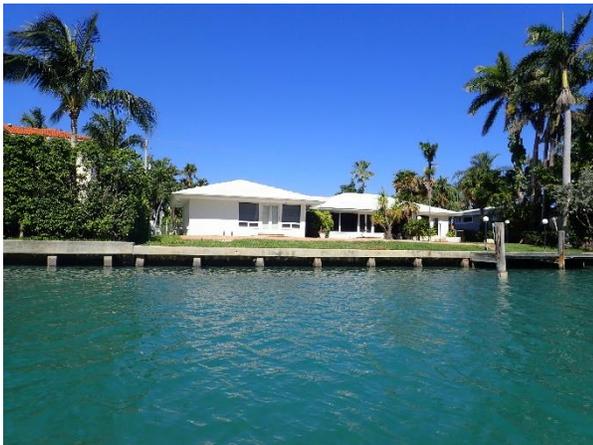
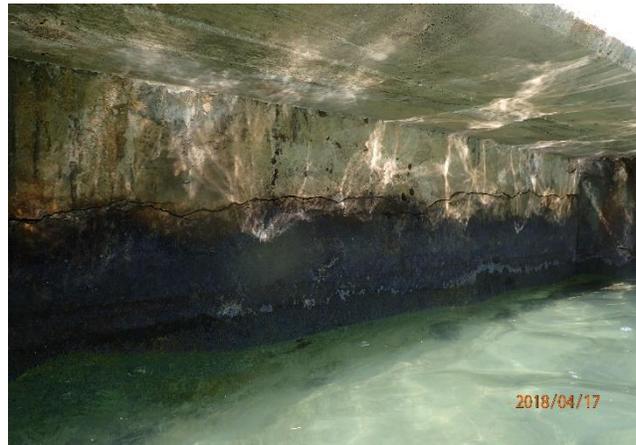
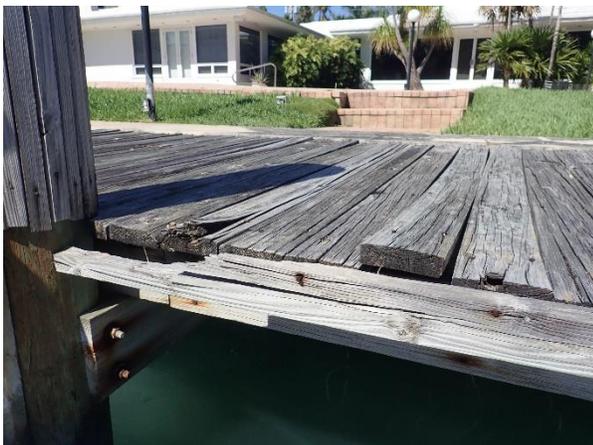
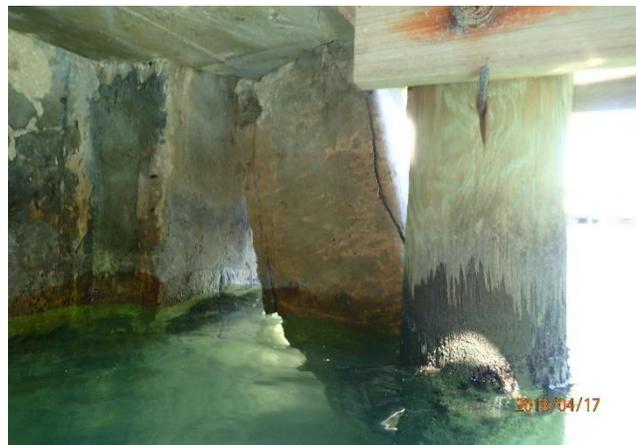
Property Address: 9601 E BROADVIEW DR  
Bay Harbor Islands, FL 33154  
Location: S-1.1 Lot#59  
Date of Inspection: 4/17/2018 @ 10:40am

- Cap – Moderate cracking at wet face
- Cap – Poor vibration during concrete installation
- Wall Panels – Rotation of wall
- Wall Panels – Severe cracking throughout panels
- Wall Panels – Upland depressions at cracking locations
- T-Piles – Cracking at spot locations
- Dock – Fastener corrosion

• Seawall Rating: Serious

• Dock Rating: Fair

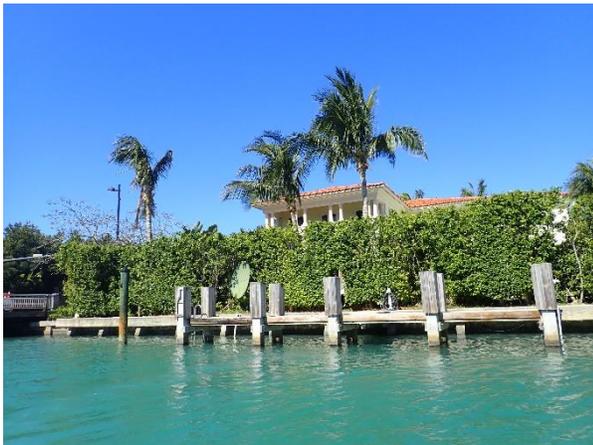
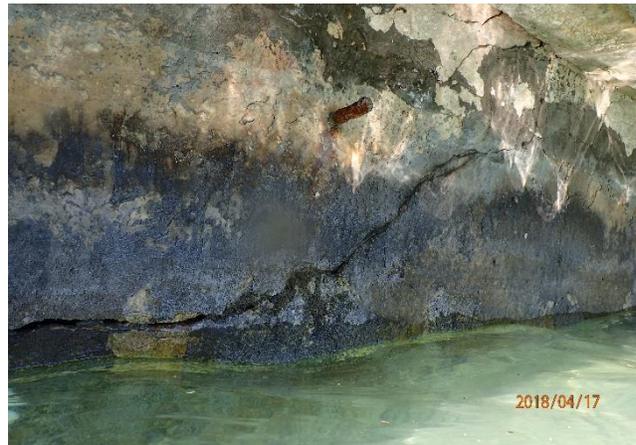
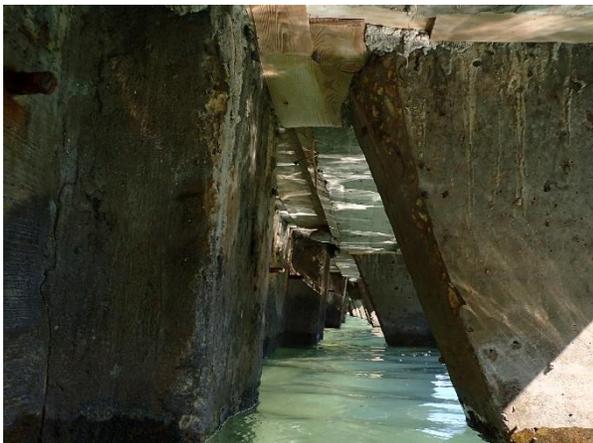
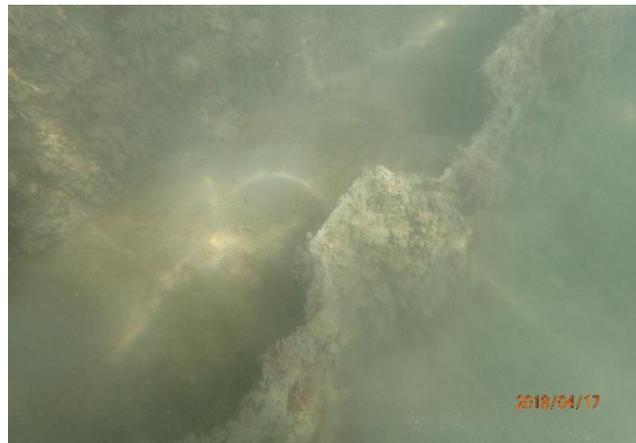
Property Address: 9551 E BROADVIEW DR  
Bay Harbor Islands, FL 33154  
Location: S-1.1 Lot#60  
Date of Inspection: 4/16/2018 @ 9:50am

- \*Cap – Severe cracks at the wet face
- \*Cap – Retrofit caps at batter piles
- \*Wall Panels – Horizontal cracking along top panels
- \*Wall Panels – Cracking above North outfall
- \*T-Piles – Minor cracking at spot locations
- \*Dock – Moderate corrosion at ledger bolts, pile deterioration

• Seawall Rating: Fair      • Dock Rating: Fair

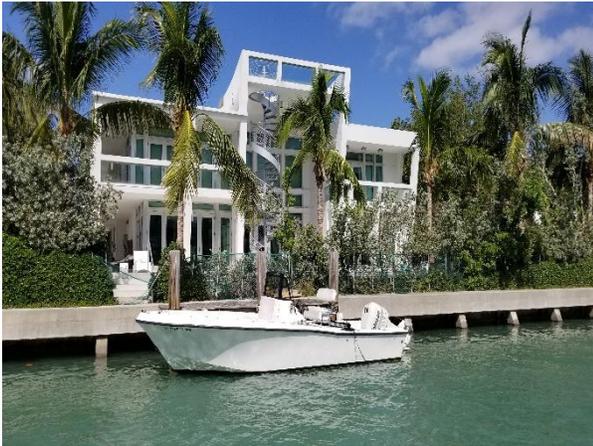
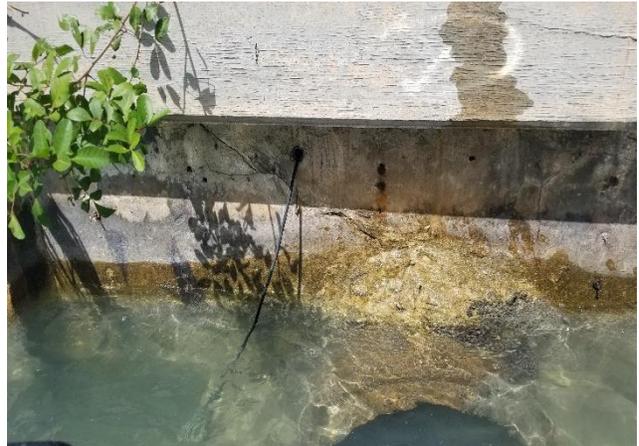
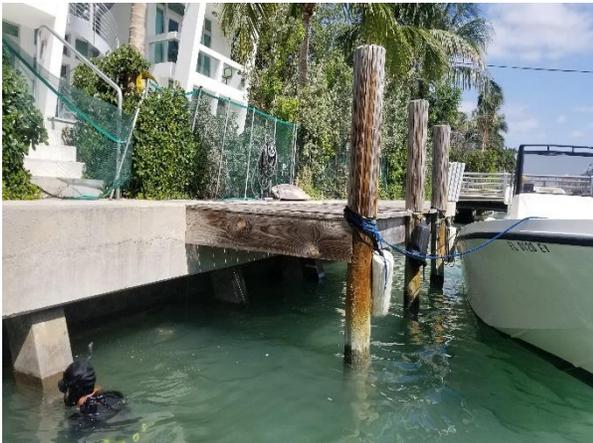
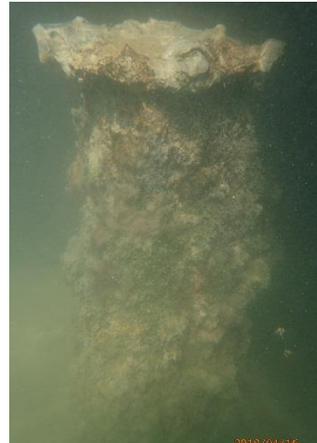
Property Address: 9525 E BROADVIEW DR  
Bay Harbor Islands, FL 33154  
Location: S-1.1 Lot#61  
Date of Inspection: 4/16/2018 @ 10:00am

- \*Cap – Upland depression adjacent to center section
- \*Wall Panels – Rotation along wall
- \*T-Piles – Severe corrosion at anchor heads
- \*T-Piles – Sediment accumulation at seabed
- \*Dock – Critical section loss of piles and salt kill
- \*Dock – Beam rotation

• Seawall Rating: Poor                      • Dock Rating: Critical

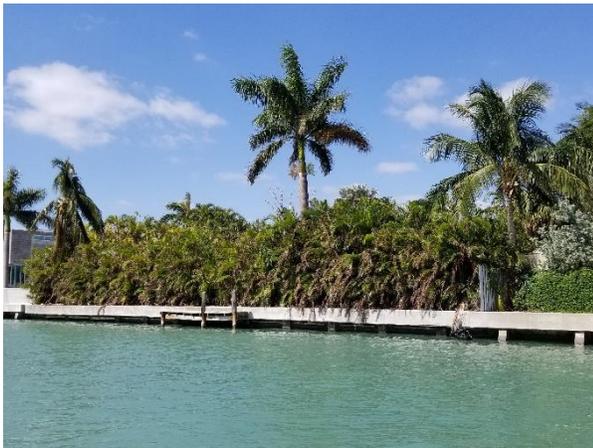
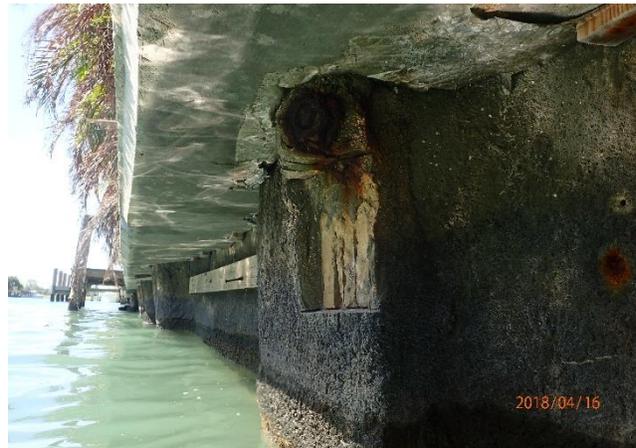
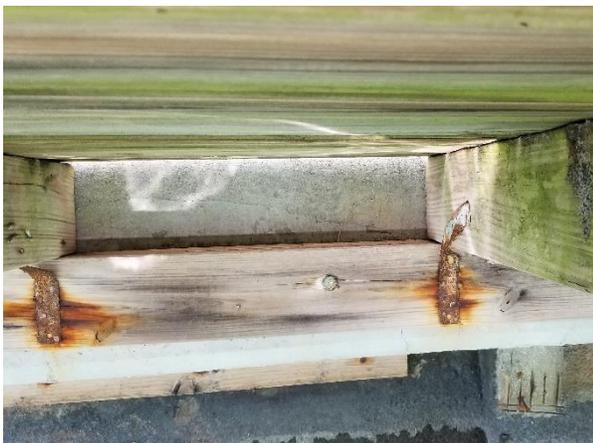
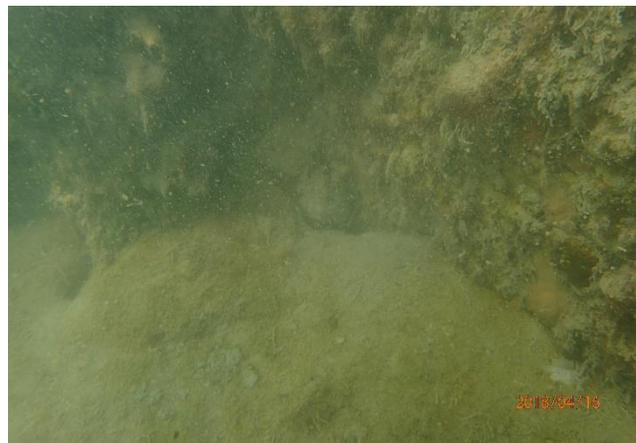
Property Address: 9501 E BROADVIEW DR  
Bay Harbor Islands, FL 33154  
Location: S-1.1 Lot#62  
Date of Inspection: 4/16/2018 @ 11:05am

- Wall Panels – Moderate cracking along top of panels
- Wall Panels – Moderate concrete erosion below tidal zone
- T-Piles – Severe corrosion at anchor heads

• Seawall Rating: Fair      • Dock Rating: Satisfactory

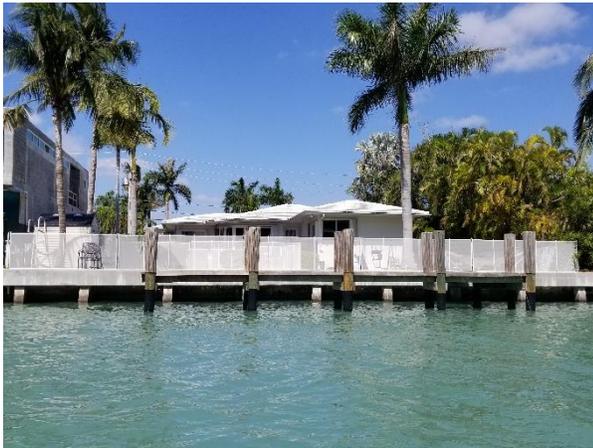
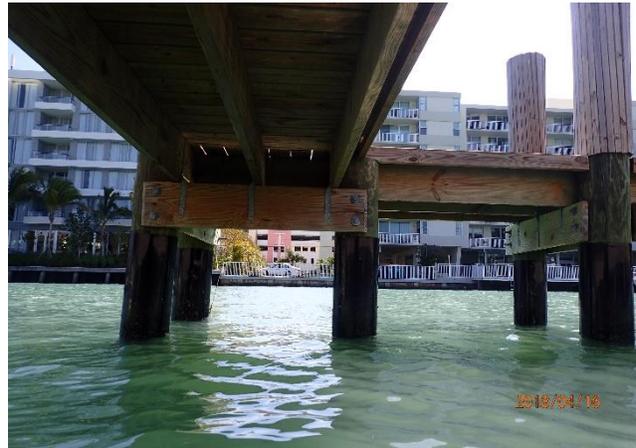
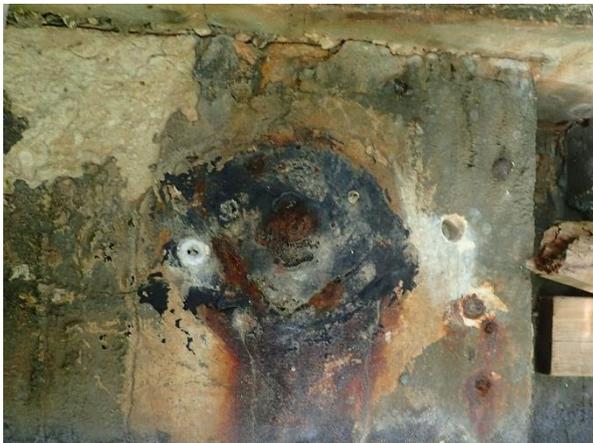
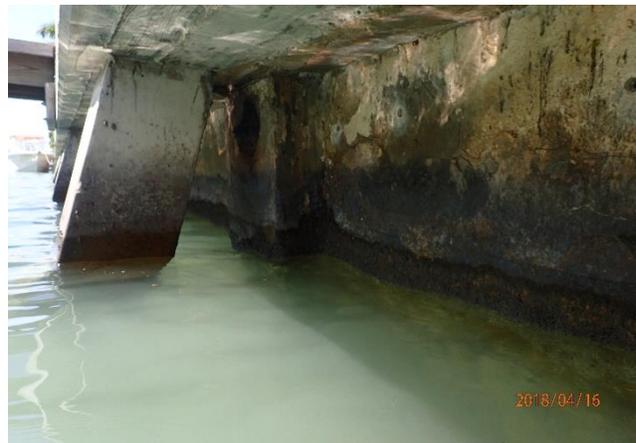
Property Address: 9461 E BROADVIEW DR  
Bay Harbor Islands, FL 33154  
Location: S-1.1 Lot#63  
Date of Inspection: 4/16/2018 @ 11:10am

- Cap – Moderate cracking and spalling along soffit
- T-Piles – Severe corrosion at anchor heads
- Batter Piles – Spalling landward side of piles

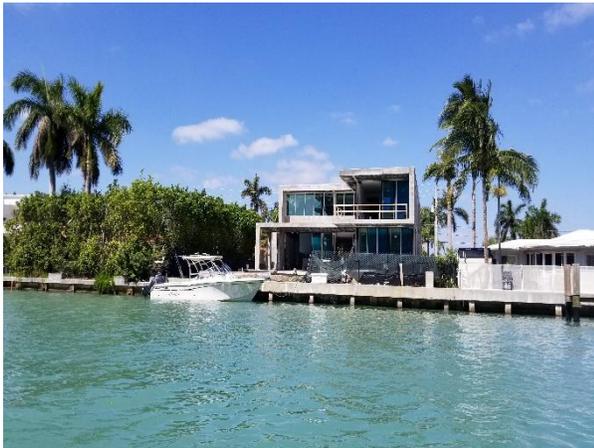
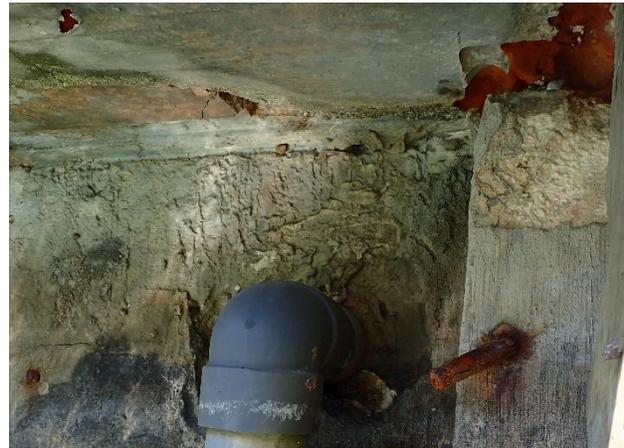
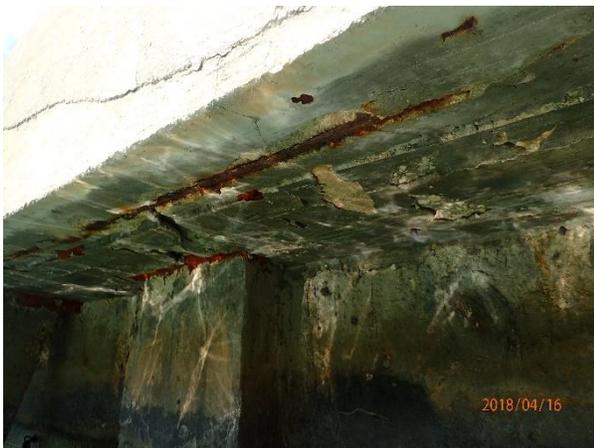
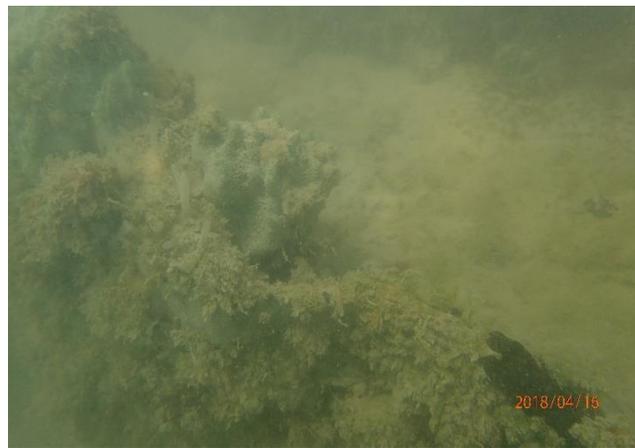
• Seawall Rating: Fair      • Dock Rating: N/A

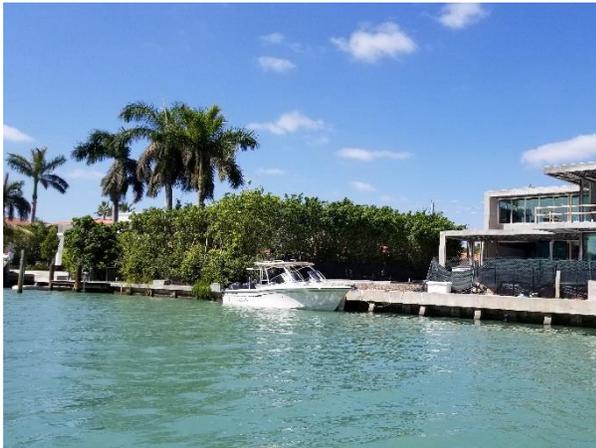
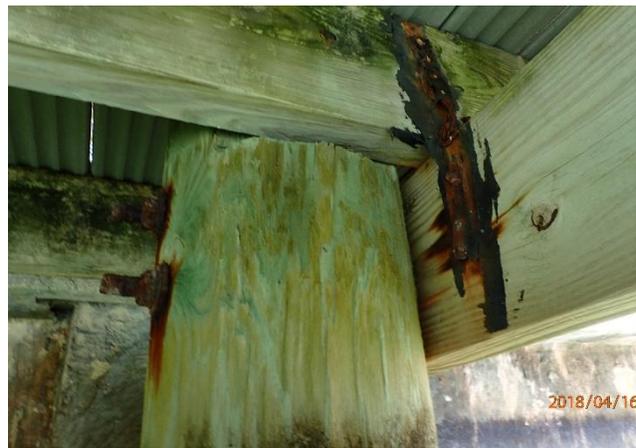
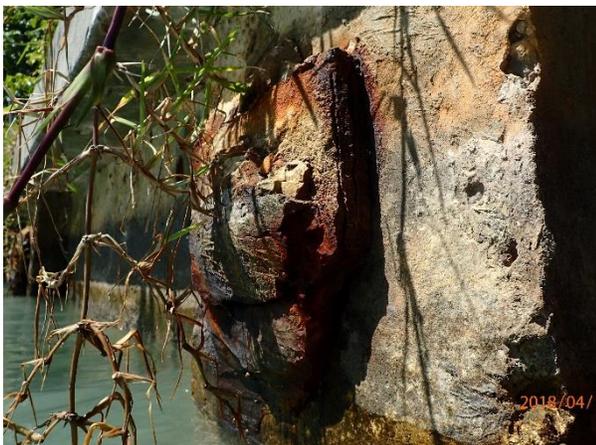
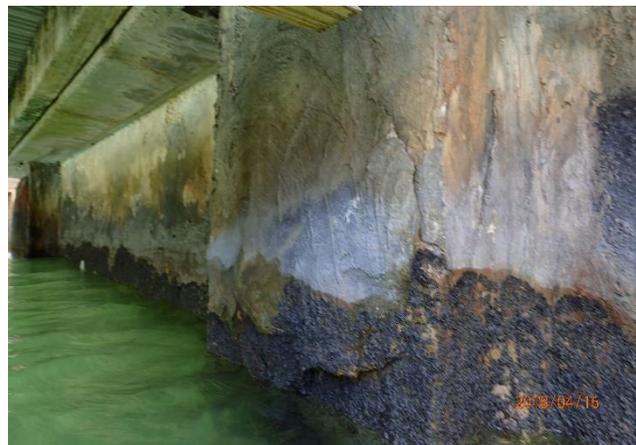
Property Address: 9451 E BROADVIEW DR  
Bay Harbor Islands, FL 33154  
Location: S-1.1 Lot#64  
Date of Inspection: 4/16/2018 @ 11:20am

- \*Cap – Moderate cracking adjacent to davit pads
- \*Cap – Moderate spalling at South section of cap
- \*Wall Panels – Moderate spalling and horizontal cracking
- \*T-Piles – Moderate to severe corrosion at anchor heads
- \*Dock – Minor to moderate corrosion at fasteners

• Seawall Rating: Fair    • Dock Rating: Fair
