# Seawall Condition and Resiliency Assessment Town of Bay Harbor Islands

October 2019 (Updated)

**Cummins Cederberg, Inc.**

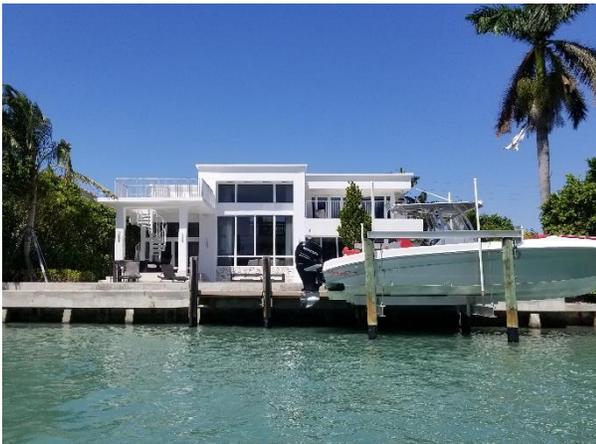
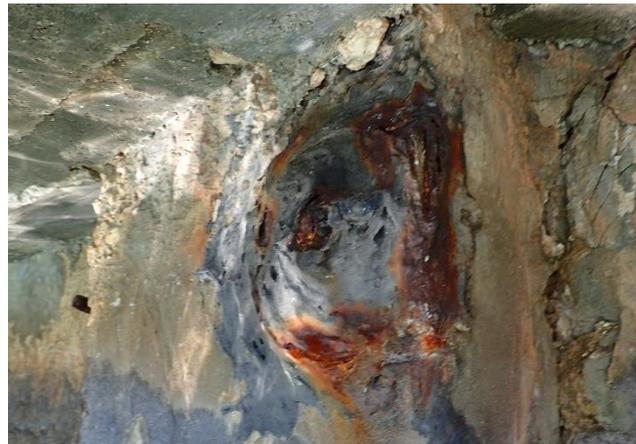
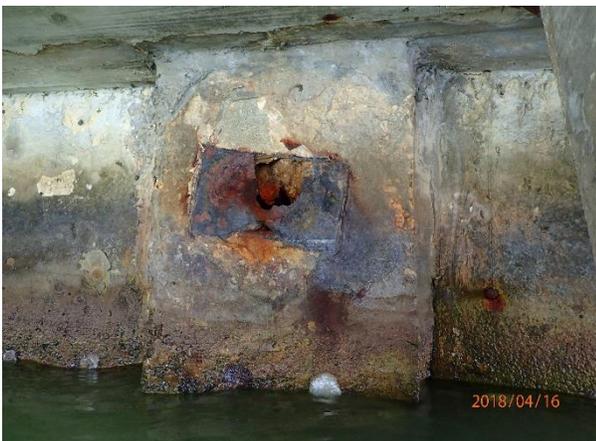
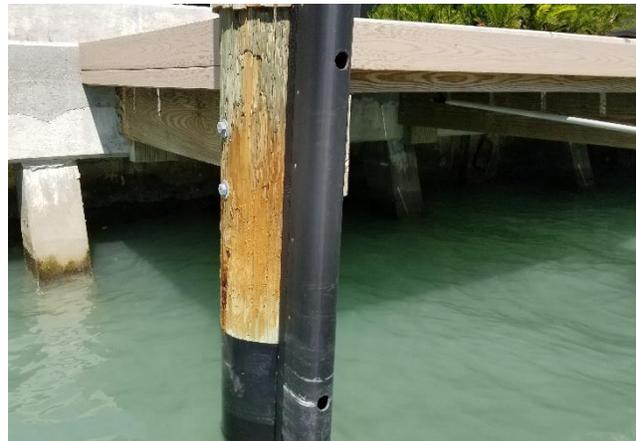
Property Address: 9441 E BROADVIEW DR  
Bay Harbor Islands, FL 33154  
Location: S-1.1 Lot#65  
Date of Inspection: 4/16/2018 @ 11:25am

- Wall Panels – Moderate horizontal cracking along top
- T-Piles – Moderate cracking
- T-Piles – Moderate corrosion at partially sealed anchors
- Dock – Moderate corrosion at fasteners
- Dock – Failed anchor at dock pile

• Seawall Rating: Fair      • Dock Rating: Satisfactory

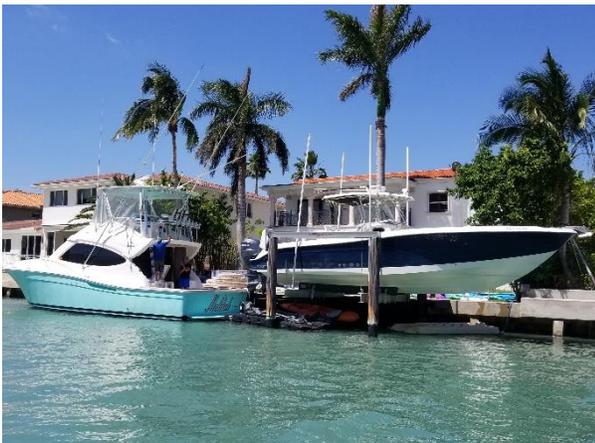
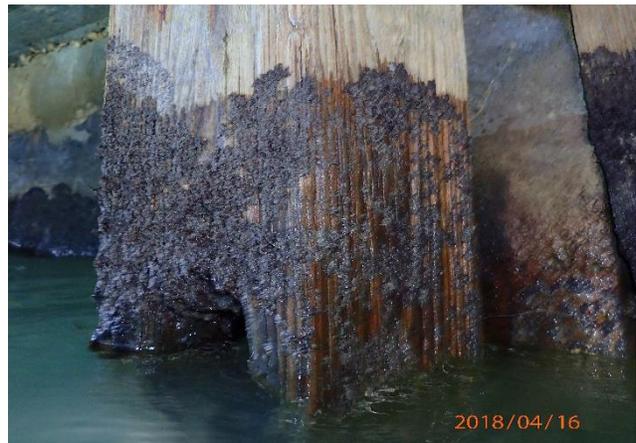
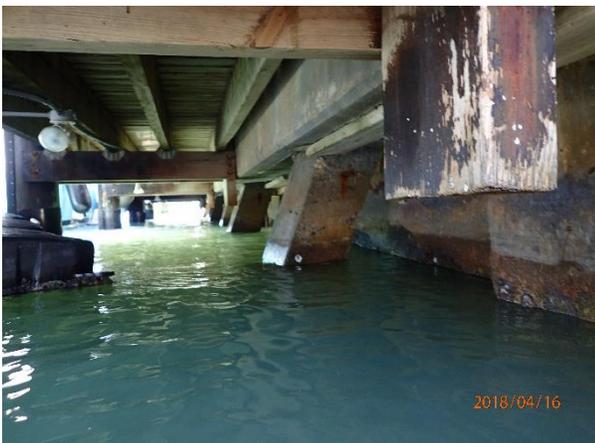
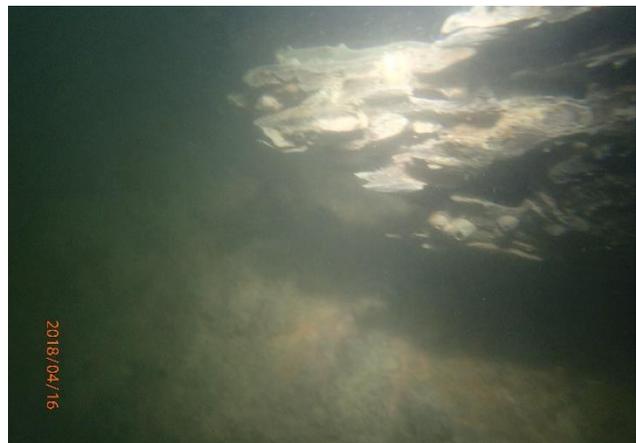
Property Address: 9431 E BROADVIEW DR  
Bay Harbor Islands, FL 33154  
Location: S-1.1 Lot#66  
Date of Inspection: 4/16/2018 @ 11:30am

- Wall Panels – Moderate cracking along top
- Wall Panels – Moderate spalling at bottom panel section
- T-Piles – Moderate cracking
- Dock – Corrosion at fasteners
- Dock –Pile wraps loose

• Seawall Rating: Fair    • Dock Rating: Fair

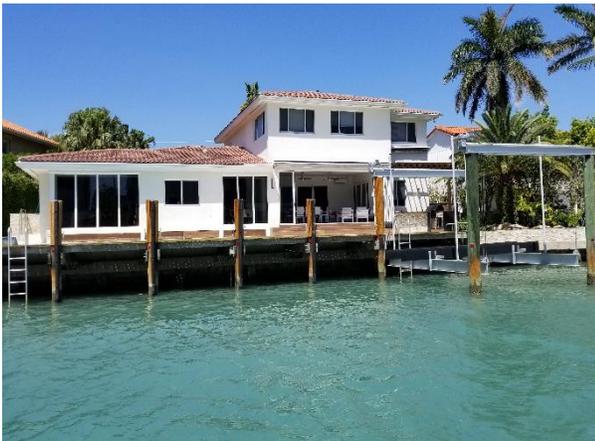
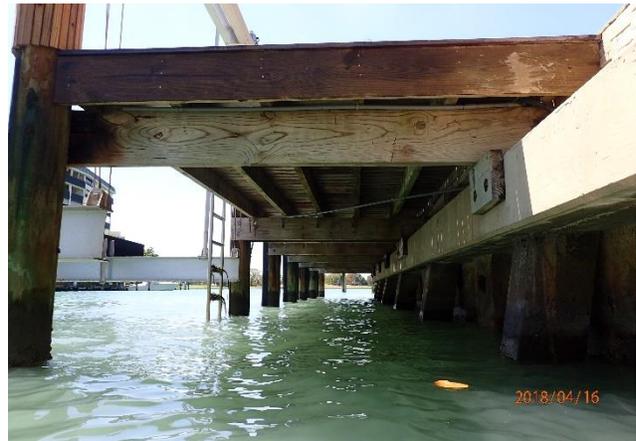
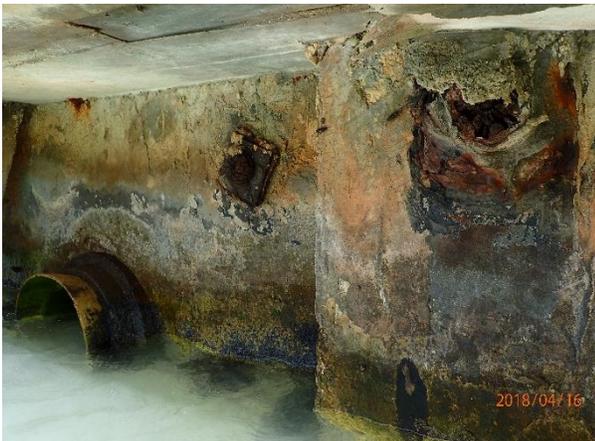
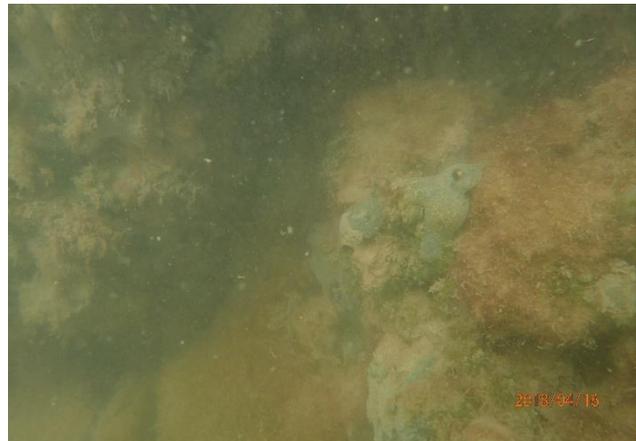
- Wall Panels – Minor concrete erosion along tidal zone
- T-Piles – Severe corrosion at anchor heads
- T-Piles – Minor spalling at spot locations
- Batter Piles – Minor spalling at spot locations
- Dock – Timber piles exhibit salt kill
- Dock – Corrosion on bolts

• Seawall Rating: Fair                      • Dock Rating: Fair

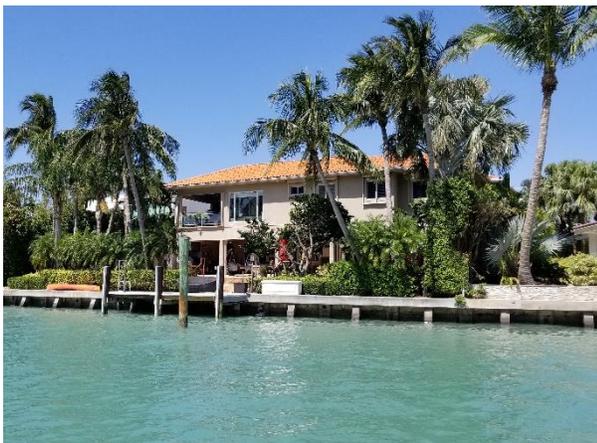
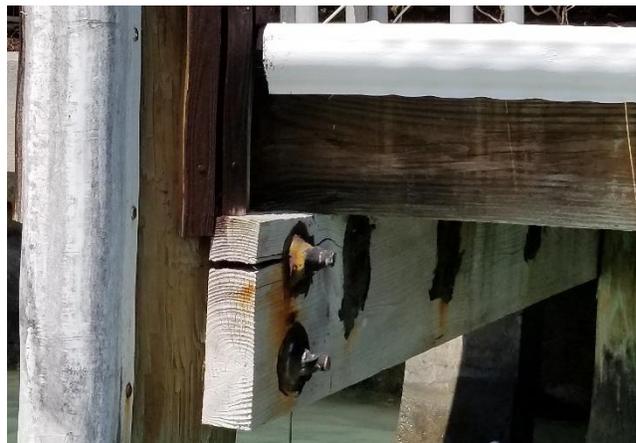
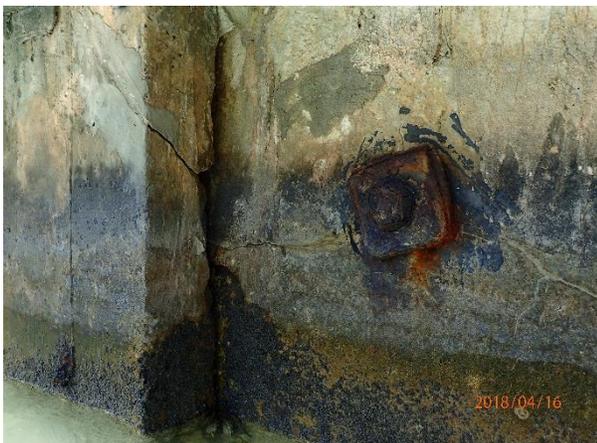
Property Address: 9411 E BROADVIEW DR  
Bay Harbor Islands, FL 33154  
Location: S-1.1 Lot#68  
Date of Inspection: 4/16/2018 @ 11:40am

- Wall Panels – Moderate cracking with prior repairs
- T-Piles – Moderate deterioration at rounded corner
- T-Piles – Severe corrosion at anchor heads
- Dock – Splitting at bolt connections
- Dock – Bolts coated with anti-corrosion material
- Dock – Timber piles exhibit salt kill

• Seawall Rating: Poor

• Dock Rating: Poor

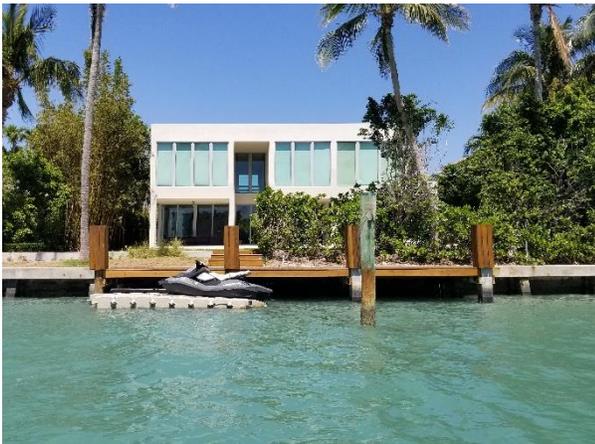
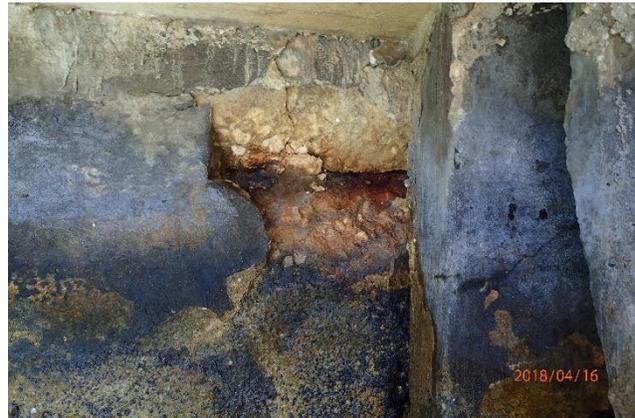
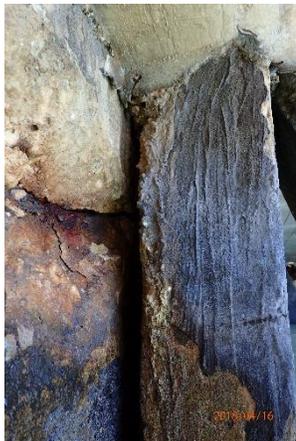
Property Address: 9407 E BROADVIEW DR  
Bay Harbor Islands, FL 33154  
Location: S-1.1 Lot#69  
Date of Inspection: 4/16/2018 @ 11:50am

- \*Cap – Moderate cracking at wet face
- \*Wall Panels – Spalling at mid-panels
- \*Wall Panels – Severe fracture through concrete at South panel section and rotation of the wall around corner
- \*T-Piles – Pile/panel separation with sediment accumulation
- \*Dock – Advanced corrosion of bolts

• Seawall Rating: Poor                  • Dock Rating: Poor

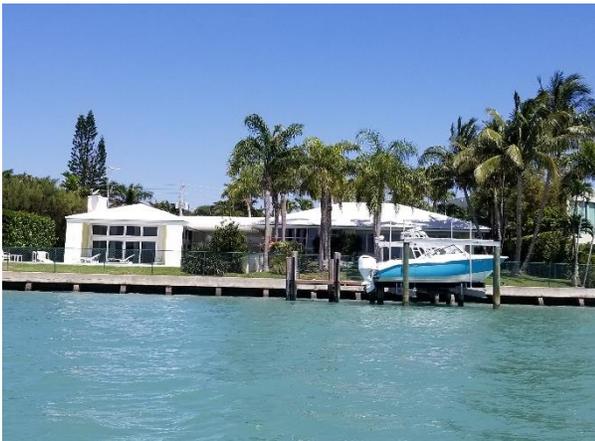
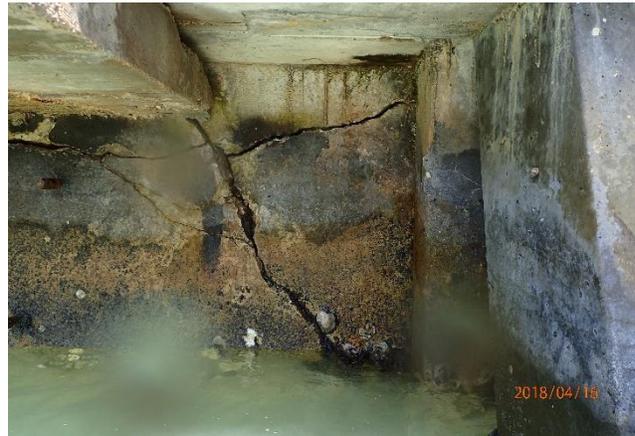
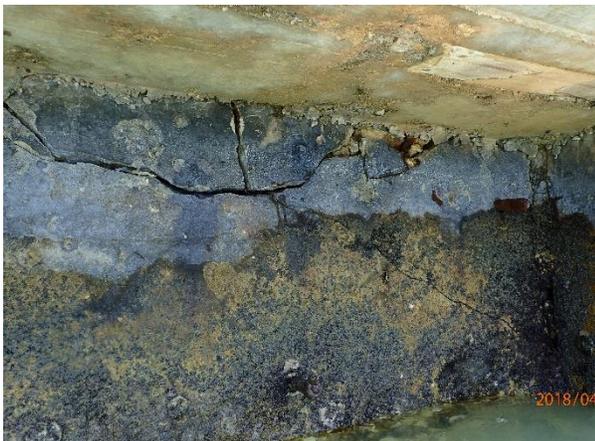
Property Address: 9405 E BROADVIEW DR  
Bay Harbor Islands, FL 33154  
Location: S-1.1 Lot#70  
Date of Inspection: 4/16/2018 @ 12:00pm

- Wall Panels – Severe spalling and fractures at North panels
- Wall Panels – Undermining at South closure pour
- Batter Piles– Spalling at pile heads and center
- Upland depressions

• Seawall Rating: Poor                  • Dock Rating: Satisfactory

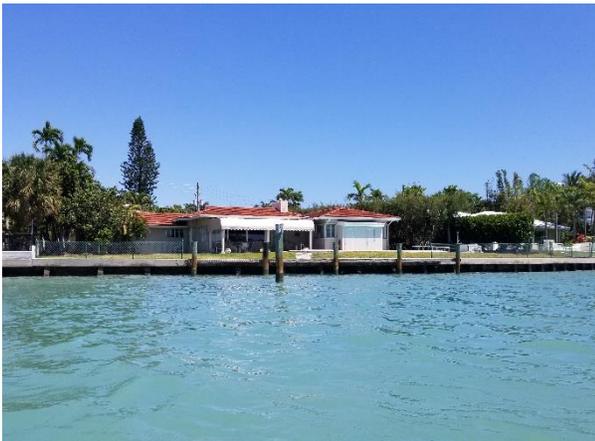
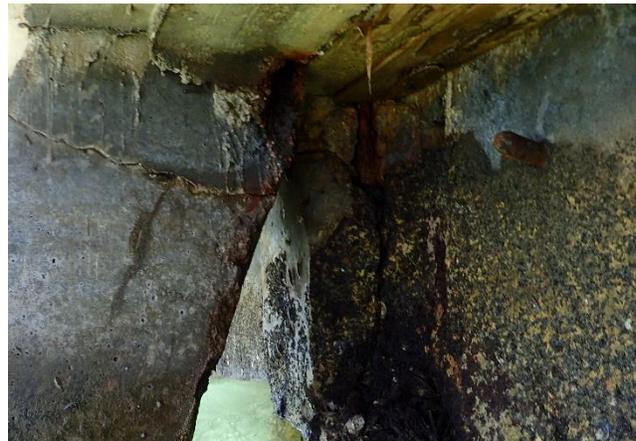
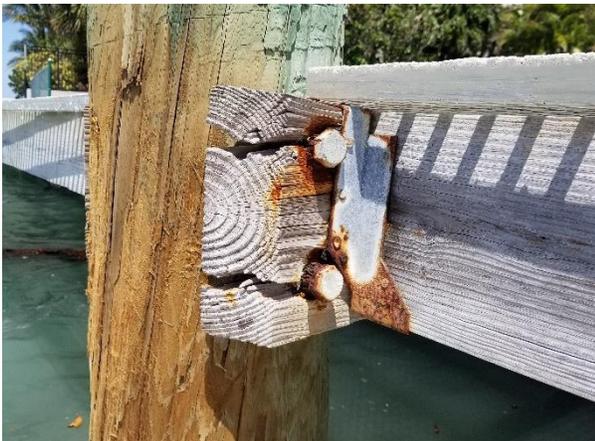
- \*Wall Panels – Severe corrosion at original wall anchors
- \*Wall Panels – Moderate cracking at South panels
- \*T-Piles – Moderate spalling at South property
- \*Batter Piles– Minor spalling
- \*Dock – Splitting at beam pile connection
- \*Dock – Timber piles exhibit salt kill

• Seawall Rating: Fair          • Dock Rating: Critical

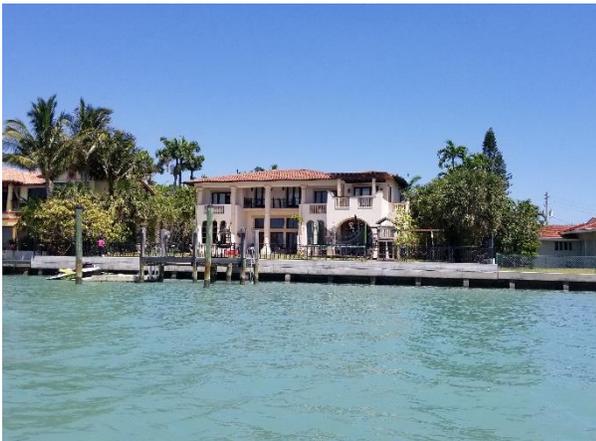
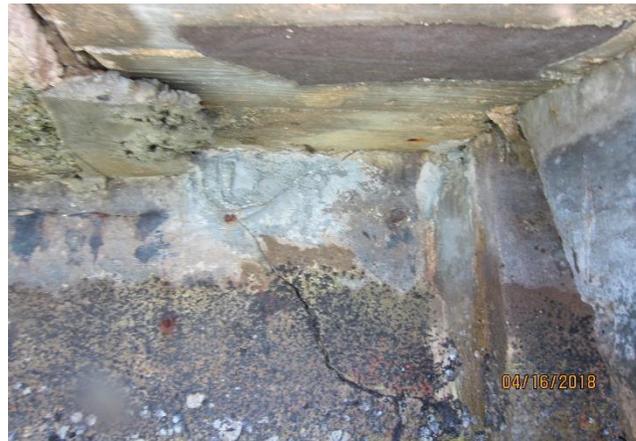
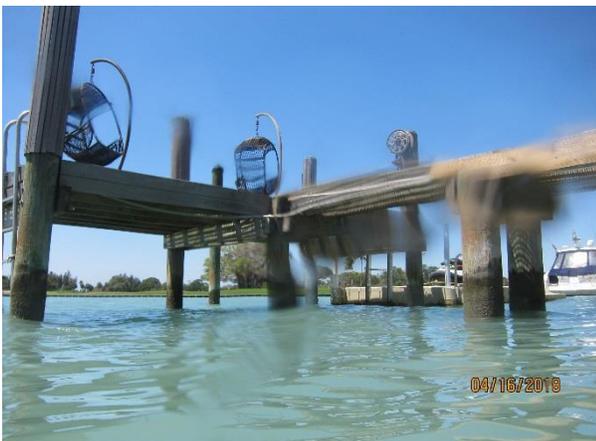
Property Address: 9406 W BROADVIEW DR  
Bay Harbor Islands, FL 33154  
Location: S-1.1 Lot#72  
Date of Inspection: 4/16/2018 @ 12:30am

- T-Piles – Minor concrete erosion at tidal zone
- Batter Piles– Severe spalling
- Wall Panels – Minor concrete erosion at tidal zone

• Seawall Rating: Fair      • Dock Rating: Fair

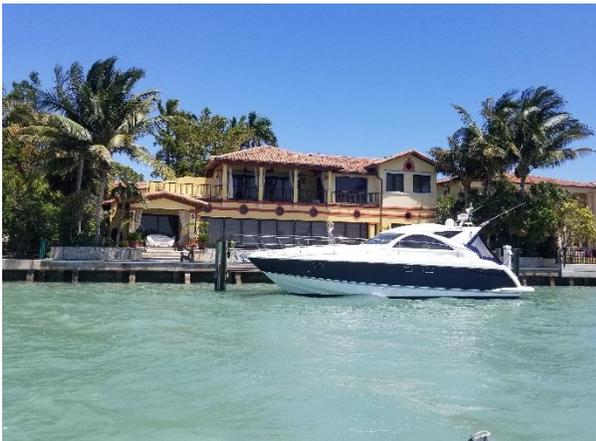
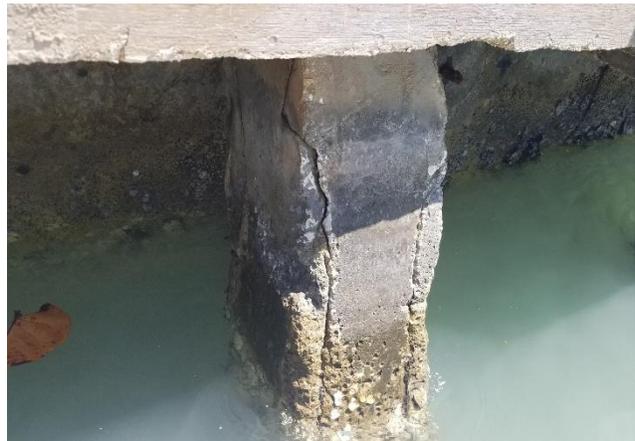
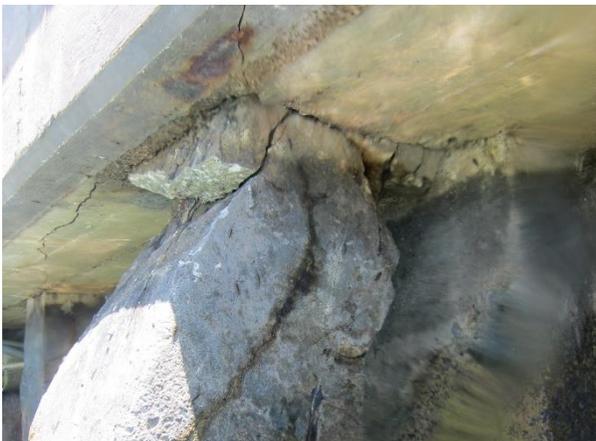
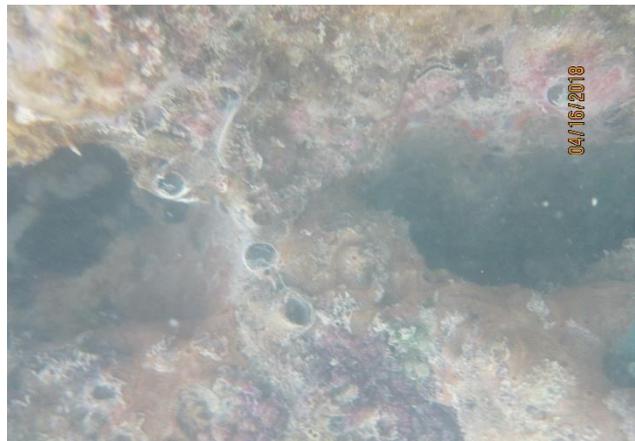
Property Address: 9408 W BROADVIEW DR  
Bay Harbor Islands, FL 33154  
Location: S-1.1 Lot#73  
Date of Inspection: 4/16/2018 @ 12:40am

- Cap – Moderate cracking at the soffit and wet face
- T-Piles – Severe cracking
- King Piles– Severe cracking
- Batter Piles– Severe cracking and deterioration
- Dock– Minor corrosion at fasteners

• Seawall Rating: Poor      • Dock Rating: Satisfactory

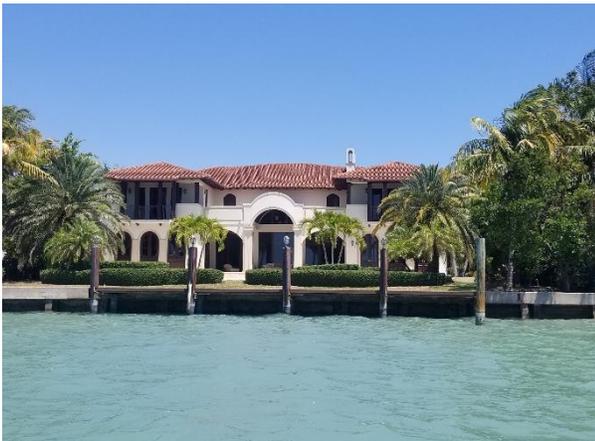
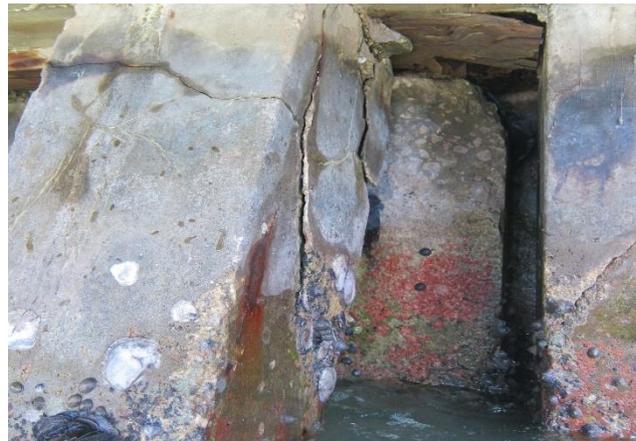
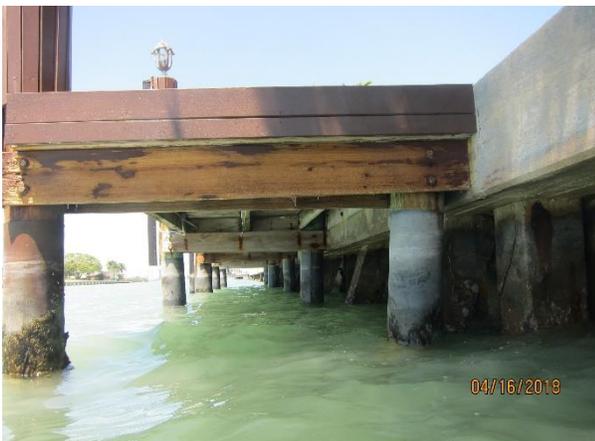
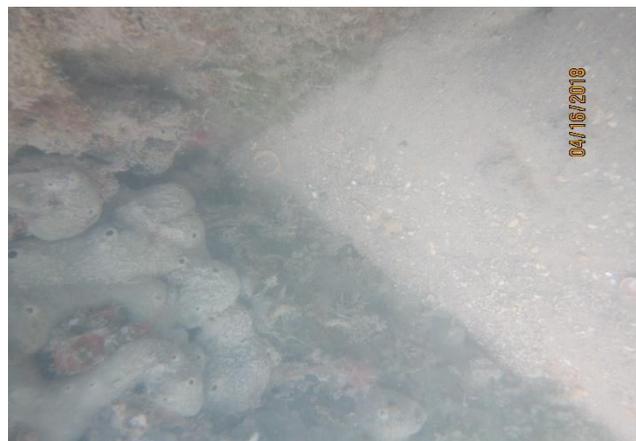
Property Address: 9410 W BROADVIEW DR  
Bay Harbor Islands, FL 33154  
Location: S-1.1 Lot#74  
Date of Inspection: 4/16/2018 @ 12:50am

- \*Cap – Severe spalling and deterioration
- \*Wall Panels – Pile/panel separation
- \*Wall Panels – Vertical cracking
- \*T-Piles – Outward movement at separation locations
- \*Batter Piles– Severe cracking and deterioration
- \*Dock – Severe corrosion at straps

• Seawall Rating: Poor                      • Dock Rating: Fair

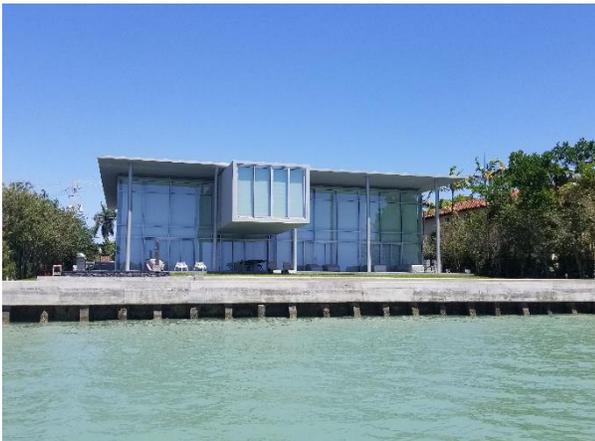
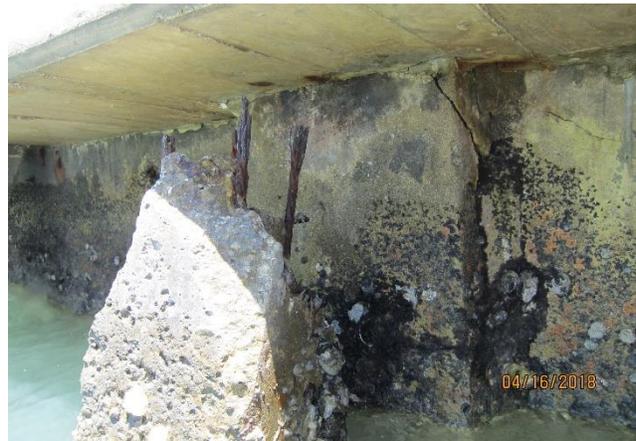
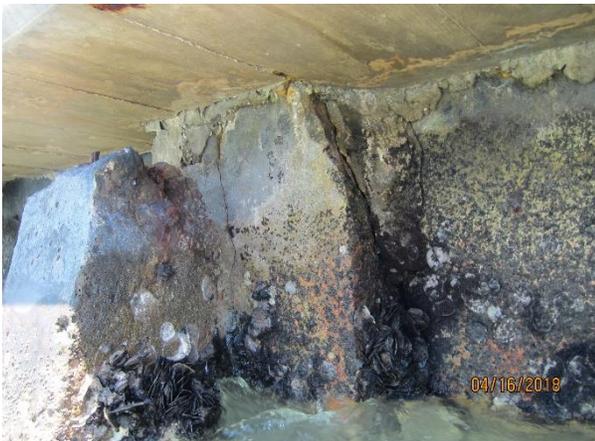
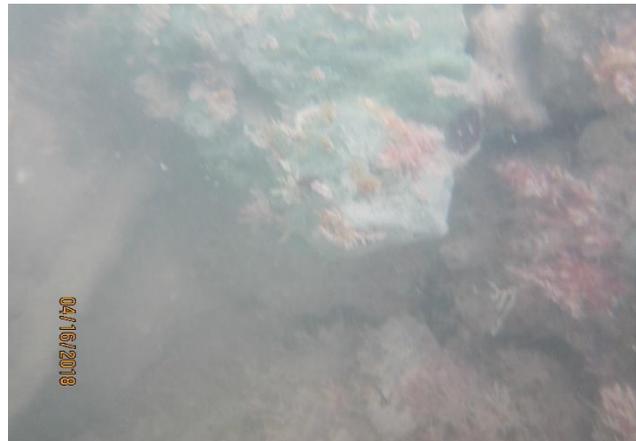
Property Address: 9414 W BROADVIEW DR  
Bay Harbor Islands, FL 33154  
Location: S-1.1 Lot#75  
Date of Inspection: 4/16/2018 @ 12:55am

- Wall Panels –Rotation of wall
- Wall Panels – Moderate cracking and spalling
- T-Piles – Moderate to severe cracking and deterioration
- Batter Piles– Older 10 in. piles disintegrated below cap

• Seawall Rating: Poor                      • Dock Rating: N/A

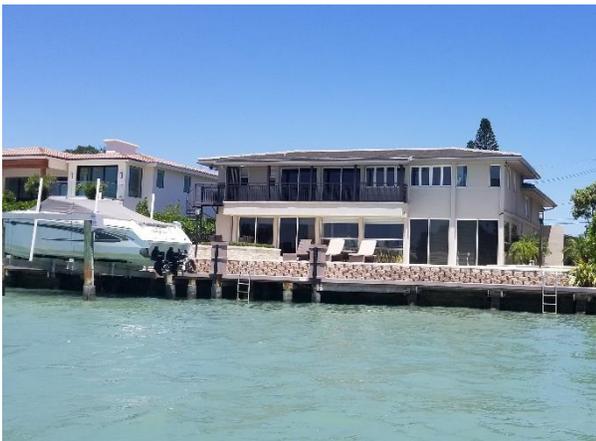
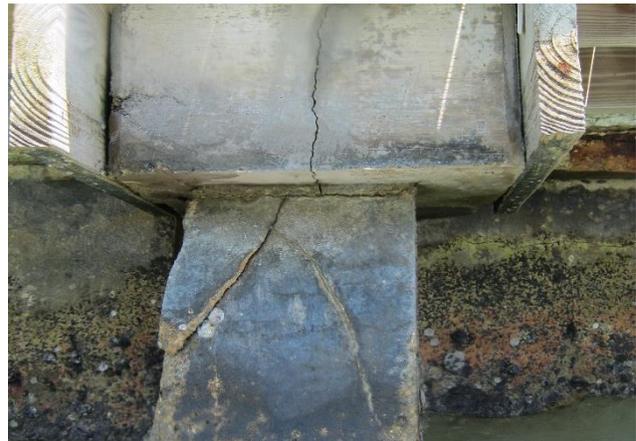
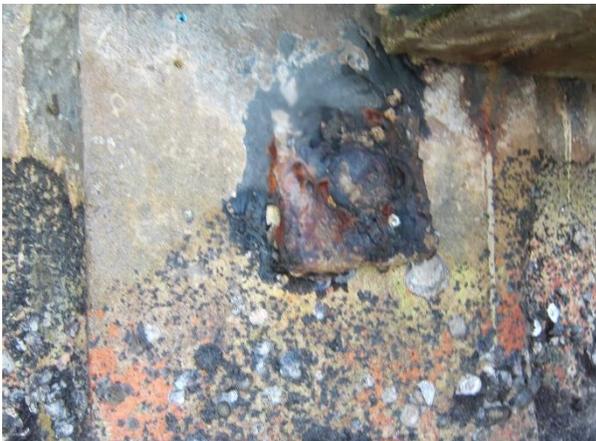
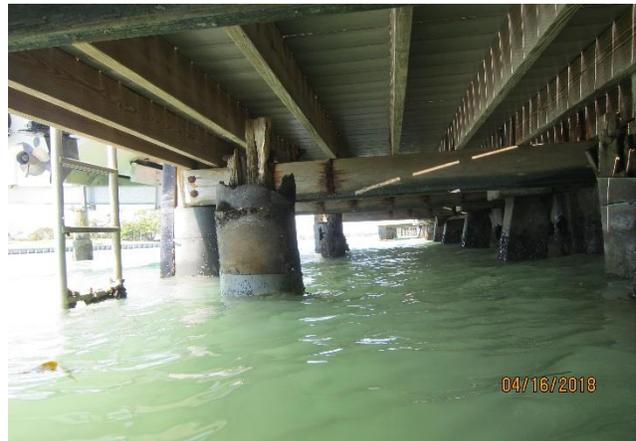
Property Address: 9418 W BROADVIEW DR  
Bay Harbor Islands, FL 33154  
Location: S-1.1 Lot#76  
Date of Inspection: 4/16/2018 @ 1:00pm

- Cap – Severe cracking and spalling along cap/retrofit caps
- T-Piles – Moderate concrete erosion and cracking
- T-Piles – Severe corrosion at anchor heads
- Batter Piles– Severe cracking and spalling
- Dock – Corrosion at fasteners and straps
- Dock – Missing east end support

• Seawall Rating: Poor      • Dock Rating: Critical

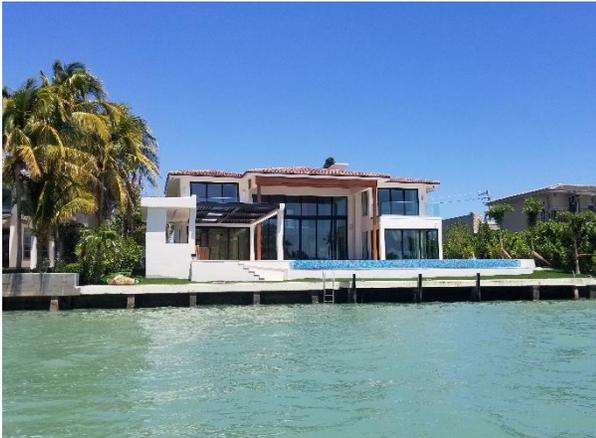
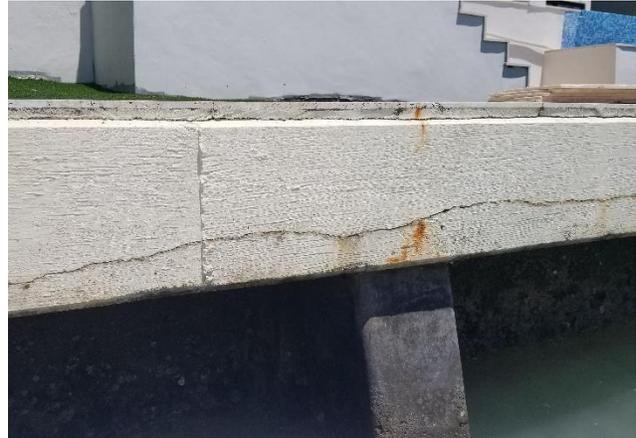
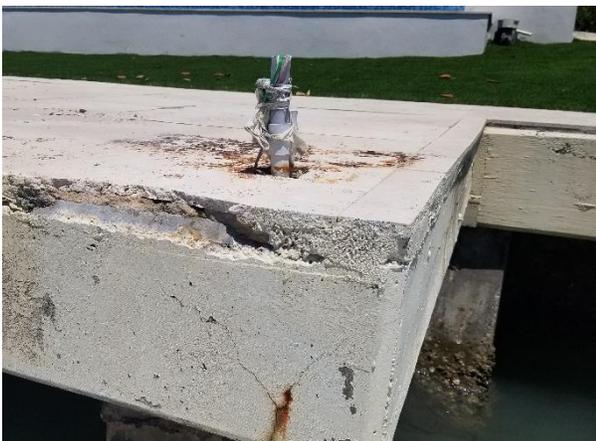
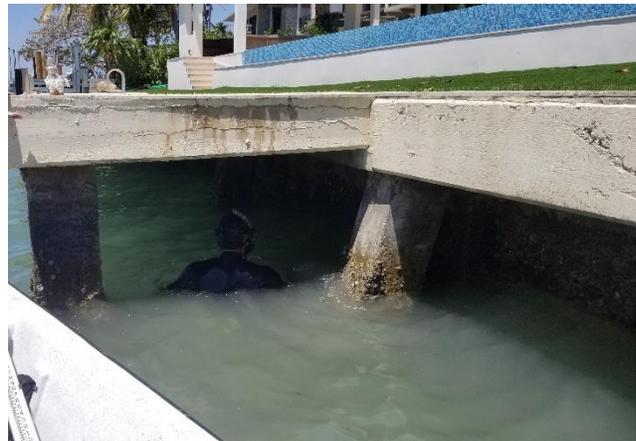
Property Address: 9420 W BROADVIEW DR  
Bay Harbor Islands, FL 33154  
Location: S-1.1 Lot#77  
Date of Inspection: 4/16/2018 @ 1:10pm

- \*Cap – Cracking at wet face and spalling at soffit
- \*Wall Panels – Moderate horizontal and diagonal cracking
- \*Dock – Minor spalling at pile heads
- \*Dock – Minor spalling at wet face and top of dock, cracking

• Seawall Rating: Fair      • Dock Rating: Fair

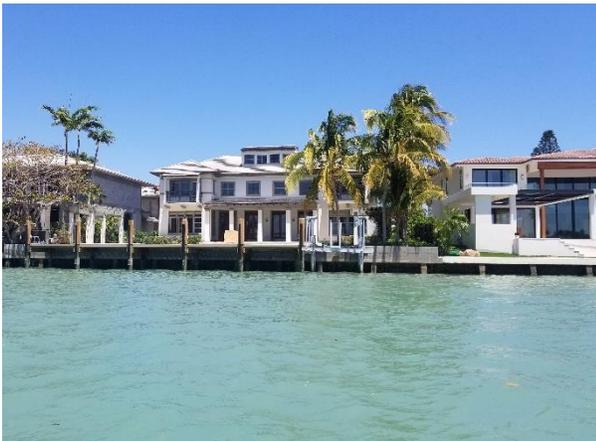
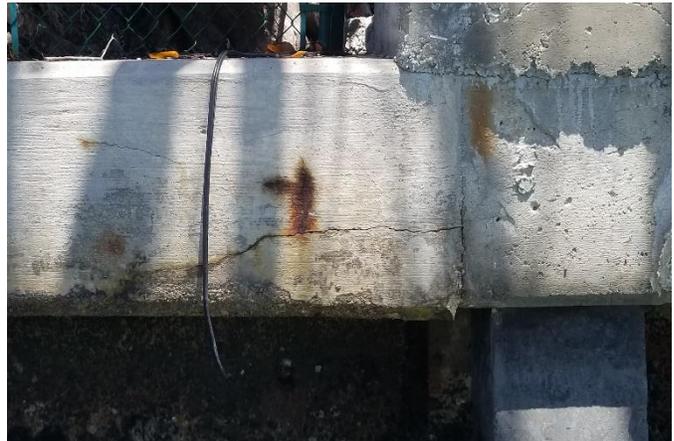
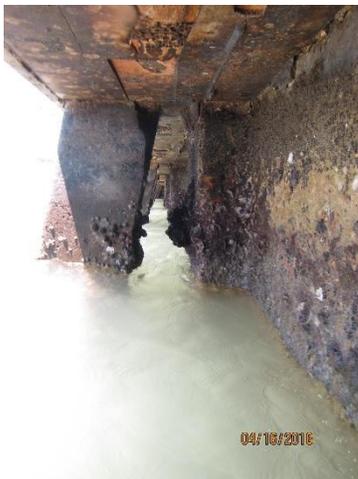
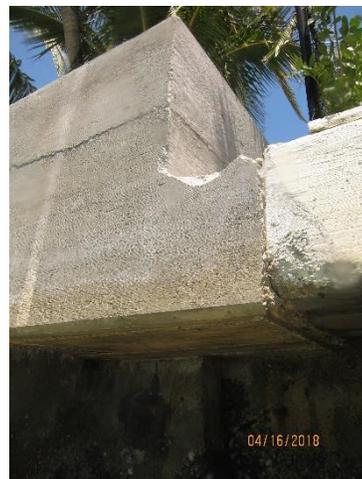
Property Address: 9424 W BROADVIEW DR  
Bay Harbor Islands, FL 33154  
Location: S-1.1 Lot#78  
Date of Inspection: 4/16/2018 @ 1:10pm

- \*Cap – Secondary cap above original
- \*Dock – Timber Piles with sleeves

• Seawall Rating: Fair      • Dock Rating: Satisfactory

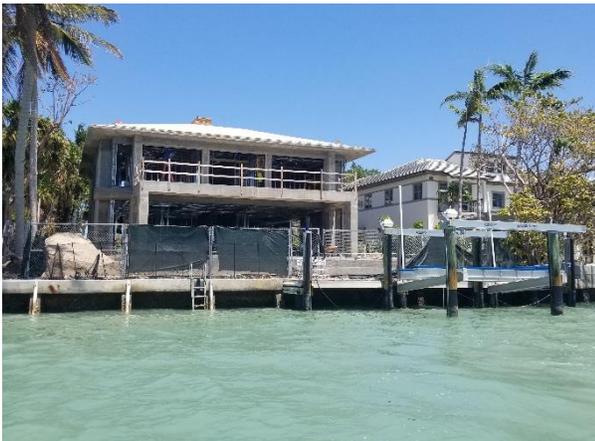
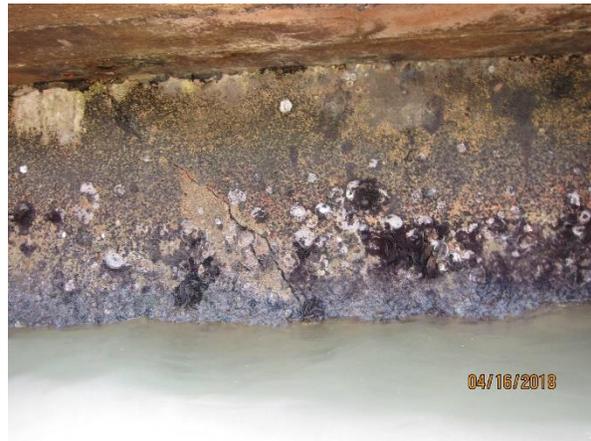
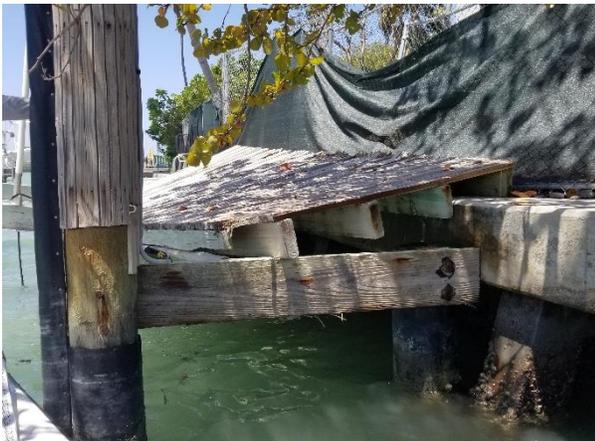
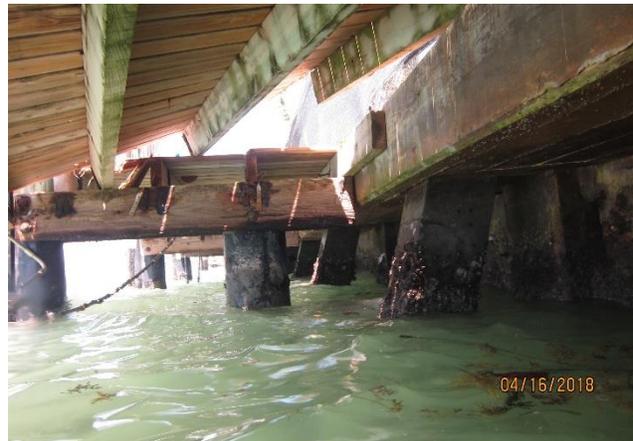
- \*Cap – Moderate cracking at East section and wet face
- \*Wall Panels – Minor to moderate cracking at panels
- \*T-Piles – Minor cracking
- \*T-Piles – Moderate erosion in tidal zone
- \*Batter Piles – Moderate cracking at North West piles
- \*Dock – Critical/failing framing with piles exhibiting salt kill

• Seawall Rating: Fair      • Dock Rating: Critical

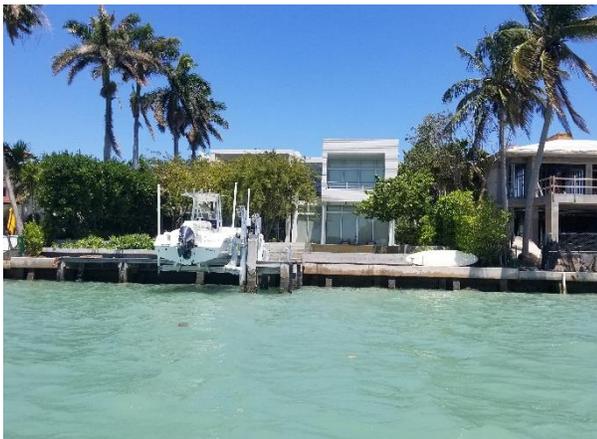
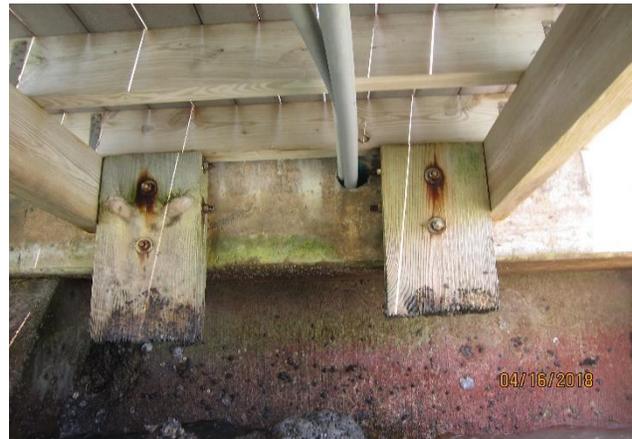
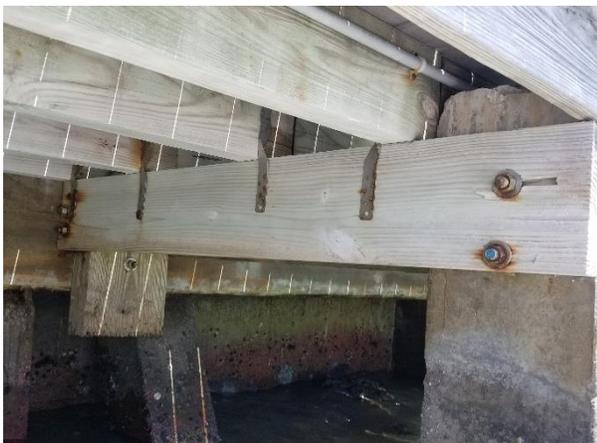
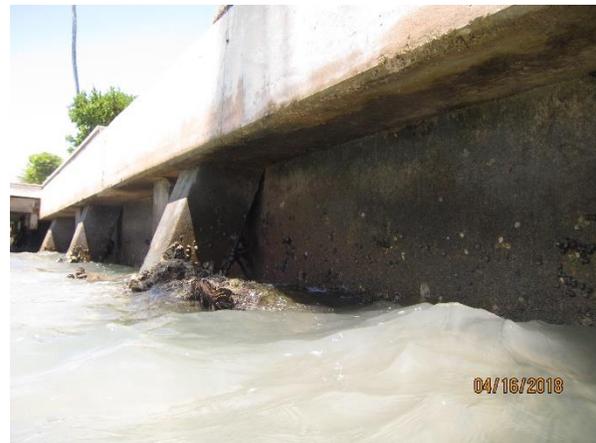
Property Address: 9434 W BROADVIEW DR  
Bay Harbor Islands, FL 33154  
Location: S-1.1 Lot#80  
Date of Inspection: 4/16/2018 @ 1:30pm

- Wall Panels – Minor cracking along top of panels
- Wall Panels – Minor concrete erosion at tidal zone
- Dock – Corrosion at fasteners, wood splitting

• Seawall Rating: Fair                      • Dock Rating: Fair

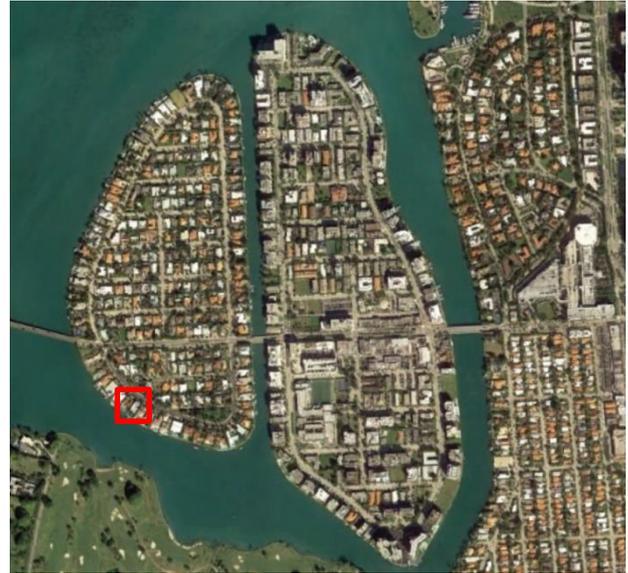
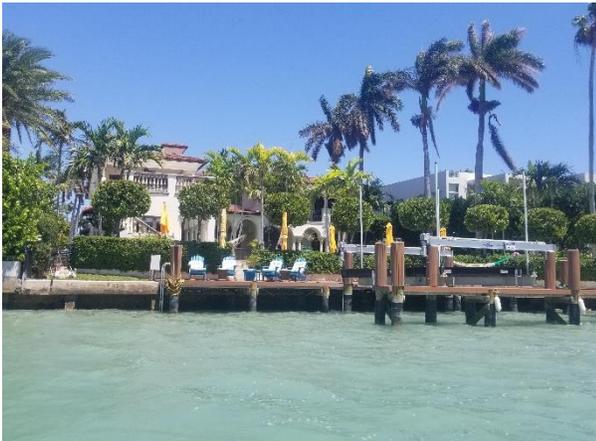
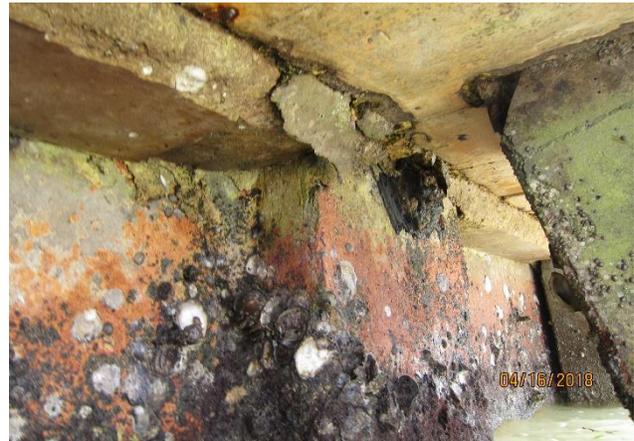
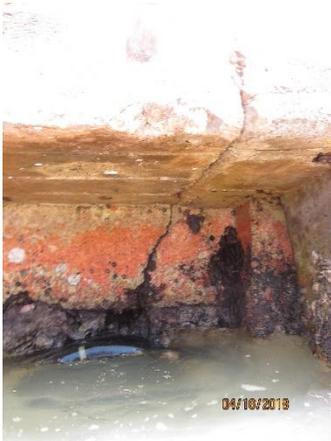
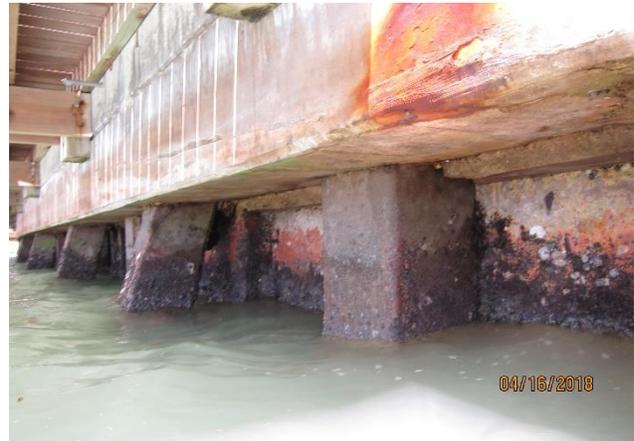
Property Address: 9440 W BROADVIEW DR  
Bay Harbor Islands, FL 33154  
Location: S-1.1 Lot#81  
Date of Inspection: 4/16/2018 @ 1:40pm

- \*Cap – Minor to severe cracking and spalling with corrosion staining at wet face and soffit
- \*Wall Panels – Minor cracking
- \*Wall Panels – Large cavity beneath panels
- \*Wall Panels – Void with severe cracking at West outfall
- \*Dock – Fastener corrosion

• Seawall Rating: Poor      • Dock Rating: Fair

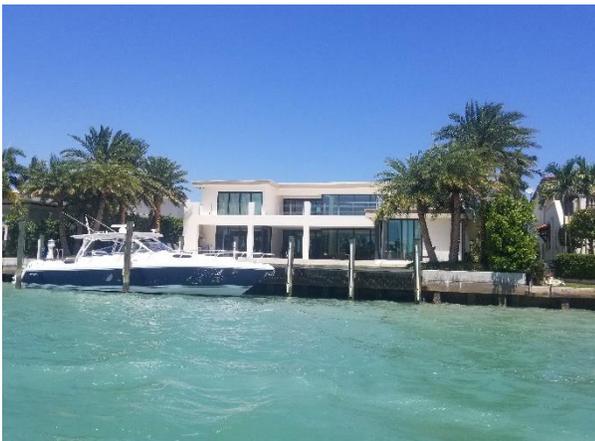
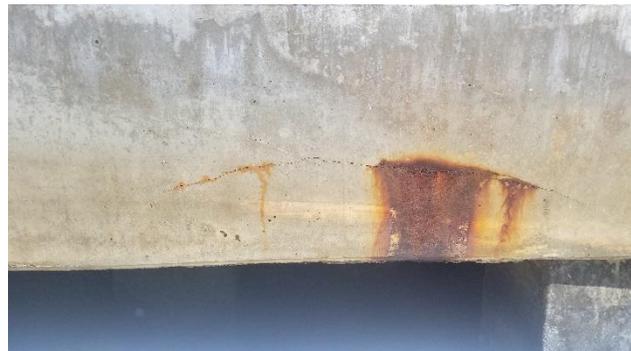
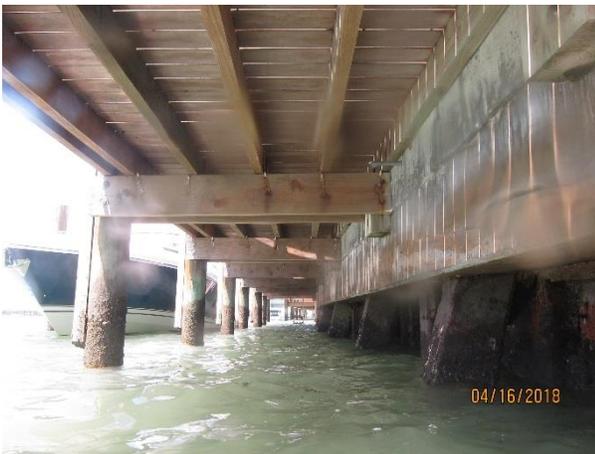
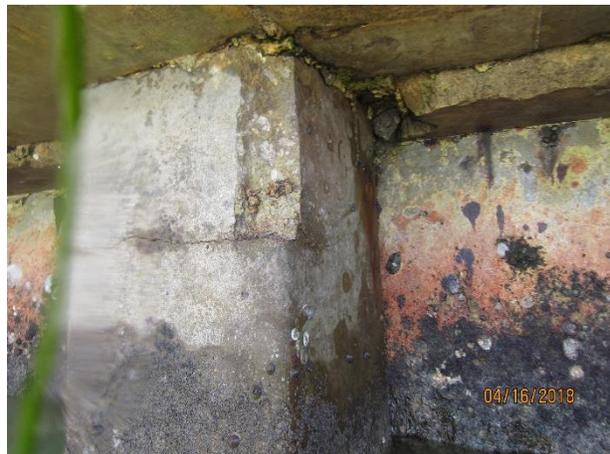
Property Address: 9448 W BROADVIEW DR  
Bay Harbor Islands, FL 33154  
Location: S-1.1 Lot#82  
Date of Inspection: 4/16/2018 @ 1:40pm

- \*Cap – Moderate cracking at the wet face
- \*Cap – Moderate cracking at soffit
- \*Wall Panels – Moderate concrete erosion in tidal zone
- \*King Piles – Moderate cracking
- \*Dock – Hardware corrosion

• Seawall Rating: Fair      • Dock Rating: Fair

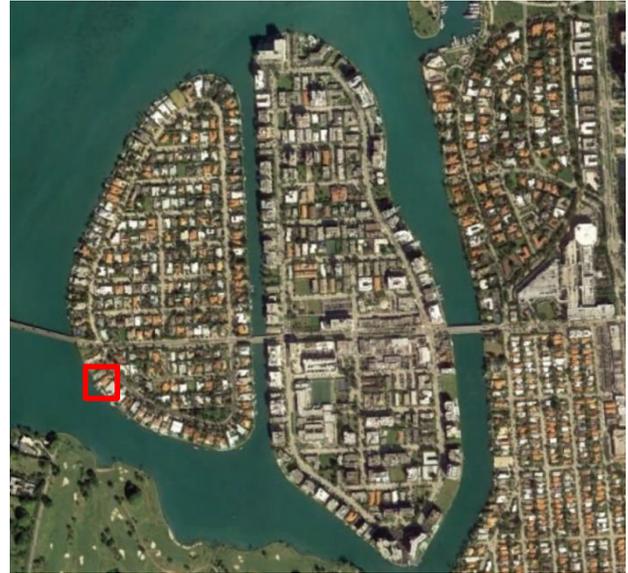
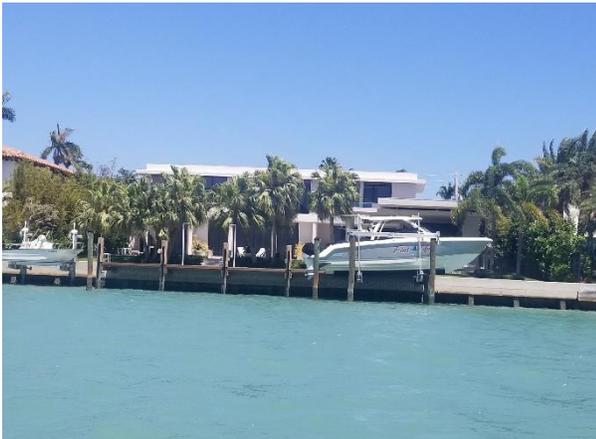
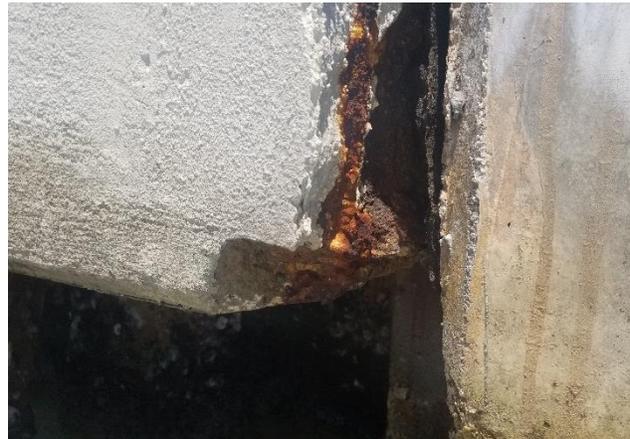
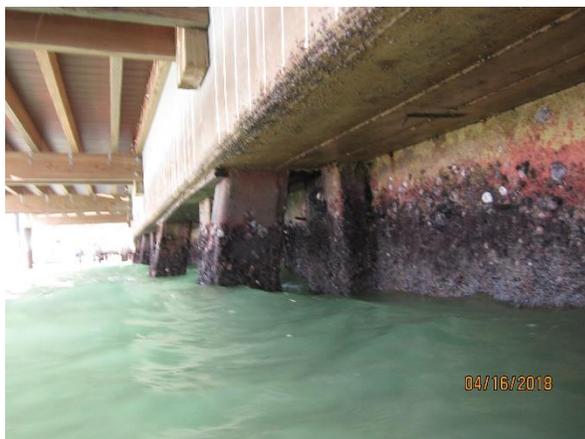
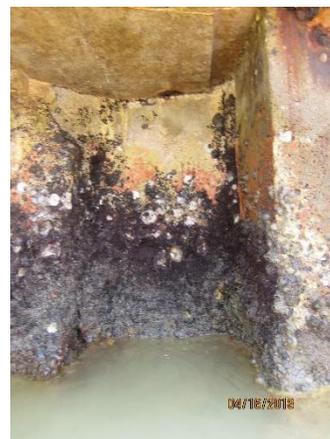
Property Address: 9500 W BROADVIEW DR  
Bay Harbor Islands, FL 33154  
Location: S-1.1 Lot#83  
Date of Inspection: 4/16/2018 @ 1:50pm

- Cap – Moderate spalling with exposed reinforcement
- Wall Panels – Moderate concrete erosion at splash zone
- T-Piles – Moderate concrete erosion in tidal zone
- Dock – Timber mooring piles exhibit salt kill

• Seawall Rating: Fair    • Dock Rating: Satisfactory

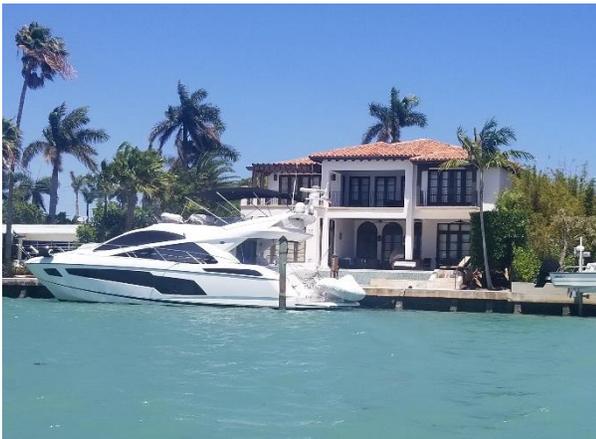
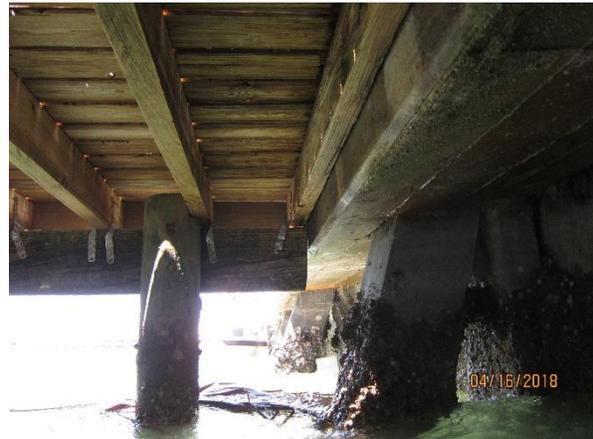
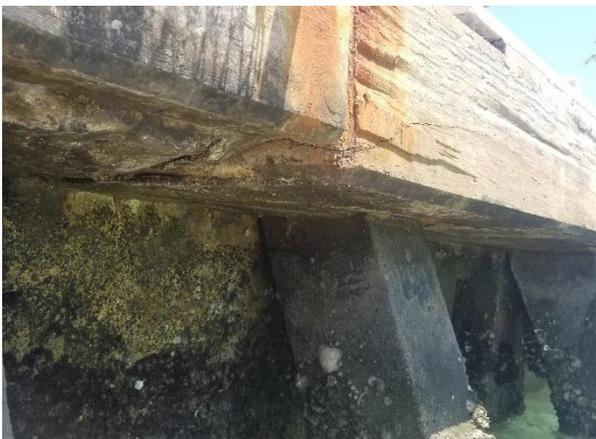
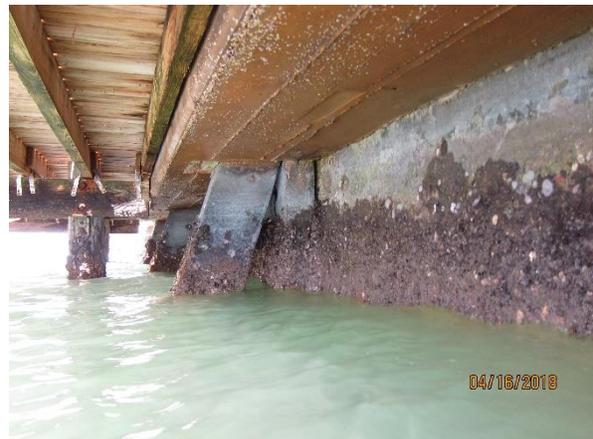
Property Address: 9510 W BROADVIEW DR  
Bay Harbor Islands, FL 33154  
Location: S-1.1 Lot#84  
Date of Inspection: 4/16/2018 @ 2:00pm

- \*Cap – Moderate spalling at West property line
- \*Cap – Moderate cracking with corrosion staining wet face
- \*Wall Panels – Moderate cracking and spalling at West property line
- \*T-Pile – Pile/panel separation
- \*Dock – Moderate corrosion at bolts

• Seawall Rating: Fair                      • Dock Rating: Fair
