# Seawall Condition and Resiliency Assessment Town of Bay Harbor Islands

October 2019 (Updated)

**Cummins Cederberg, Inc.**

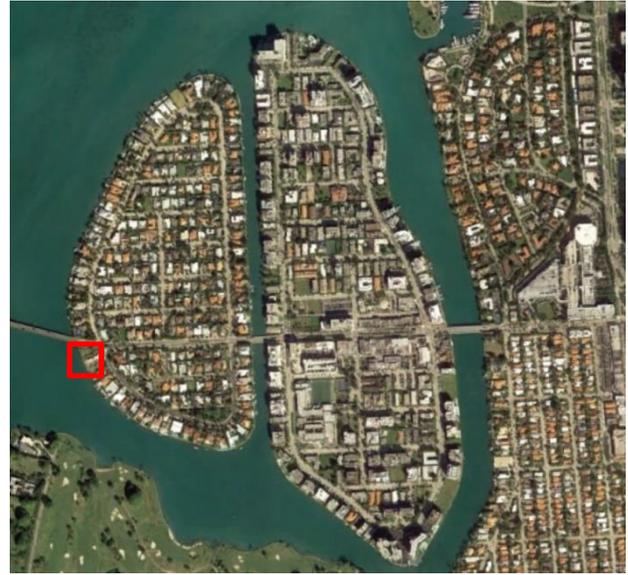
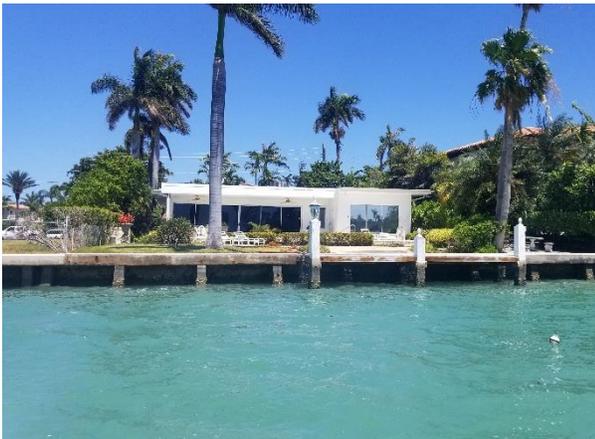
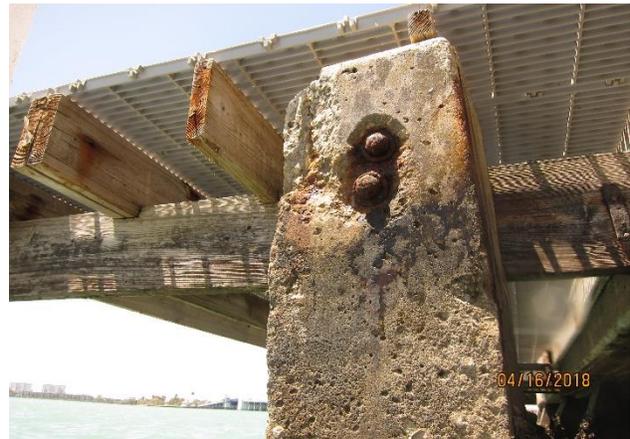
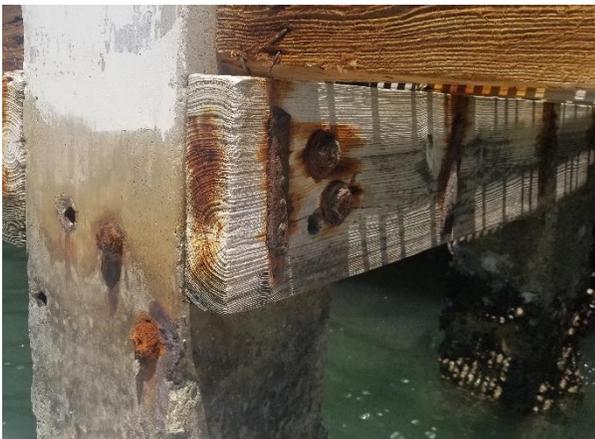
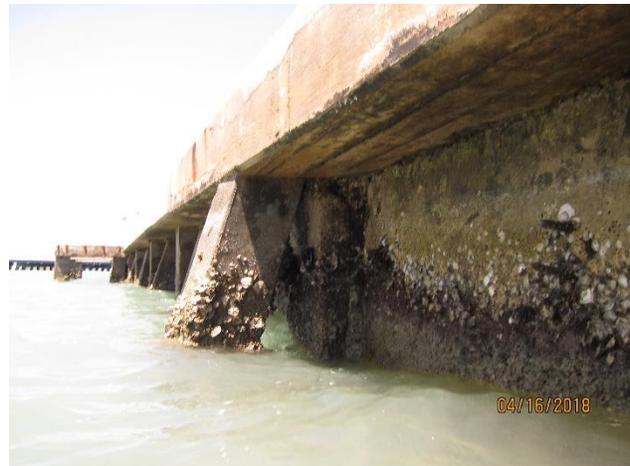
Property Address: 9520 W BROADVIEW DR  
Bay Harbor Islands, FL 33154  
Location: S-1.1 Lot#85  
Date of Inspection: 4/16/2018 @ 1:10pm

- Cap – Minor cracking wet face with corrosion staining
- Wall Panels – Severe spalling at northwest end of property
- Wall Panels – Severe rotation of panels
- T-Piles – Deterioration at the head for 2/3 of the property
- Dock – Wood decay
- Dock – Severe corrosion and deterioration of straps and fasteners
- Dock – Deterioration at piles

• Seawall Rating: Poor      • Dock Rating: Poor

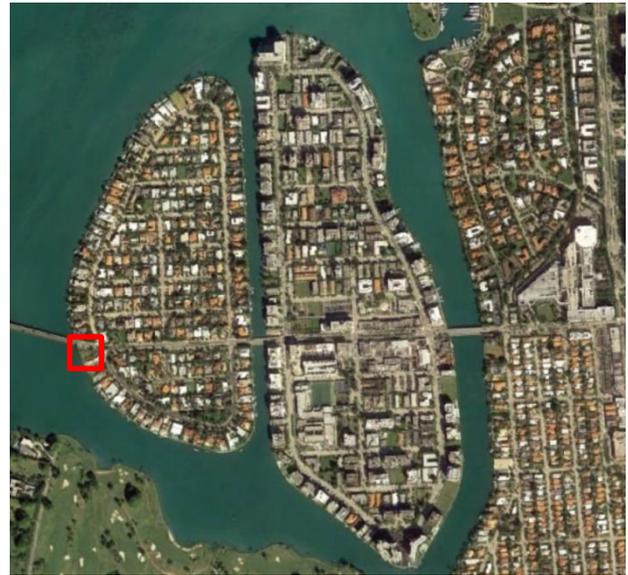
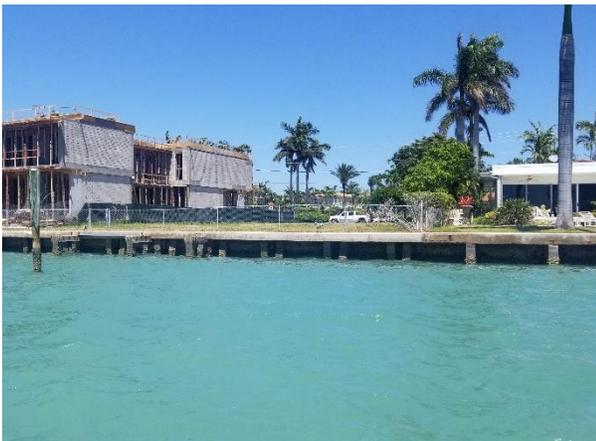
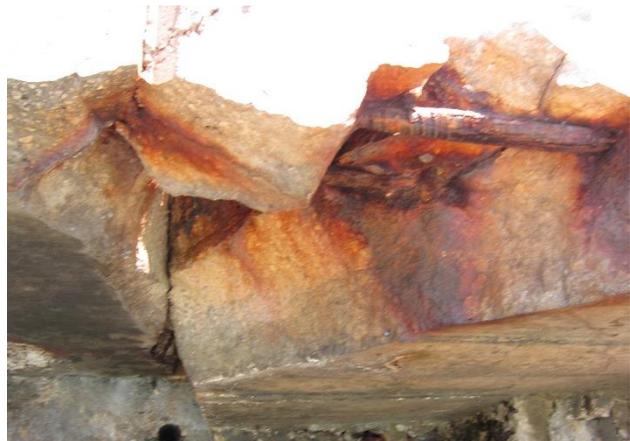
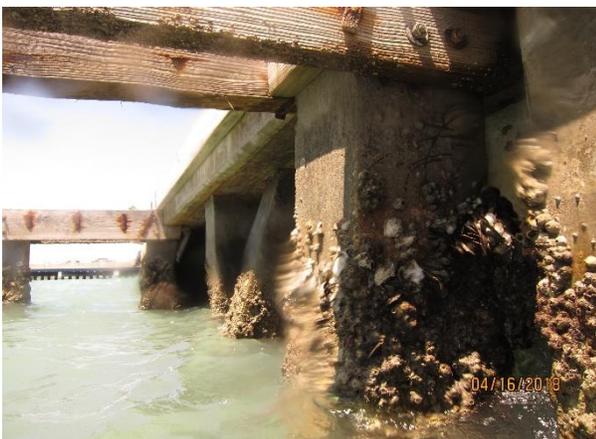
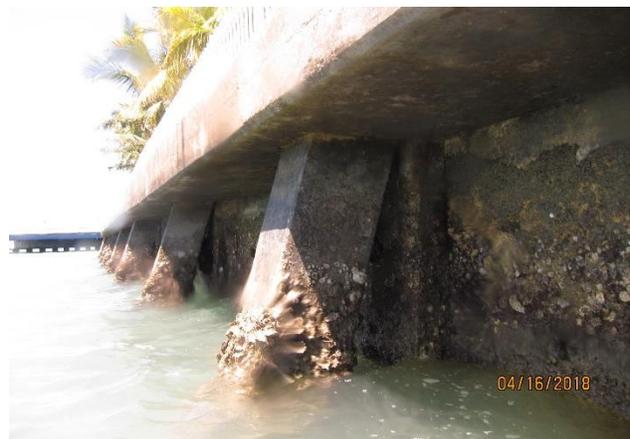
Property Address: 9530 W BROADVIEW DR  
Bay Harbor Islands, FL 33154  
Location: S-1.1 Lot#86  
Date of Inspection: 4/16/2018 @ 2:20pm

- \*Cap – Cracking and section loss with exposed reinforcement
- \*T-Piles – Deterioration piles replaced with king piles
- \*King Piles – Minor cracking at pile heads
- \*Wall Panels – Minor concrete erosion at tidal zone
- \*Dock – Wood deck demolished

• Seawall Rating: Fair      • Dock Rating: N/A

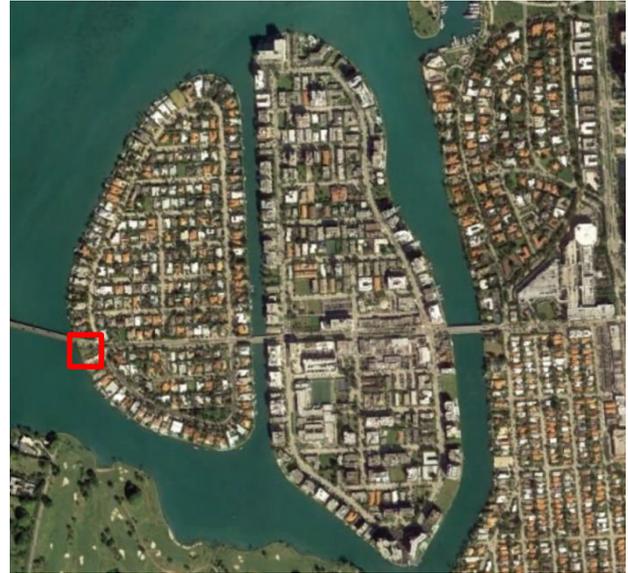
Property Address: 9540 W BROADVIEW DR  
Bay Harbor Islands, FL 33154  
Location: S-1.1 Lot#87  
Date of Inspection: 4/16/2018 @ 2:30pm

- \*Cap – Moderate cracking at wet face
- \*Cap – Severe spalling at Northern property line
- \*King Piles – Moderate cracking at Northern piles
- \*Batter Piles – Cracking at pile heads

• Seawall Rating: Fair      • Dock Rating: N/A

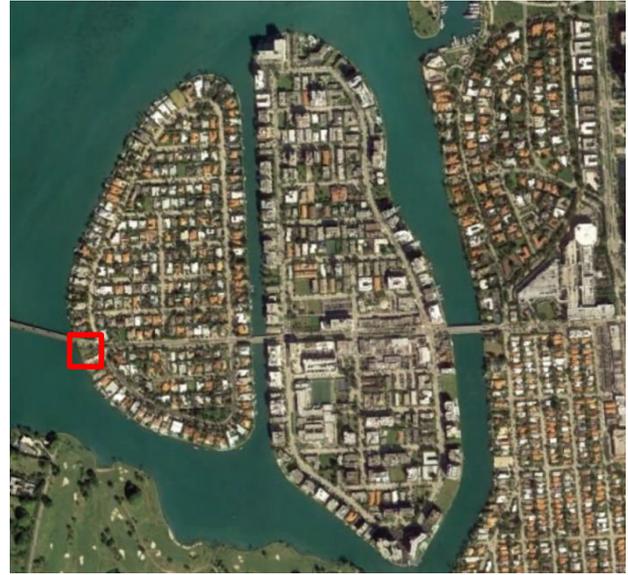
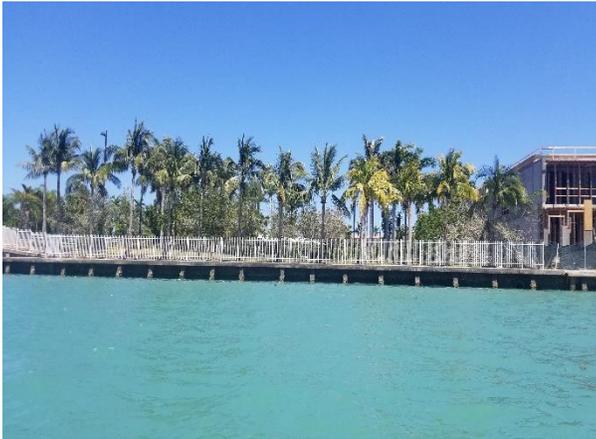
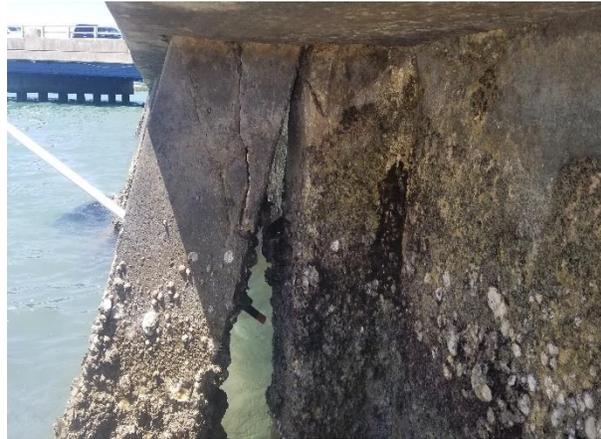
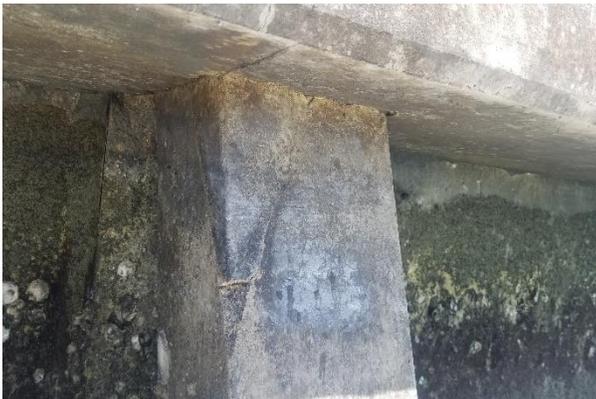
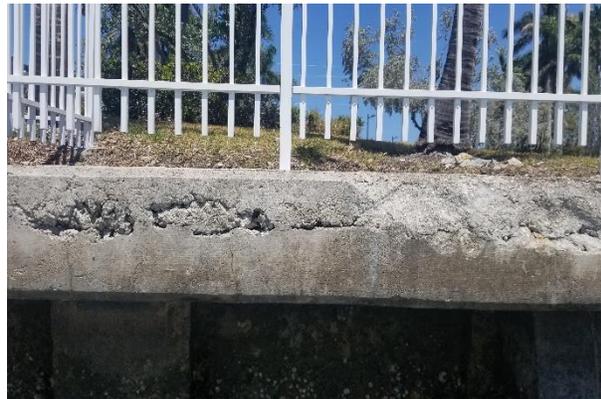
Property Address: Address Not Applicable  
Bay Harbor Islands, FL 33154  
Location: S-1.1 Lot#88  
Date of Inspection: 4/16/2018 @ 2:30pm

- \*Cap – Severe spalling at South property line
- \*Cap – Moderate vertical cracking wet face
- \*T-Piles – Moderate spalling and deterioration
- \*Batter Piles – Moderate cracking at center piles
- \*Toe Wall – Separation from wall panels

• Seawall Rating: Poor      • Dock Rating: N/A

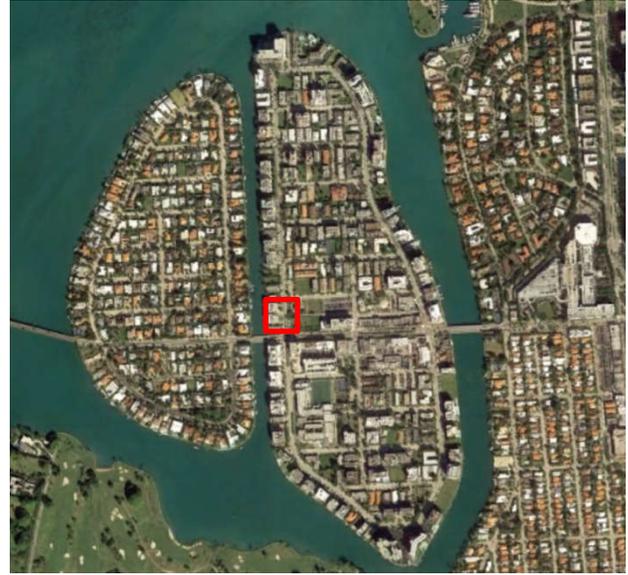
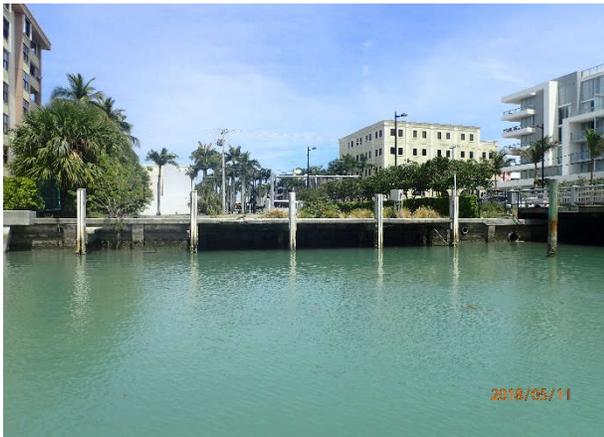
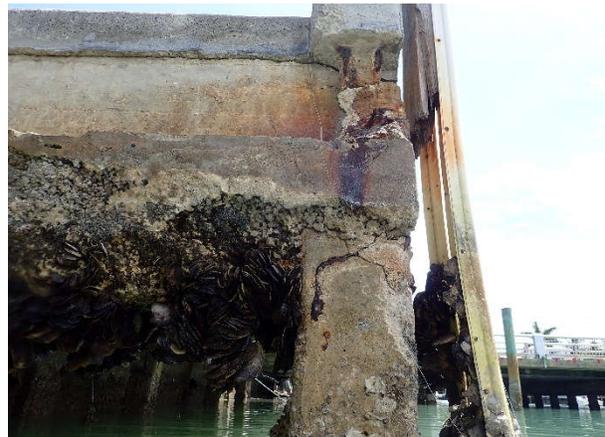
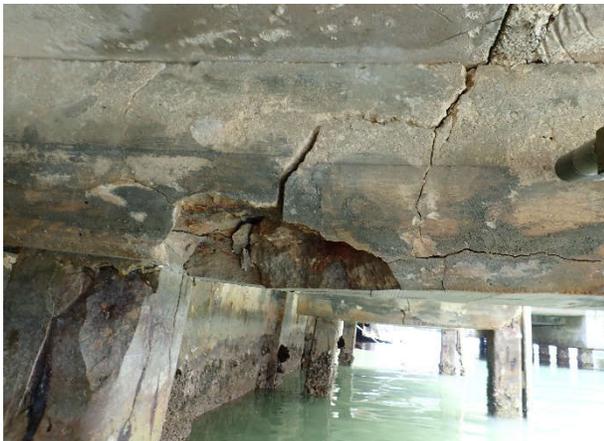
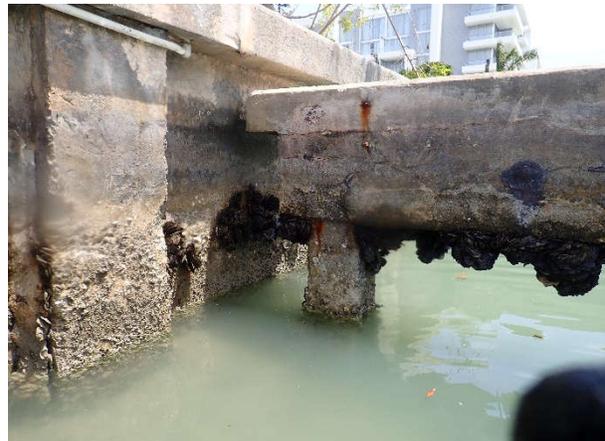
- Wall Panels – Moderate concrete erosion in tidal zone
- Wall Panels – Moderate cracking along panels
- T-Piles – Moderate cracking and necking at tidal zone
- Dock – Severe cracking and deterioration throughout concrete dock and piles

• Seawall Rating: Fair      • Dock Rating: Critical

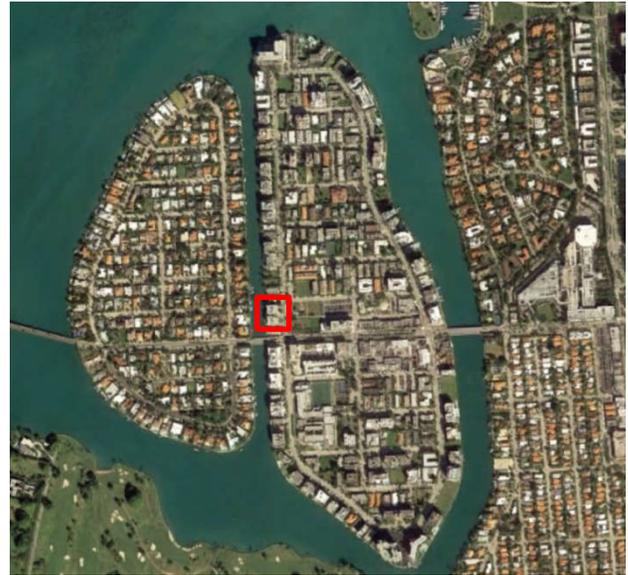
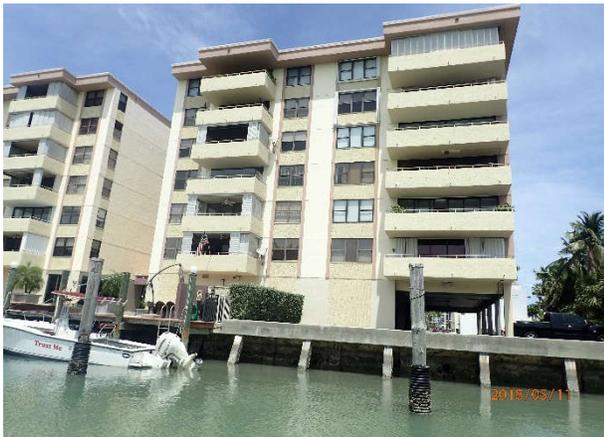
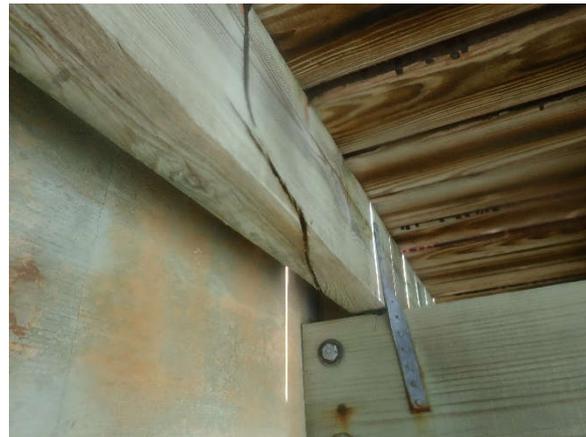
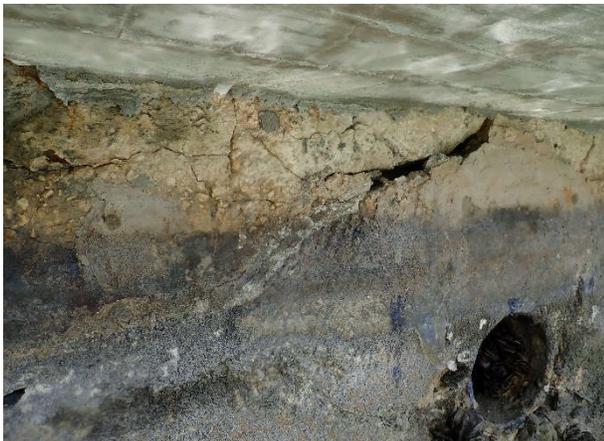
Property Address: 9660 W BAY HARBOR DR  
Bay Harbor Islands, FL 33154  
Location: S-1.1 Lot#2  
Date of Inspection: 5/11/2018 @ 2:30pm

- Wall Panels – Moderate to severe cracking and spalling along tops of panels
- Wall Panels – Moderate concrete erosion in splash zone
- T-Piles – Cracking and necking of piles in the tidal zones
- Dock – Mooring piles severe deterioration
- Dock – Moderate corrosion at fasteners
- Dock – Moderate cracking at joists

• Seawall Rating: Poor                      • Dock Rating: Fair

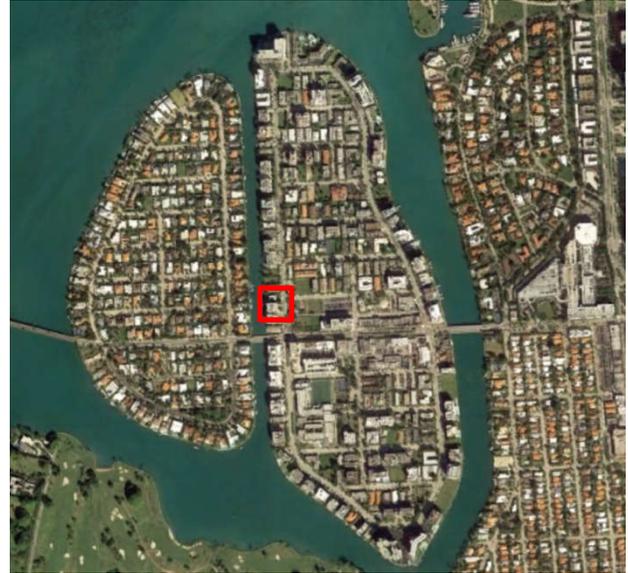
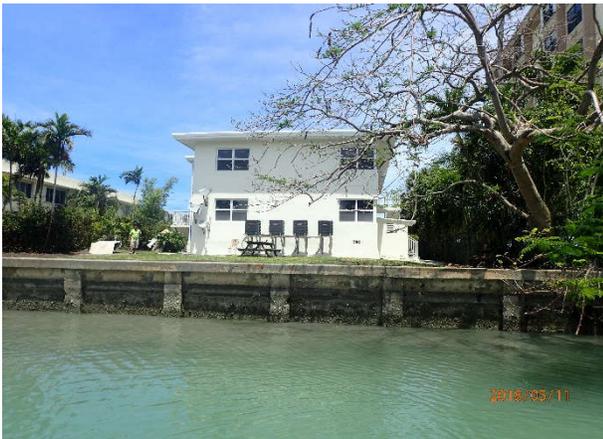
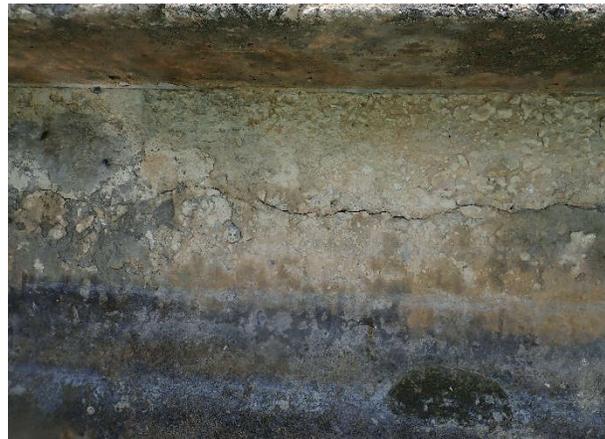
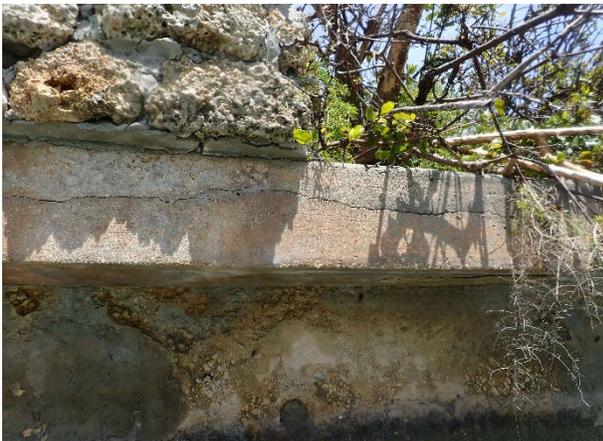
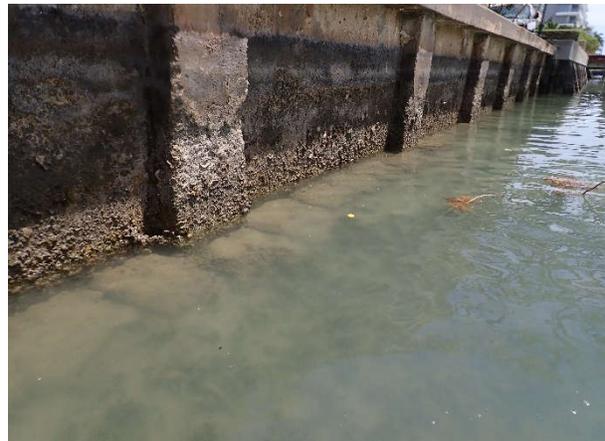
Property Address: 9700 W BAY HARBOR DR  
Bay Harbor Islands, FL 33154  
Location: S-1.1 Lot#3  
Date of Inspection: 5/11/2018 @ 2:20pm

- Cap – Minor cracking and spalling at wet face
- T-Piles – Necking concrete erosion at tidal zones
- Wall Panels – Erosion of the concrete in wall panels in the splash zone
- Wall Panels – Minor to moderate cracking at panels

• Seawall Rating: Fair      • Dock Rating: N/A

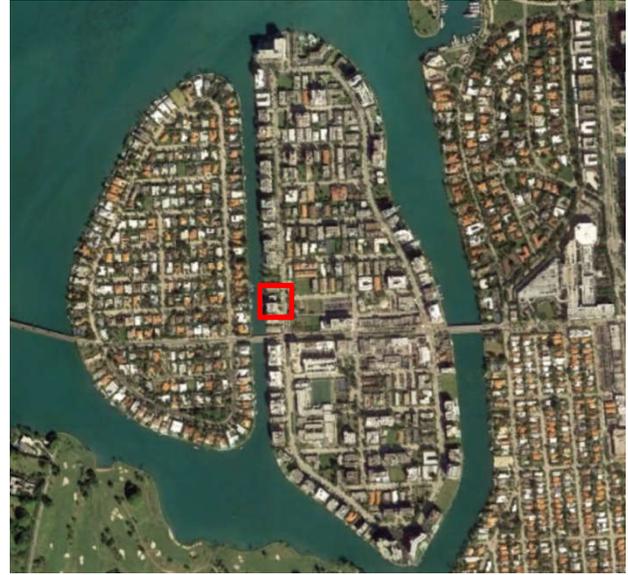
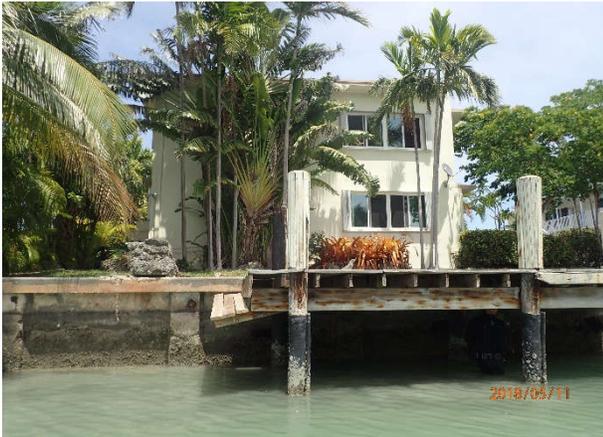
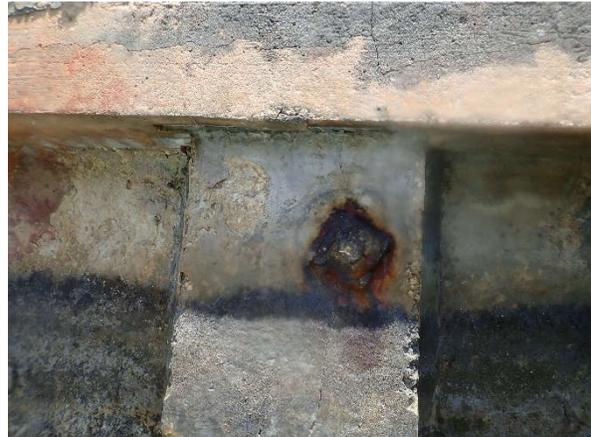
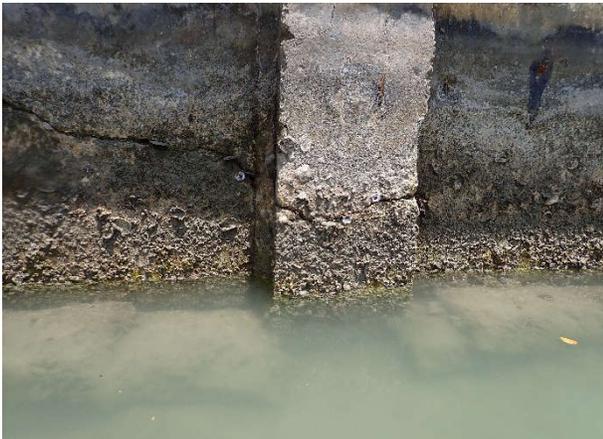
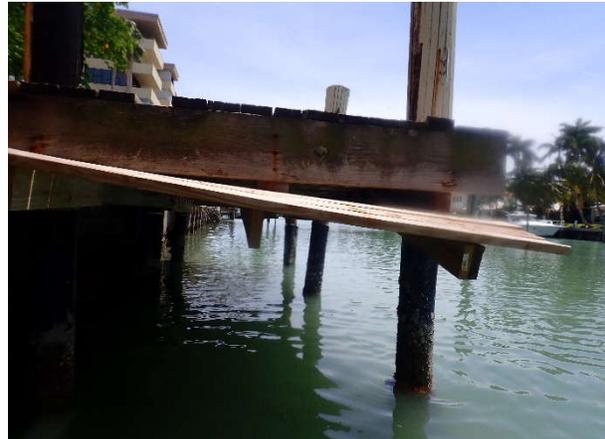
Property Address: 9720 W BAY HARBOR DR  
Bay Harbor Islands, FL 33154  
Location: S-1.1 Lot#4  
Date of Inspection: 5/11/2018 @ 2:20pm

- Cap – Moderate cracking at wet face
- Wall Panels – Severe cracking through panels
- T-Piles – Severe cracking and necking at tidal zone
- T-Piles – Moderate to severe corrosion at anchor heads
- Dock – Advanced corrosion at fasteners
- Dock – Splitting at beams, pile decay/rotation, partial deck collapse

• Seawall Rating: Poor      • Dock Rating: Serious

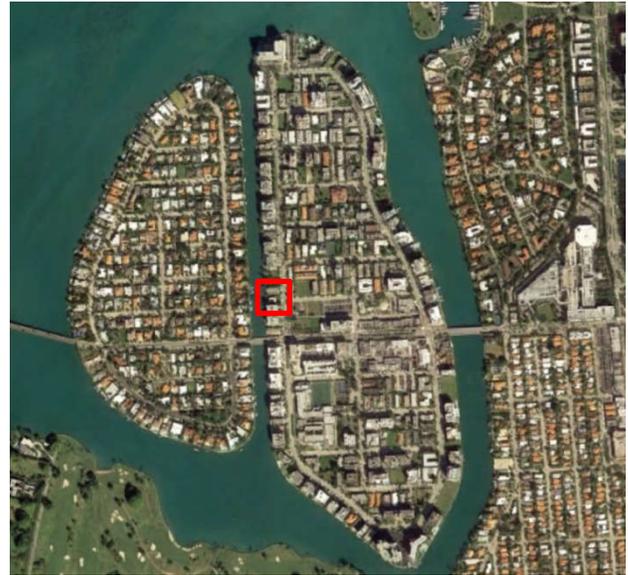
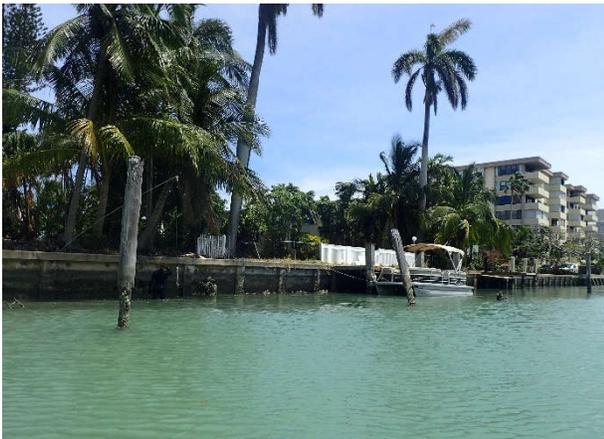
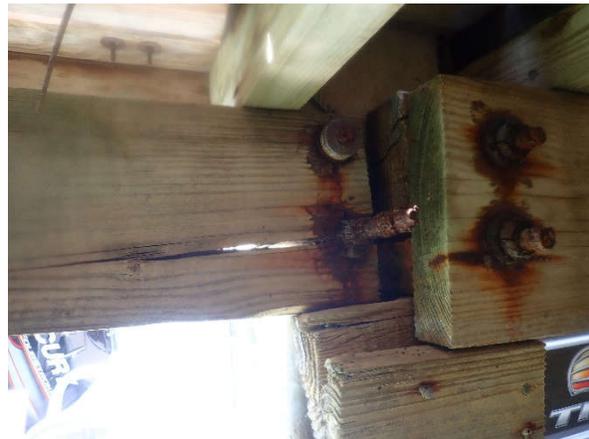
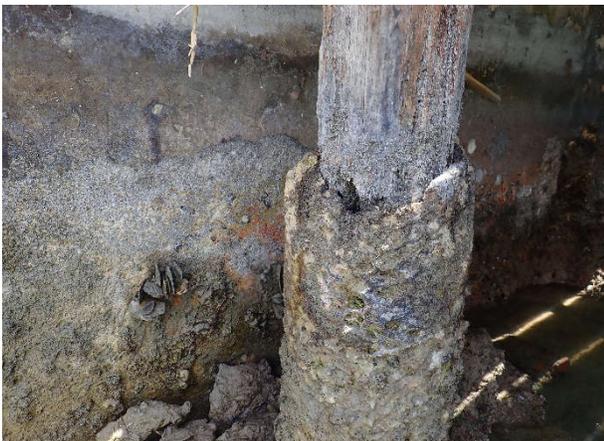
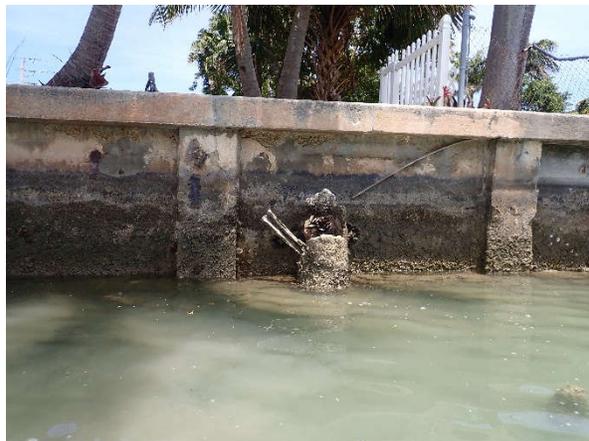
Property Address: 9740 W BAY HARBOR DR  
Bay Harbor Islands, FL 33154  
Location: S-1.1 Lot#5  
Date of Inspection: 5/11/2018 @ 2:10pm

- Cap – Minor cracking and spalling at wet face and soffit
- Wall Panels – Moderate concrete erosion at tidal zone
- T-Piles – Necking at tidal zone
- Dock – Moderate corrosion at fasteners
- Dock – Splitting at bolted beam connections
- Dock – Pile decay

• Seawall Rating: Fair      • Dock Rating: Critical

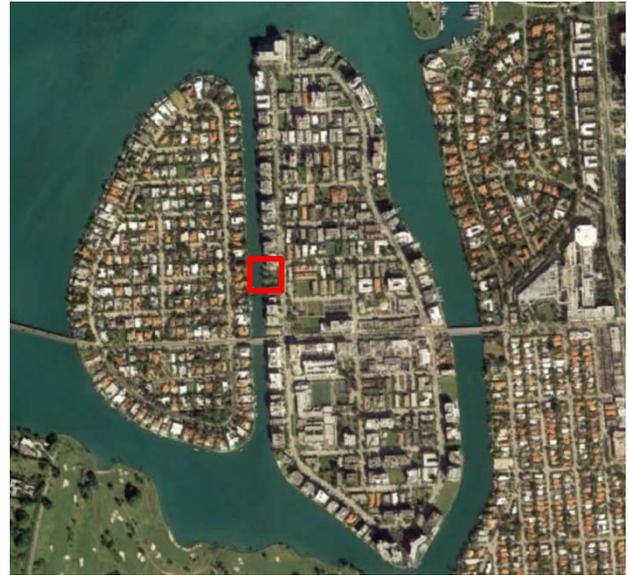
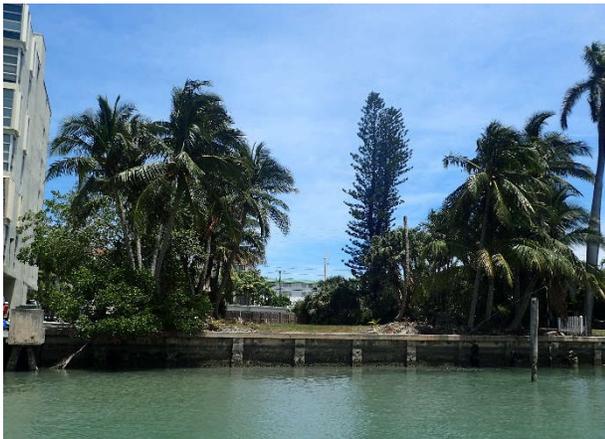
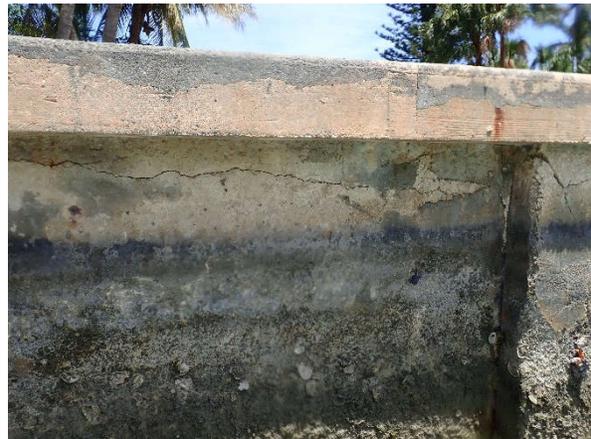
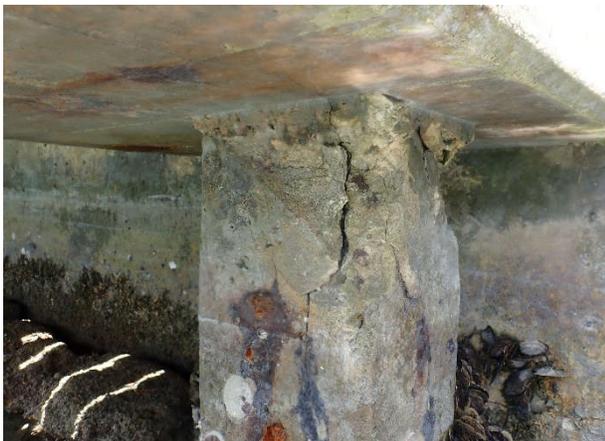
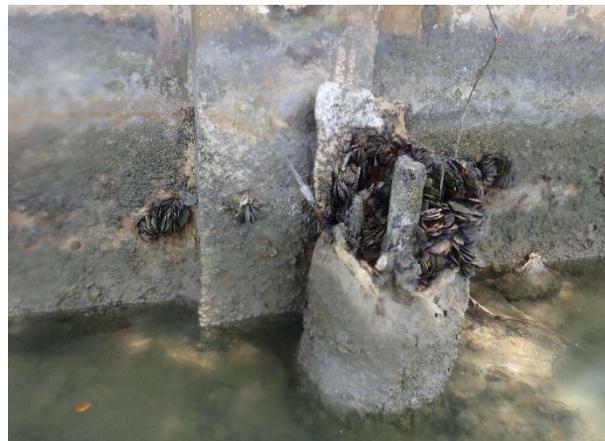
Property Address: 9760 W BAY HARBOR DR  
Bay Harbor Islands, FL 33154  
Location: S-1.1 Lot#6  
Date of Inspection: 5/11/2018 @ 2:10pm

- Cap – Minor cracking and spalling at wet face
- Wall Panels – Moderate cracking through panels
- T-Piles – Necking and concrete erosion at tidal zone
- T-Piles – Moderate to severe cracking
- Dock – Demolished timber components

• Seawall Rating: Poor      • Dock Rating: N/A

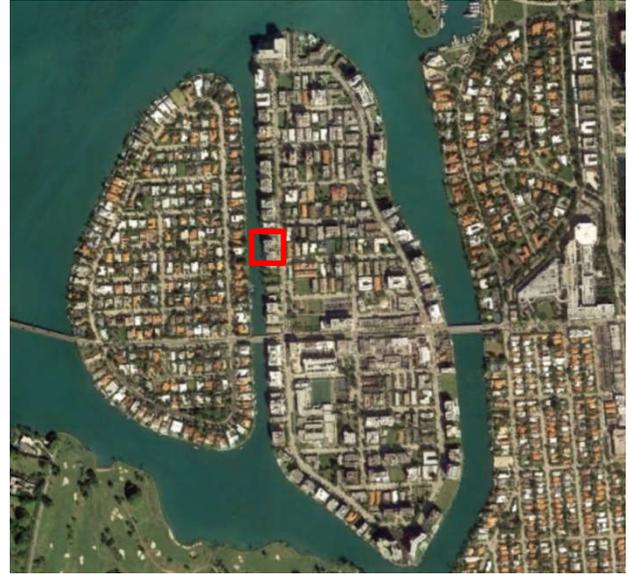
Property Address: 9800 W BAY HARBOR DR  
Bay Harbor Islands, FL 33154  
Location: S-1.1 Lot#7  
Date of Inspection: 5/11/2018 @ 2:00pm

- Cap – Minor cracking at wet face
- Wall Panels – Moderate cracking and concrete erosion
- T-Piles – Moderate necking and concrete erosion
- T-Piles – Sediment accumulation through fillets at seabed
- Dock – Collapse at North framing, wood decay/splitting, bolt corrosion

• Seawall Rating: Poor      • Dock Rating: Critical

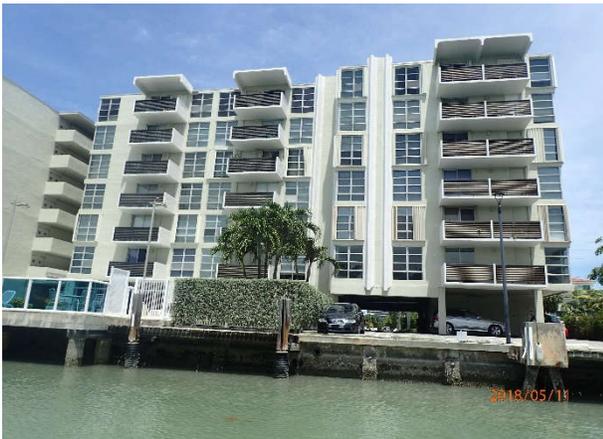
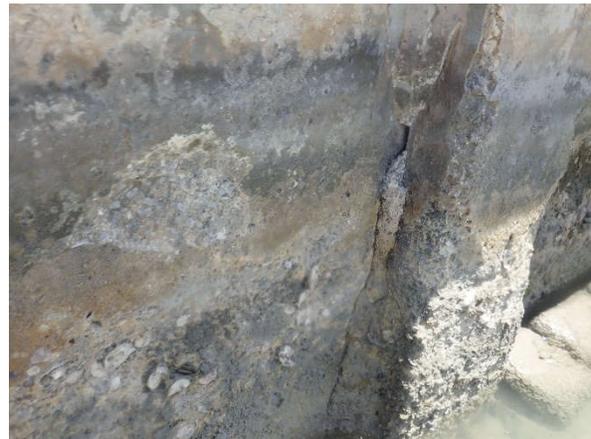
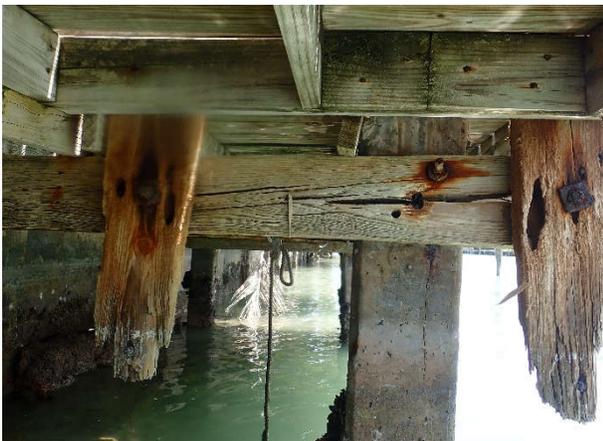
Property Address: 9880 W BAY HARBOR DR  
Bay Harbor Islands, FL 33154  
Location: S-1.1 Lot#8  
Date of Inspection: 5/11/2018 @ 1:50pm

- Cap – Moderate cracking and spalling at wet face
- Wall Panels – Moderate cracking and concrete erosion
- T-Piles – Necking and concrete erosion
- Dock – Rotted timber decking
- Dock – Moderate corrosion at fasteners

• Seawall Rating: Fair      • Dock Rating: Fair

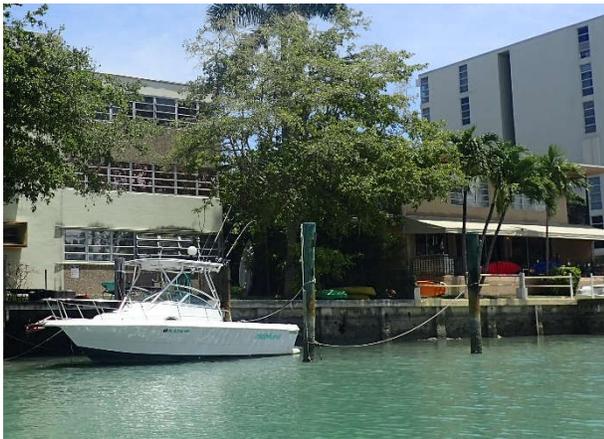
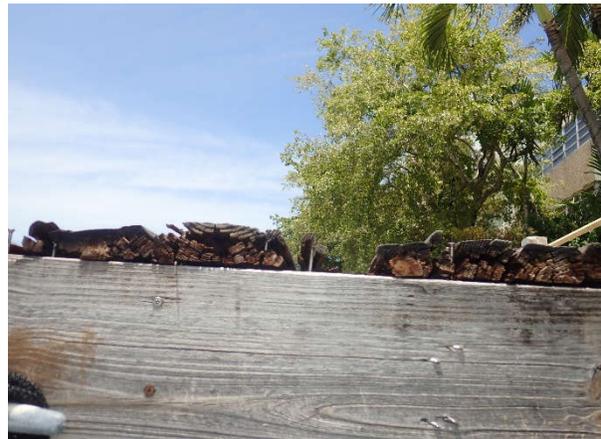
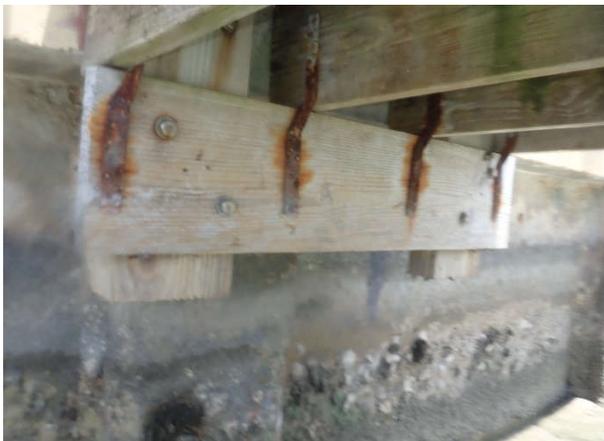
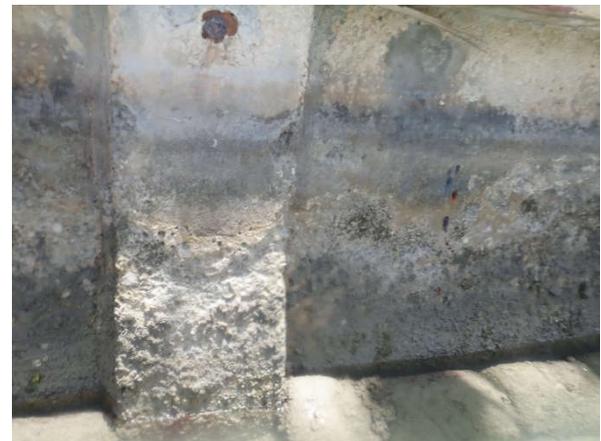
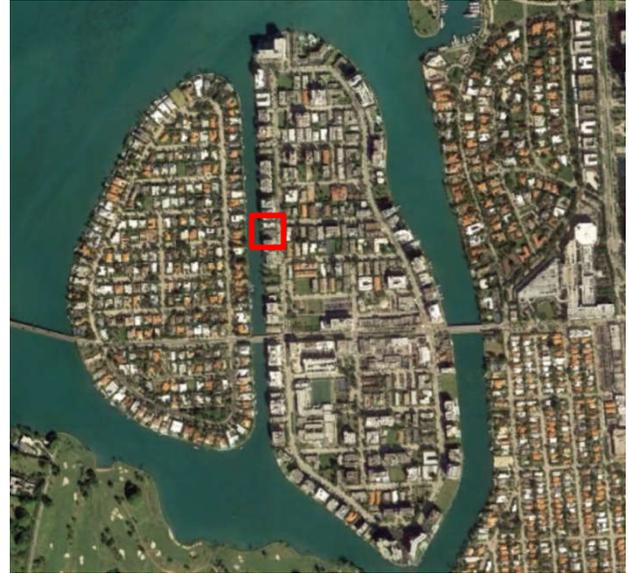
Property Address: 9900 W BAY HARBOR DR  
Bay Harbor Islands, FL 33154  
Location: S-1.1 Lot#9  
Date of Inspection: 5/11/2018 @ 1:50pm

- \*Cap – Moderate cracking and spalling with exposed steel reinforcement
- \*Wall Panels – Concrete erosion at tidal zone
- \*T-Piles – Necking and moderate corrosion at anchor heads
- \*Dock – Corrosion at fasteners

• Seawall Rating: Fair      • Dock Rating: Fair

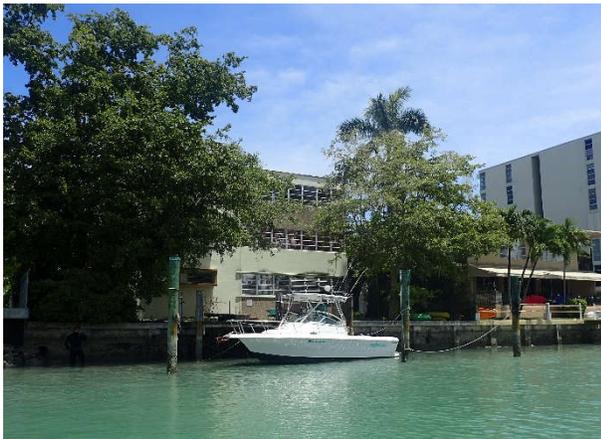
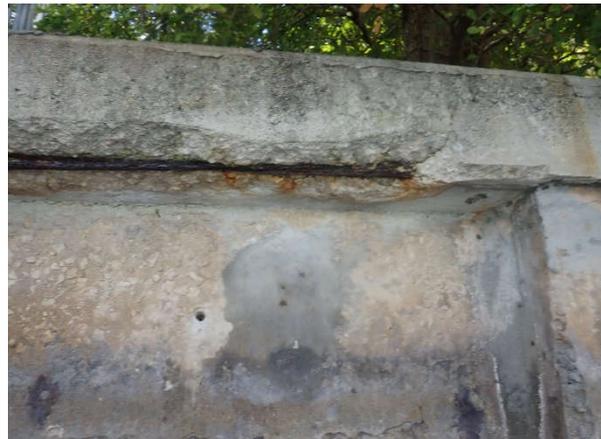
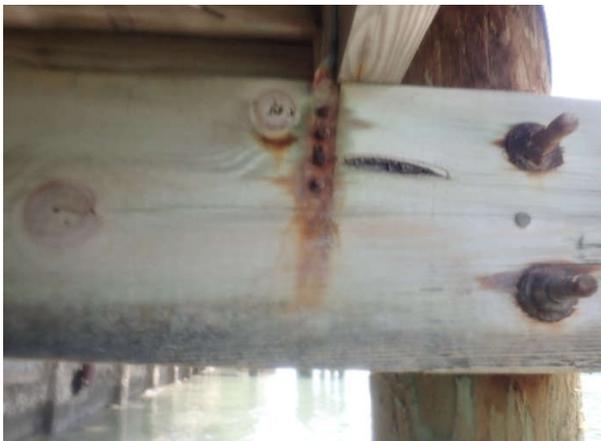
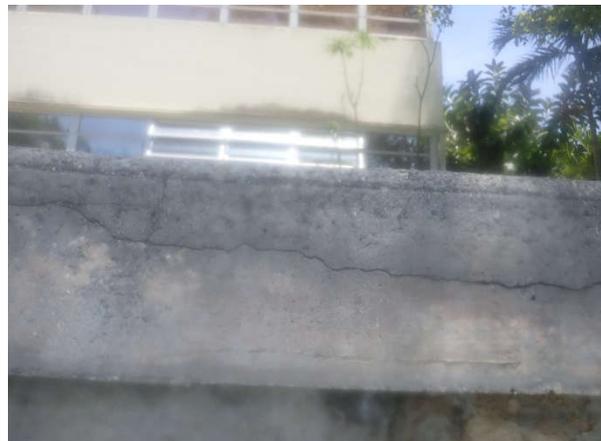
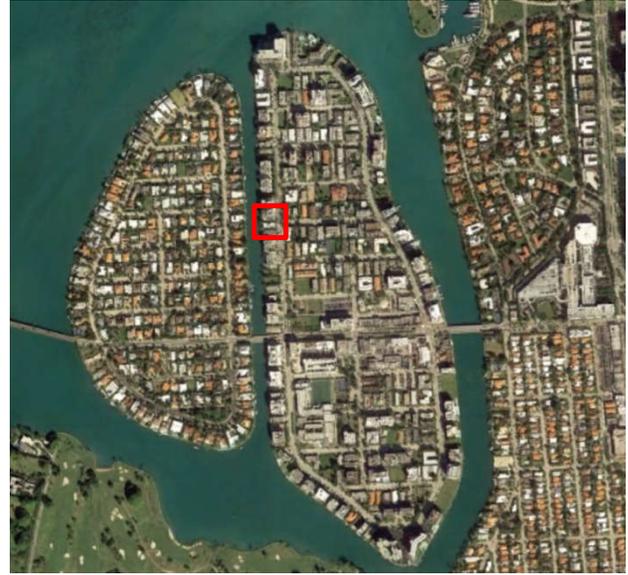
Property Address: 9940 W BAY HARBOR DR  
Bay Harbor Islands, FL 33154  
Location: S-1.1 Lot#10  
Date of Inspection: 5/11/2018 @ 1:40pm

- Wall Panels – Corrosion
- Seawall – New Construction
- Dock – New construction

- Seawall Rating: Satisfactory
- Dock Rating: Good

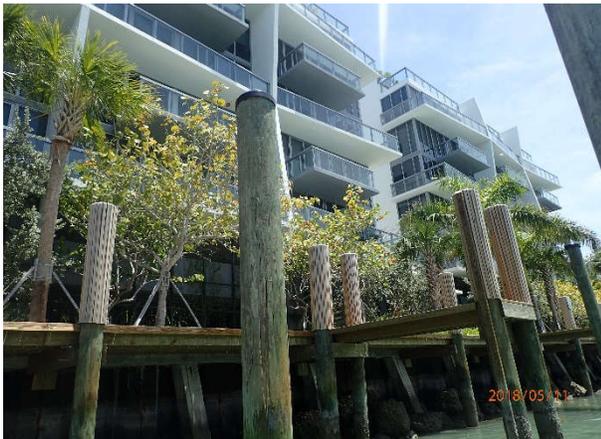
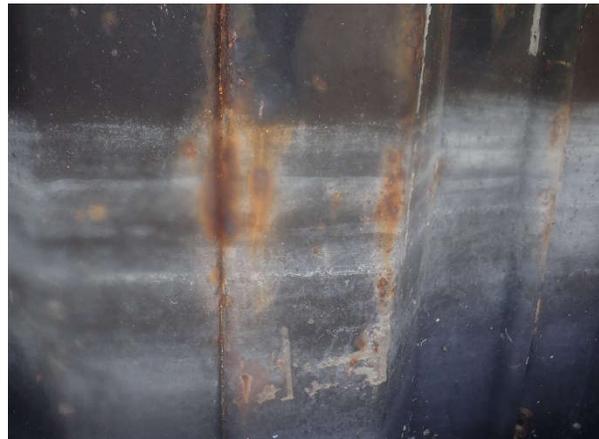
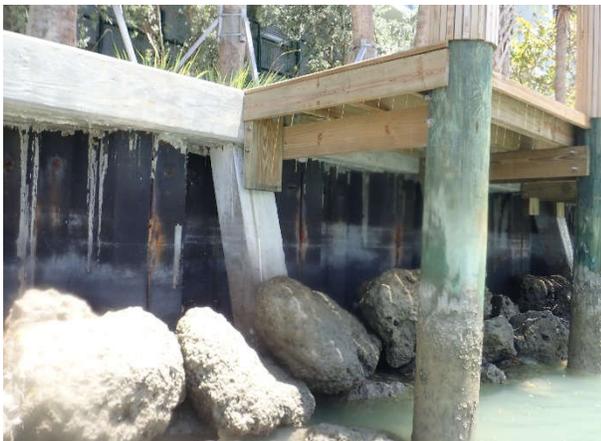
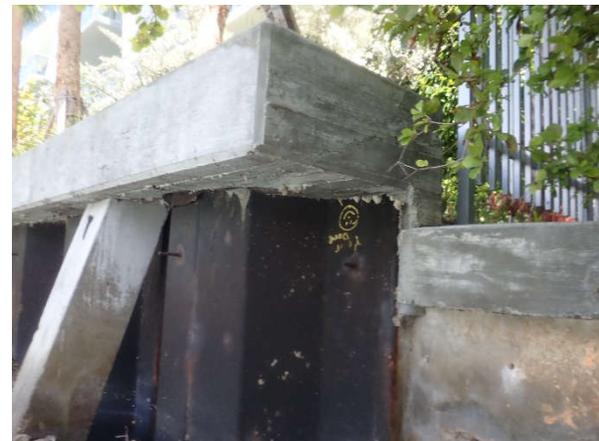
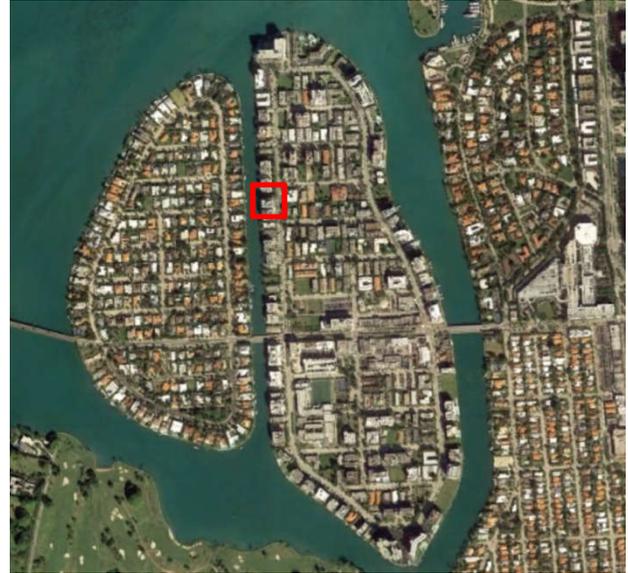
Property Address: 10000 W BAY HARBOR DR  
Bay Harbor Islands, FL 33154  
Location: S-1.1 Lot#11  
Date of Inspection: 5/11/2018 @ 1:30pm

- \*Cap – Moderate cracking along wet face
- \*Wall Panels – Horizontal cracking along panels
- \*Wall Panels – Concrete erosion at tidal zone
- \*T-Piles – Pile/panel separation
- \*T-Piles – Moderate necking
- \*Dock – Minor deflection at joists

• Seawall Rating: Fair      • Dock Rating: Fair

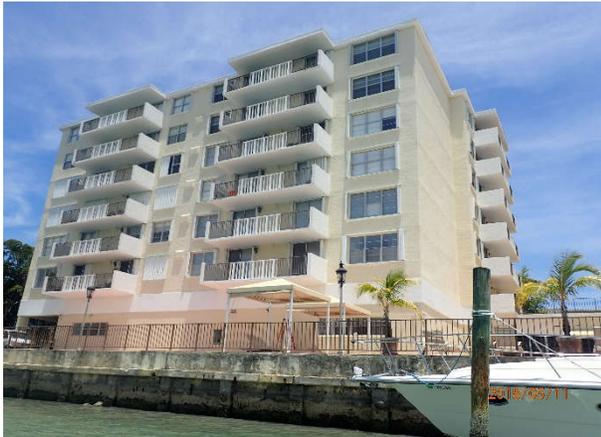
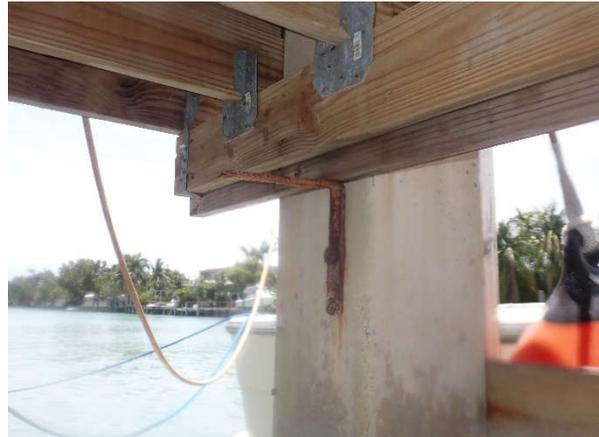
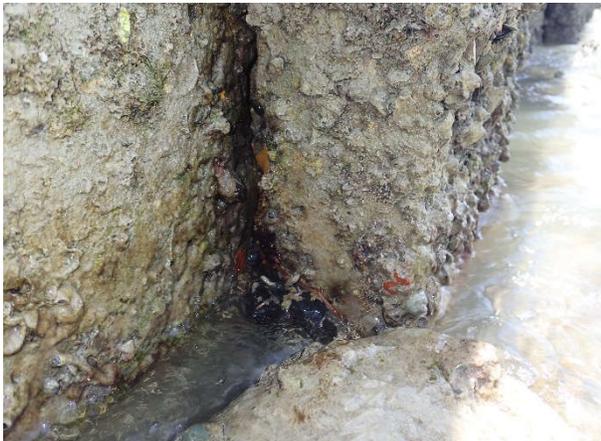
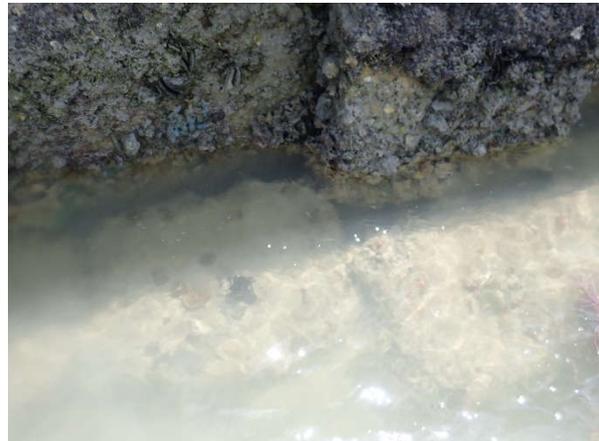
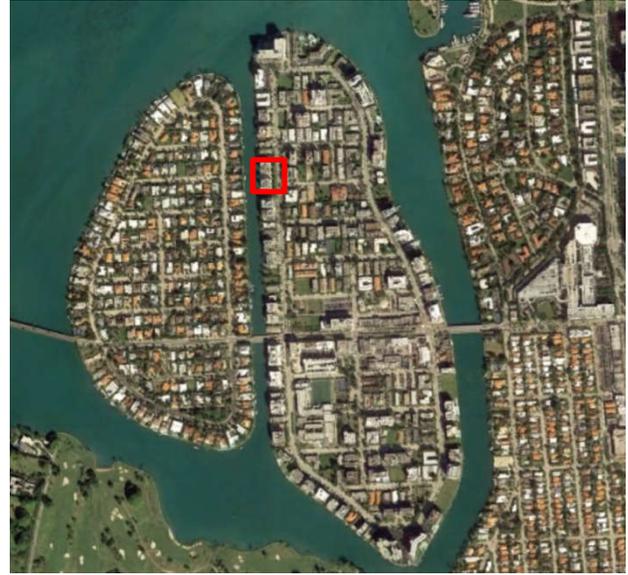
Property Address: 10084 W BAY HARBOR DR  
Bay Harbor Islands, FL 33154  
Location: S-1.1 Lot#12  
Date of Inspection: 5/11/2018 @ 1:20pm

- \*Cap – Severe cracking along wet face
- \*Wall Panels – Moderate concrete erosion at tidal zone
- \*Wall Panels – Moderate rotation of wall
- \*Wall Panels – Moderate to severe horizontal cracking
- \*T-Piles – Moderate necking and cracking in tidal zone
- \*Dock – Concrete fender piles in fair condition

\* Seawall Rating: Poor      \* Dock Rating: N/A

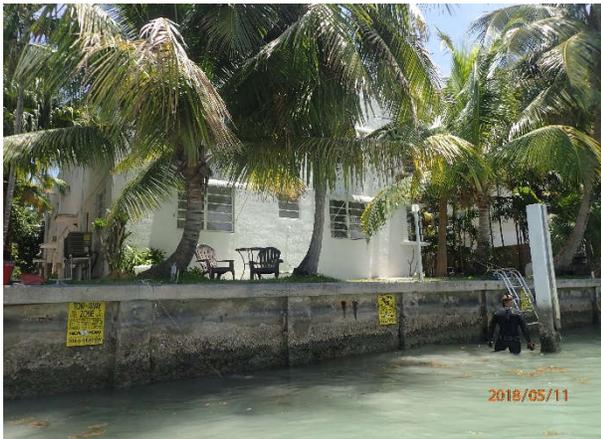
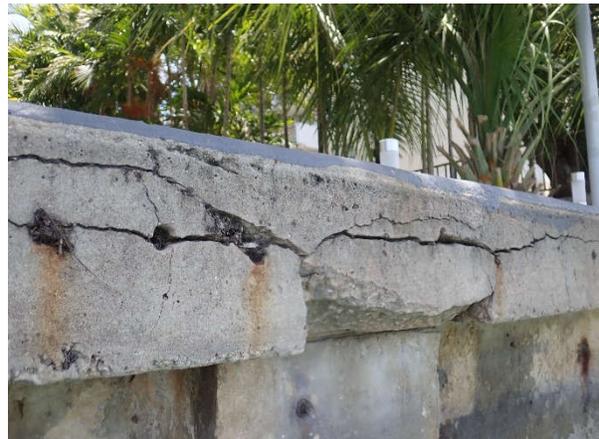
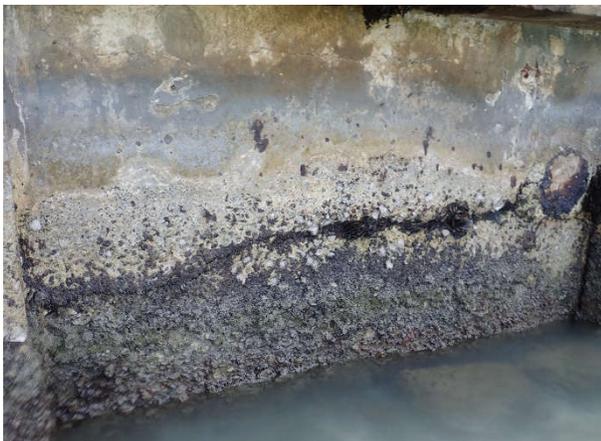
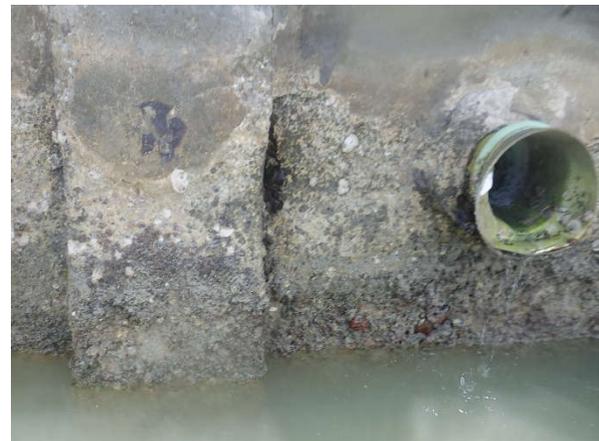
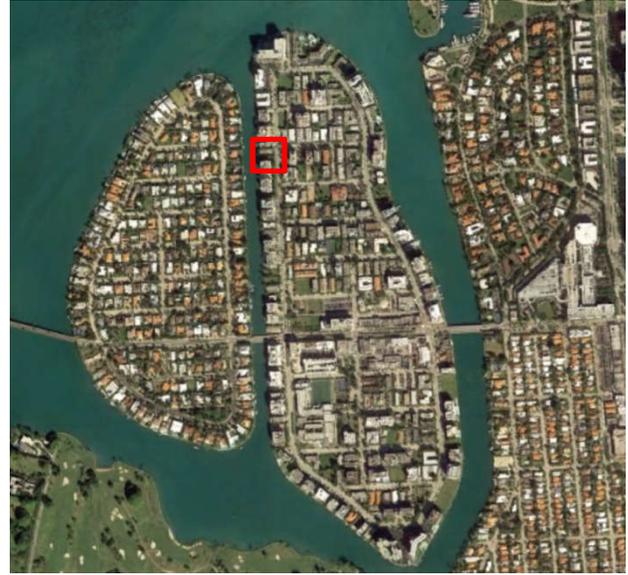
Property Address: 10110 W BAY HARBOR DR  
Bay Harbor Islands, FL 33154  
Location: S-1.1 Lot#13  
Date of Inspection: 5/11/2018 @ 1:20pm

- Wall Panels – Moderate concrete erosion at tidal zone
- Wall Panels – Moderate rotation of the wall
- T-Piles – Moderate necking at tidal zone
- T-Piles – Failed pile anchor
- Dock – Moderate corrosion at bolts

• Seawall Rating: Fair      • Dock Rating: Fair
