# Seawall Condition and Resiliency Assessment Town of Bay Harbor Islands

October 2019 (Updated)

**Cummins Cederberg, Inc.**

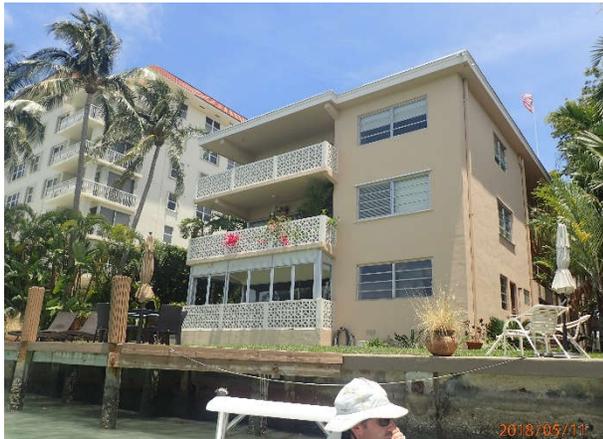
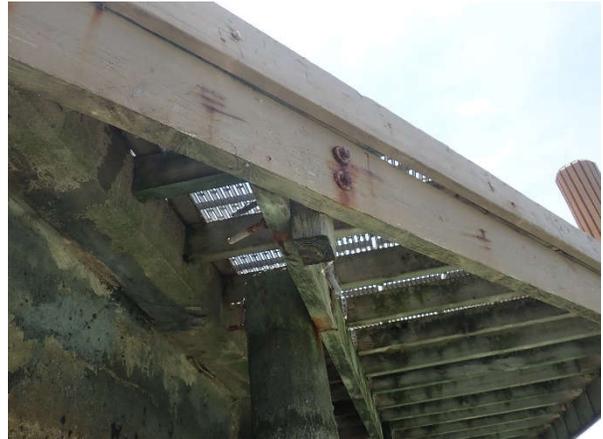
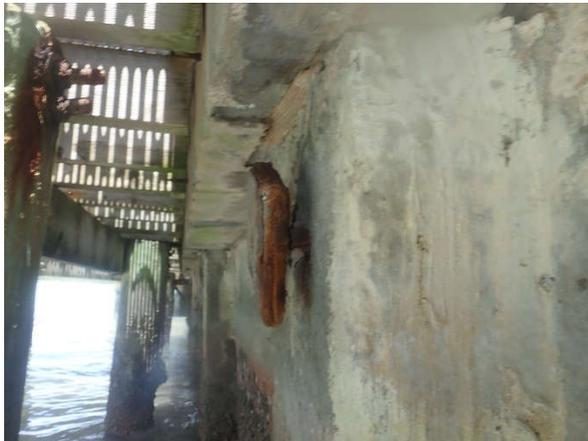
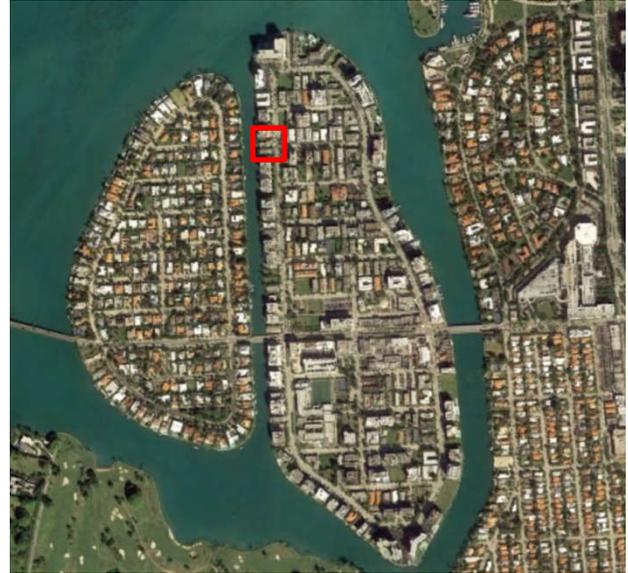
Property Address: 10140 W BAY HARBOR DR  
Bay Harbor Islands, FL 33154  
Location: S-1.1 Lot#14  
Date of Inspection: 5/11/2018 @ 1:10pm

- Cap – Minor cracking with corrosion staining
- Wall Panels – Moderate horizontal cracking along panels
- Wall Panels – Moderate concrete erosion in splash zone
- T-Piles – Moderate necking at tidal zone
- Dock – Severe corrosion at bolts and straps

• Seawall Rating: Fair                      • Dock Rating: Poor

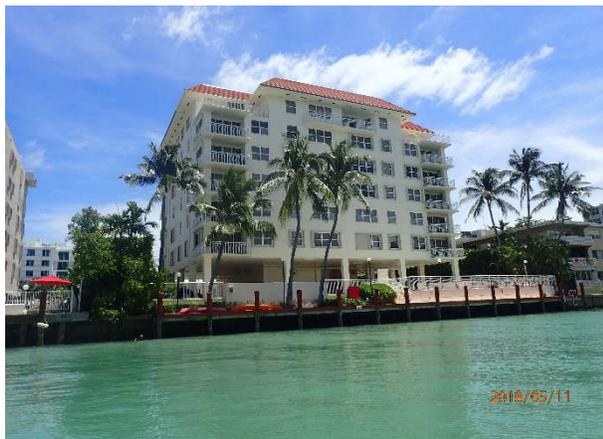
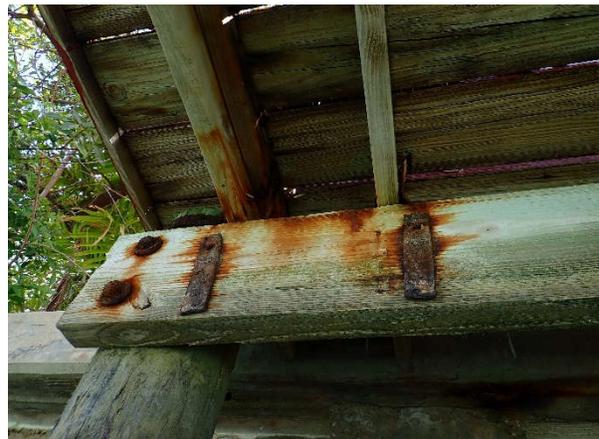
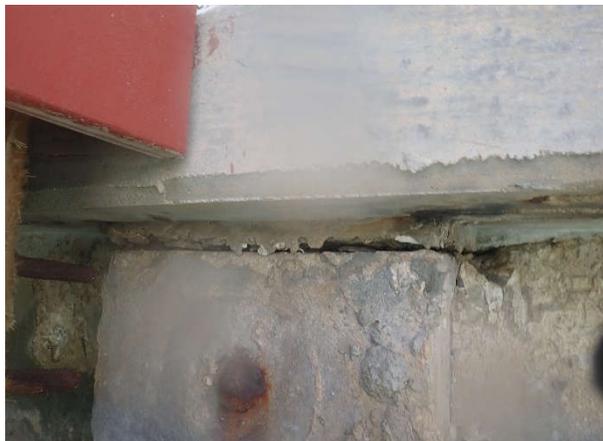
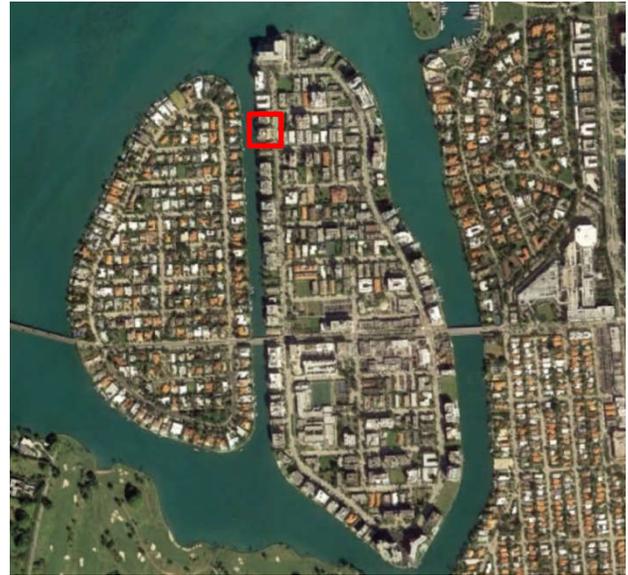
Property Address: 10180 W BAY HARBOR DR  
Bay Harbor Islands, FL 33154  
Location: S-1.1 Lot#15  
Date of Inspection: 5/11/2018 @ 1:00pm

- Cap – Minor cracking and spalling at old cap
- Wall Panels – Severe cracking with concrete erosion
- T-Piles – Moderate cracking with pile/panel separation
- T-Piles – Pile failure with voids at spot piles
- Batter Piles – Driving damage at pile heads
- Dock – Moderate corrosion at fasteners and straps
- Dock – Severe wood decay

• Seawall Rating: Poor                      • Dock Rating: Serious

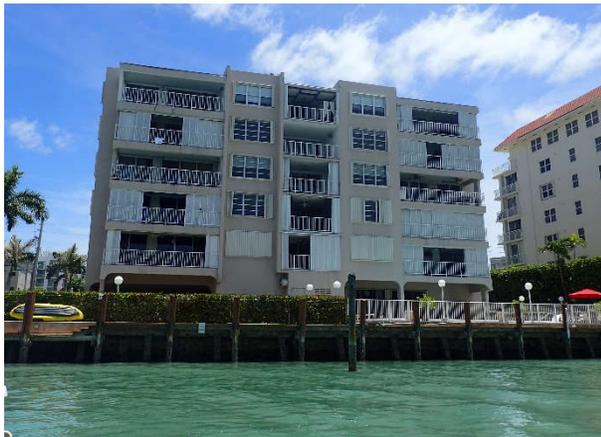
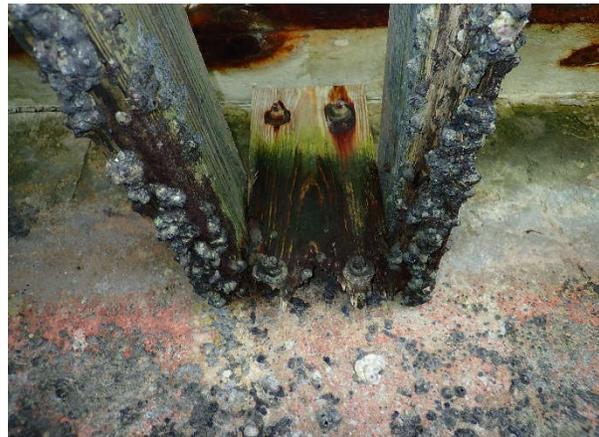
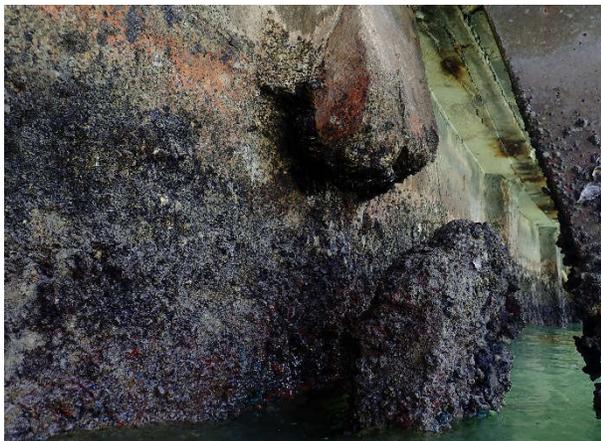
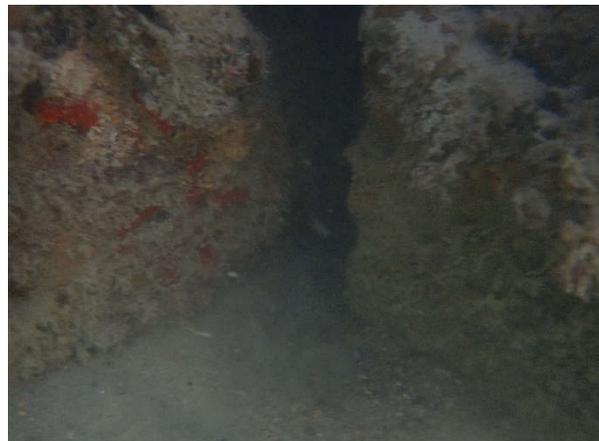
Property Address: 10250 W BAY HARBOR DR  
Bay Harbor Islands, FL 33154  
Location: S-1.1 Lot#16  
Date of Inspection: 5/11/2018 @ 12:50pm

- Cap – Minor to moderate cracking and spalling with exposed steel reinforcement
- Wall Panels – Moderate to severe concrete erosion at splash zone
- T-Piles – Moderate to severe flexural cracking
- T-Piles – Sediment accumulation at seabed
- Dock – Severe corrosion at fasteners

• Seawall Rating: Poor                      • Dock Rating: Poor

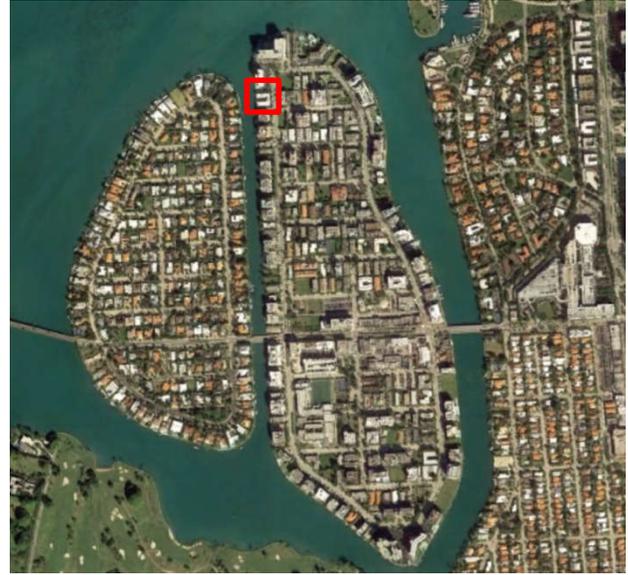
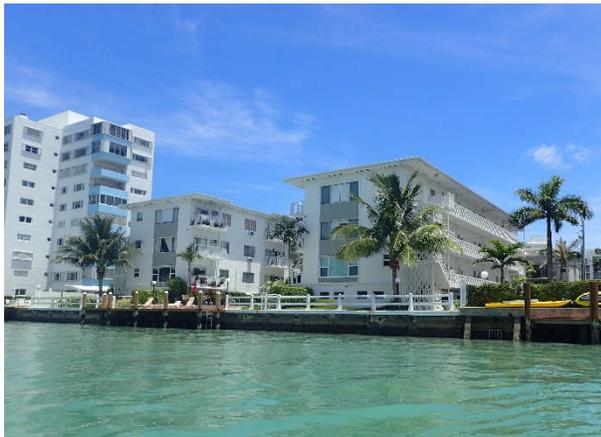
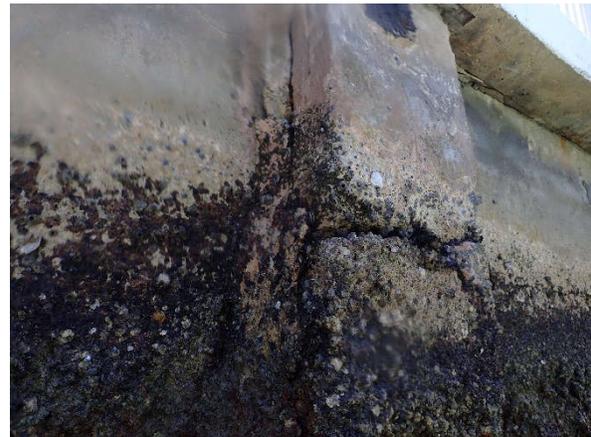
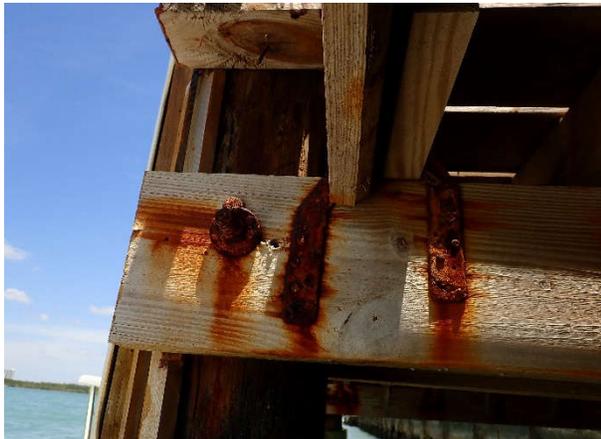
Property Address: 10300 W BAY HARBOR DR  
Bay Harbor Islands, FL 33154  
Location: S-1.1 Lot#17  
Date of Inspection: 5/11/2018 @ 12:40pm

- Cap – Moderate cracking and spalling with exposed steel
- Wall Panels – Moderate pile/panel separation with sediment erosion through fillets
- Wall Panels – Moderate to severe erosion and cracking
- T-Piles – Severe cracking and necking
- Dock – Severe deterioration of piling, bolt corrosion

• Seawall Rating: Poor                      • Dock Rating: Poor

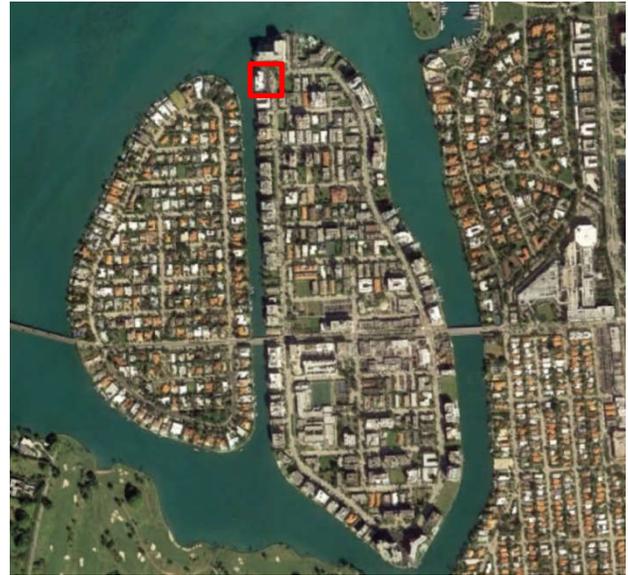
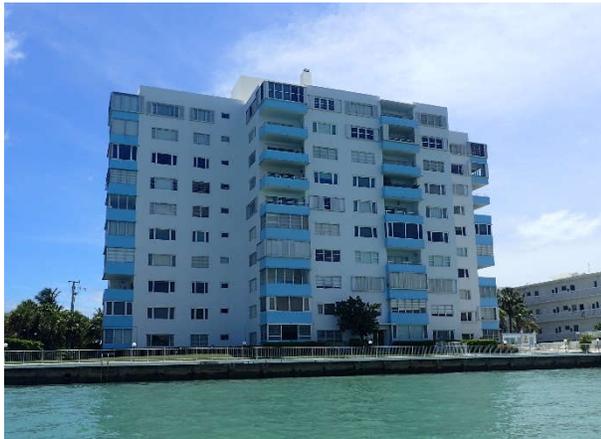
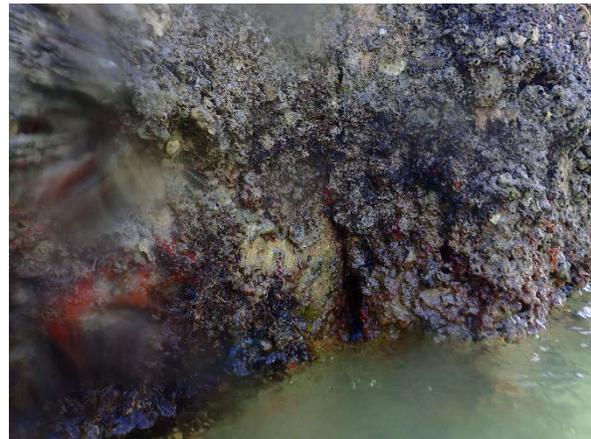
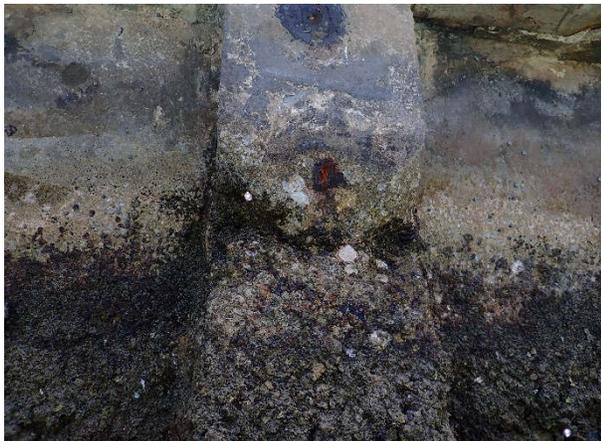
Property Address: 10350 W BAY HARBOR DR  
Bay Harbor Islands, FL 33154  
Location: S-1.1 Lot#18  
Date of Inspection: 5/11/2018 @ 12:30pm

- Wall Panels – Severe concrete erosion and cracking with wall rotation at West end
- Wall Panels – Undermining along toe wall
- T-Piles – Severe pile/panel separation
- T-Piles – Moderate necking and cracking, deterioration
- Dock – Moderate corrosion at fasteners/straps, wood splitting

• Seawall Rating: Poor                      • Dock Rating: Fair

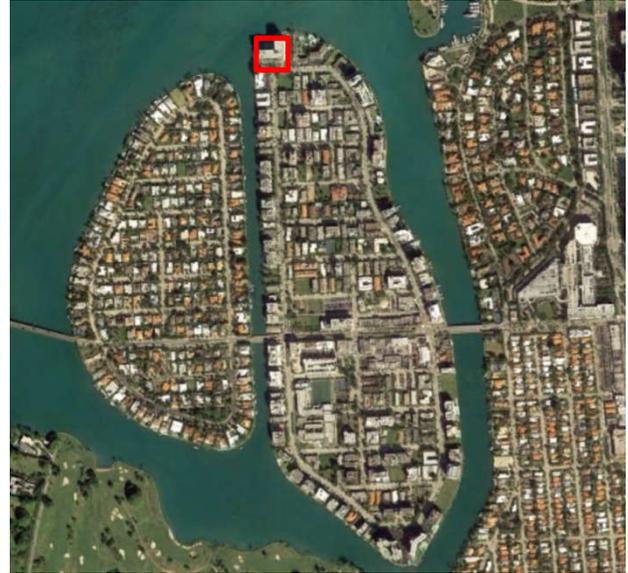
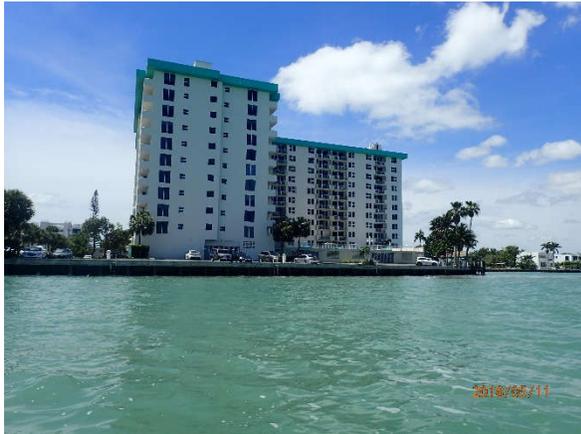
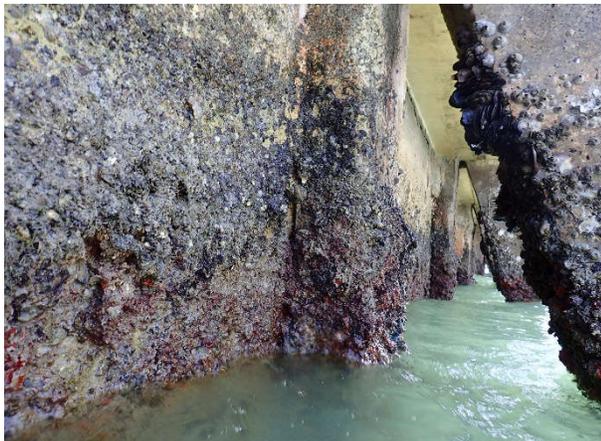
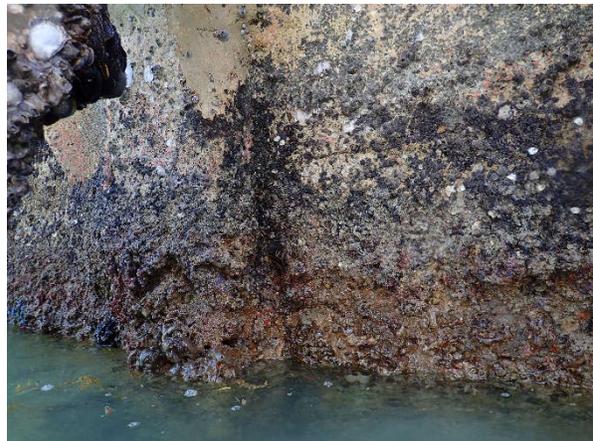
Property Address: 1155 103 ST  
Bay Harbor Islands, FL 33154  
Location: S-1.1 Lot#19  
Date of Inspection: 5/11/2018 @ 12:20pm

- Cap – Moderate spalling with exposed steel reinforcement
- Wall Panels – Moderate to severe cracking and outward rotation
- T-Piles – Moderate necking
- Dock – Splitting and deterioration at beams, fastener corrosion
- Dock – Dock piles rotated, deteriorated

• Seawall Rating: Poor      • Dock Rating: Poor

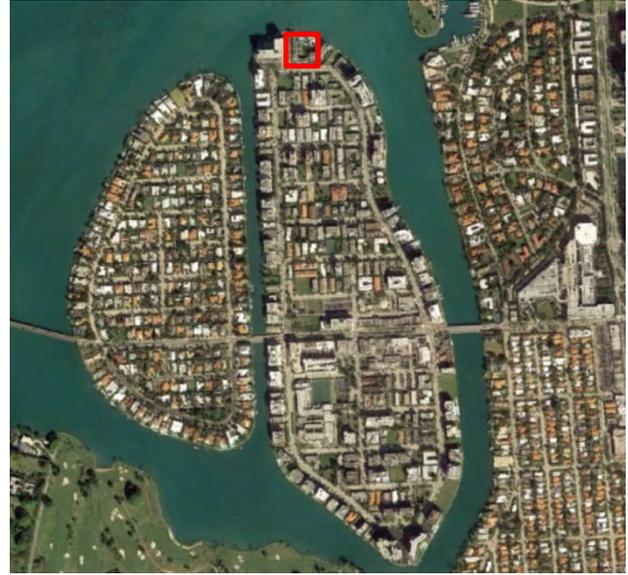
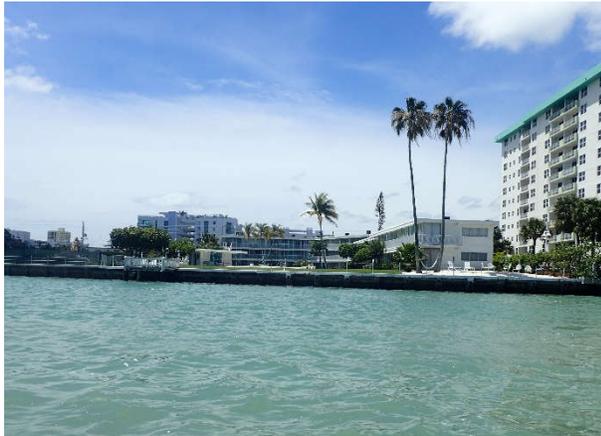
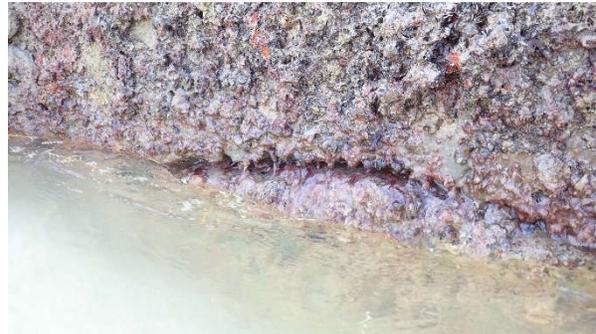
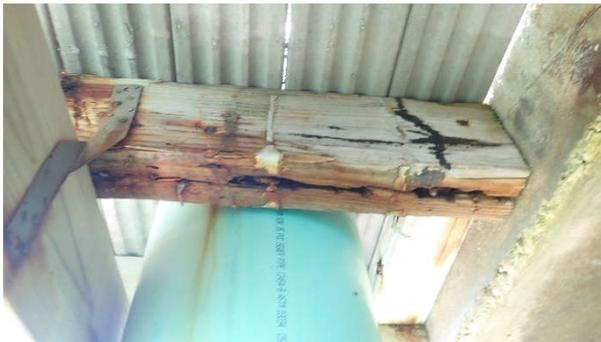
Property Address: 1135 103 ST  
Bay Harbor Islands, FL 33154  
Location: S-1.1 Lot#20  
Date of Inspection: 5/11/2018 @ 12:10pm

- Cap – Severe cracking and spalling with exposed steel reinforcement
- Wall Panels – Moderate concrete erosion at splash zone
- Wall Panels – Rotation of wall at North end
- T-Piles – Severe necking and erosion
- Dock – Demolished, moderate rotation at remaining piles

• Seawall Rating: Poor      • Dock Rating: N/A

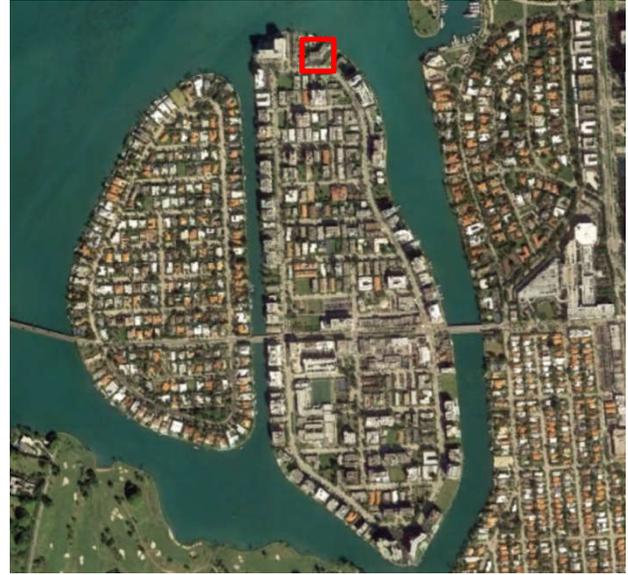
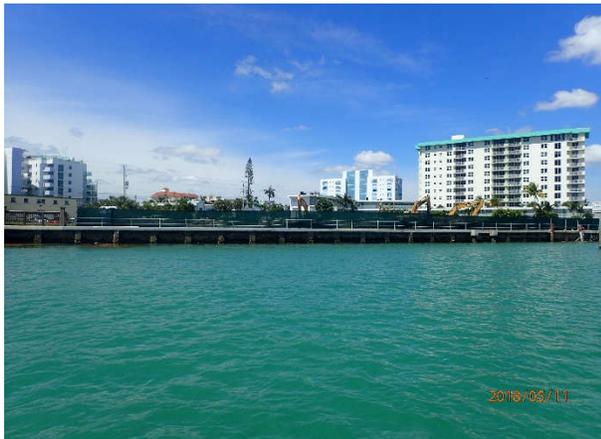
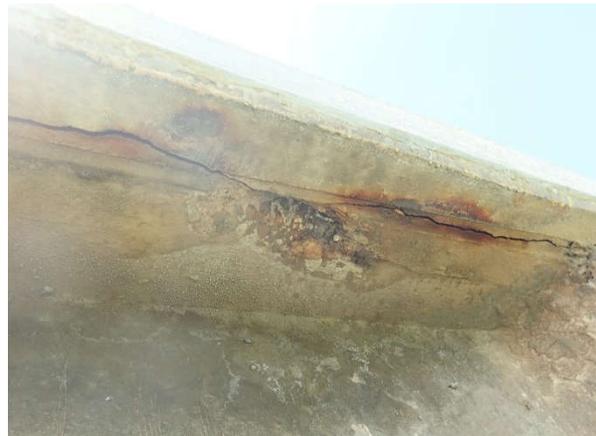
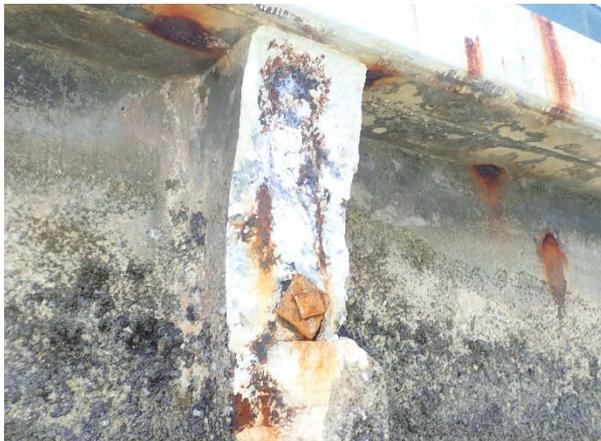
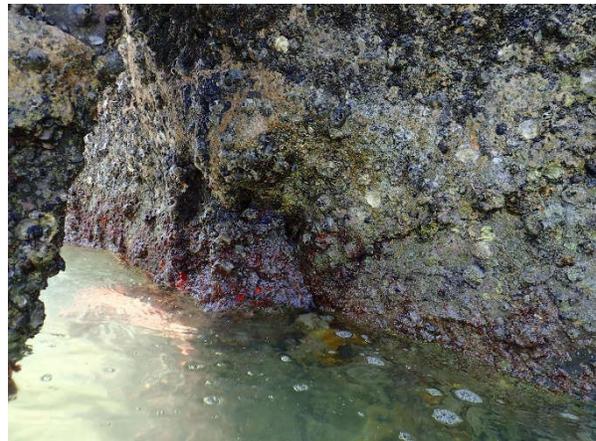
Property Address: 10301 E BAY HARBOR DR  
Bay Harbor Islands, FL 33154  
Location: S-1.1 Lot#21  
Date of Inspection: 5/11/2018 @ 12:00pm

- \*Cap – Moderate cracking at wet face
- \*Wall Panels – Moderate concrete erosion at splash zone
- \*T-Piles – Pile/panel separation
- \*T-Piles – Moderate cracking and necking with fillet erosion
- \*Dock – Severe corrosion at fasteners
- \*Dock – Spalling at piles, Severe crack at north pile

• Seawall Rating: Poor                      • Dock Rating: Poor

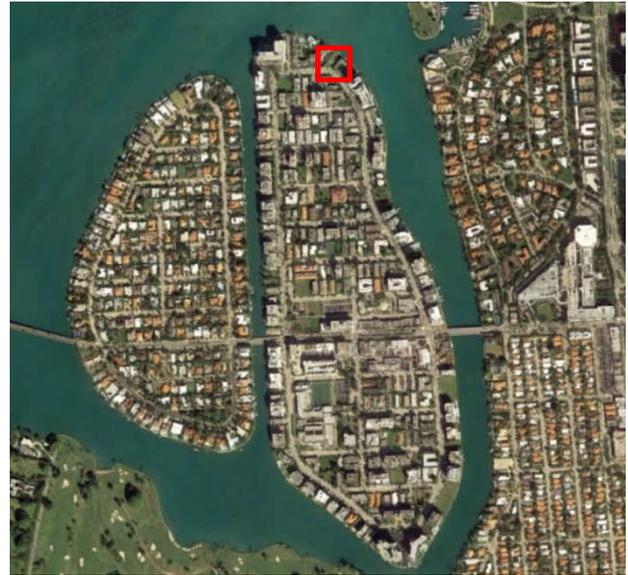
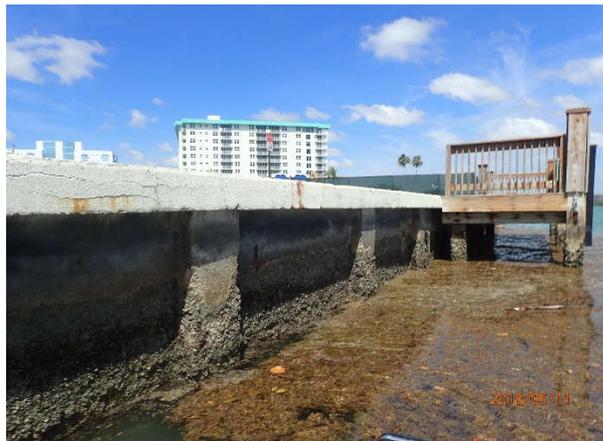
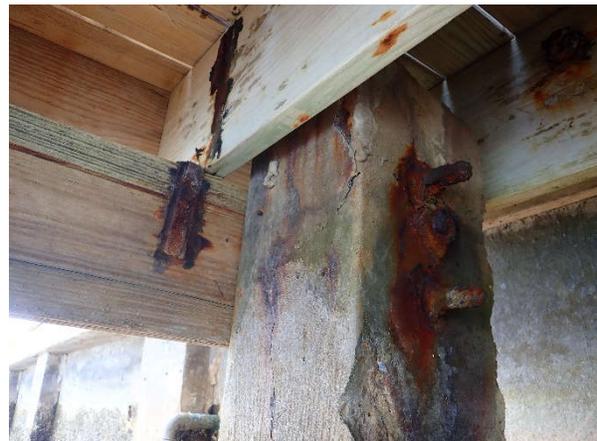
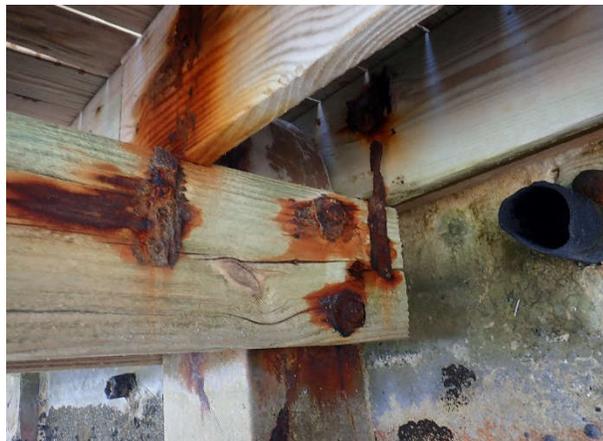
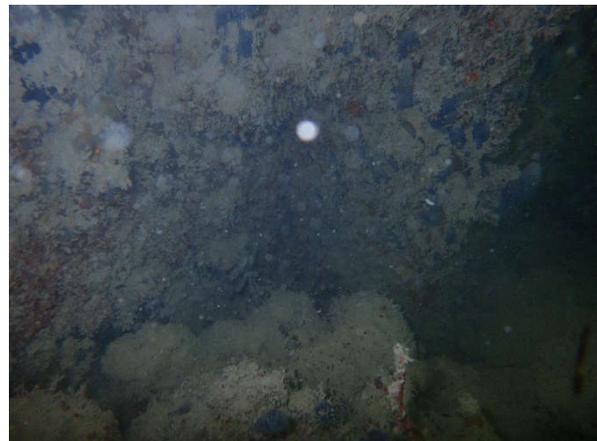
Property Address: 10281 E BAY HARBOR DR  
Bay Harbor Islands, FL 33154  
Location: S-1.1 Lot#22  
Date of Inspection: 5/11/2018 @ 10:50am

- \*Cap – Moderate cracking
- \*Wall Panels – Moderate concrete erosion at splash zone
- \*T-Piles – Pile panel separation with fillet erosion
- \*T-Piles – Moderate cracking above seabed
- \*Batter Piles – Moderate cracking/ corrosion at pile heads
- \*Dock – Severe corrosion at fasteners

• Seawall Rating: Poor          • Dock Rating: Poor

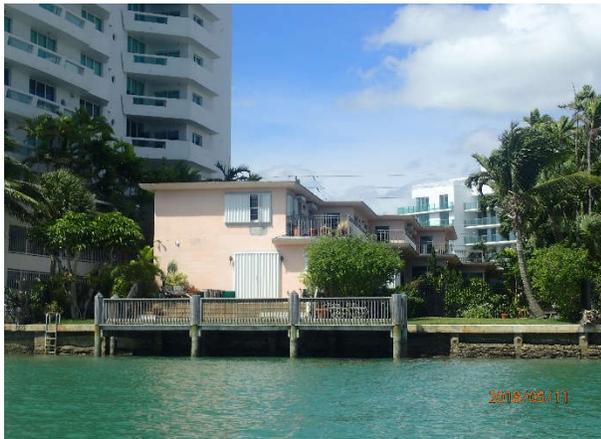
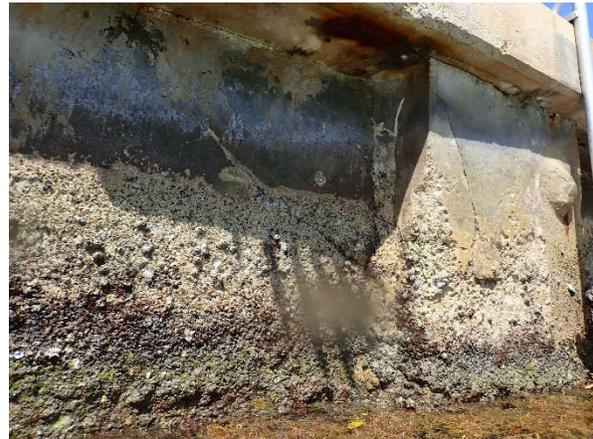
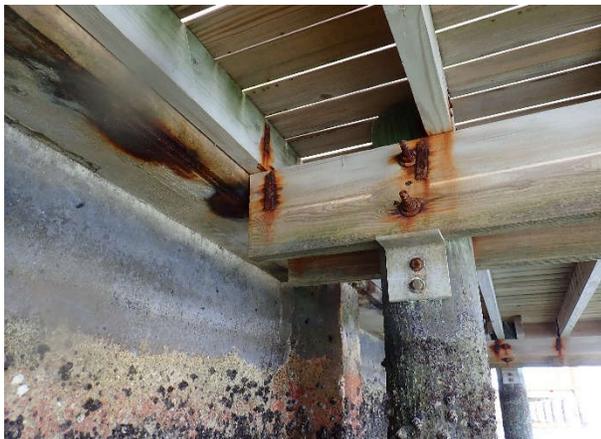
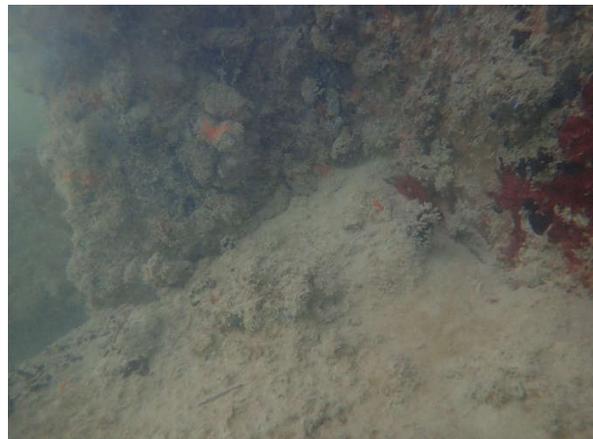
- \*Cap – Moderate cracking with corrosion staining
- \*Wall Panels – Pile panel separation at North end
- \*Wall Panels – Moderate cracking and concrete erosion
- \*King Piles – Moderate necking
- \*King Piles – Void at fillets at North end
- \*Dock – Severe corrosion at fasteners

• Seawall Rating: Poor      • Dock Rating: Poor

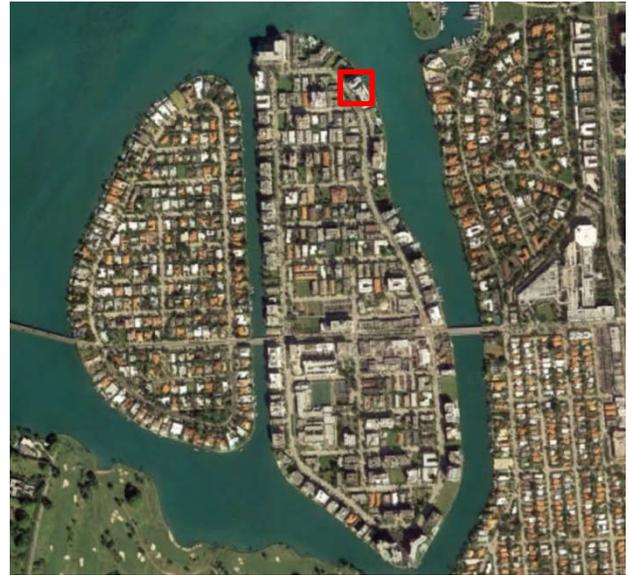
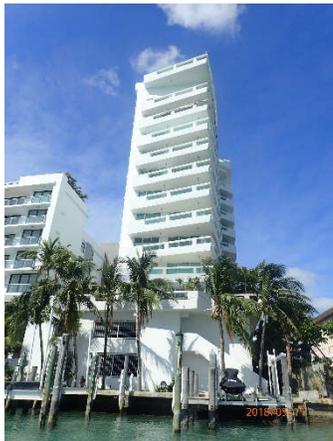
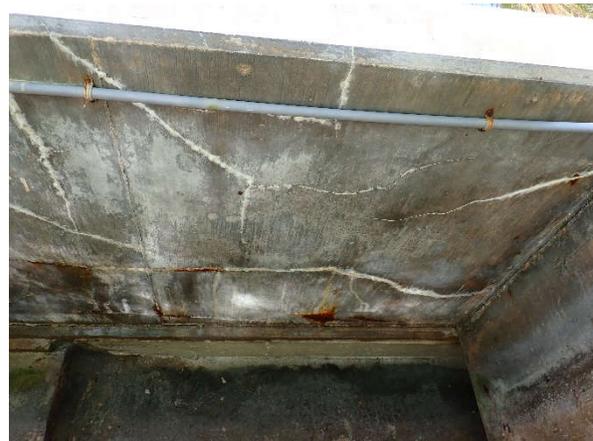
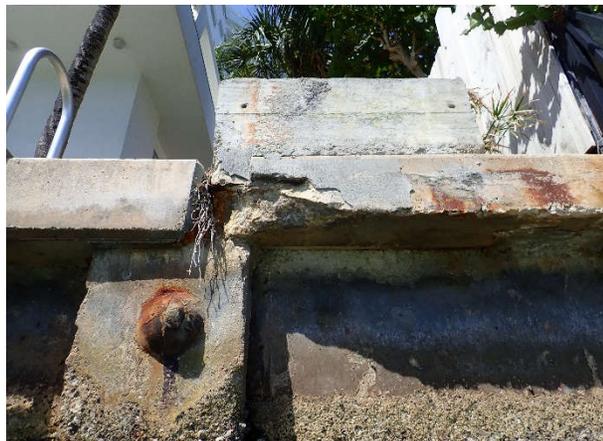
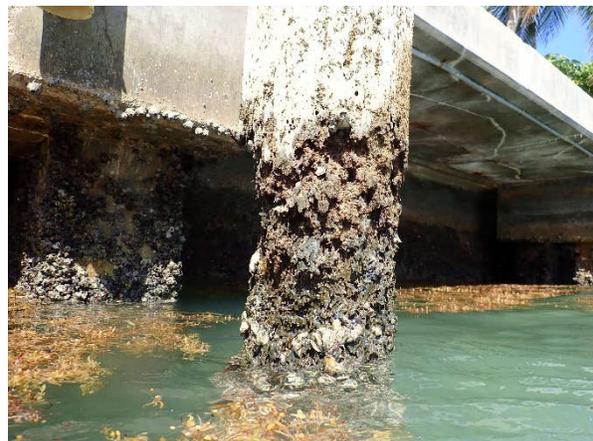
Property Address: 10261 E BAY HARBOR DR  
Bay Harbor Islands, FL 33154  
Location: S-1.1 Lot#24  
Date of Inspection: 5/11/2018 @ 10:30am

- \*Cap – Moderate spalling at cap corner
- \*Wall Panels – Minor cracking and concrete erosion
- \*T-Piles – Moderate necking and cracking at tidal zones
- \*Dock – Severe corrosion of fasteners
- \*Dock – Prior crack repairs at soffit
- \*Dock – Severe deterioration of piles

• Seawall Rating: Fair      • Dock Rating: Serious

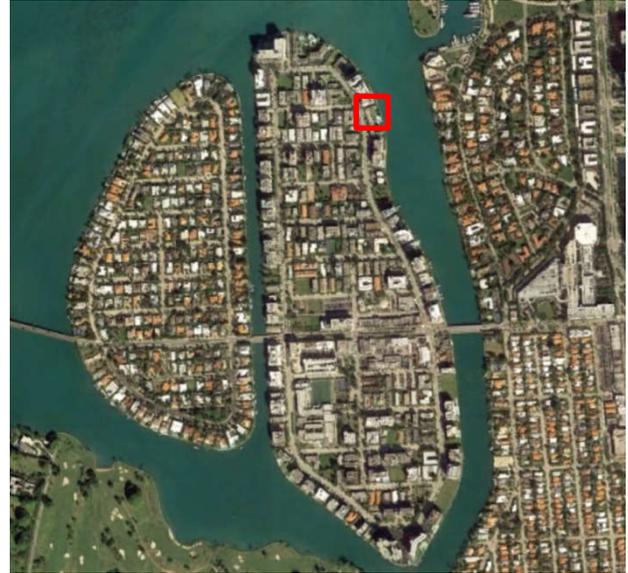
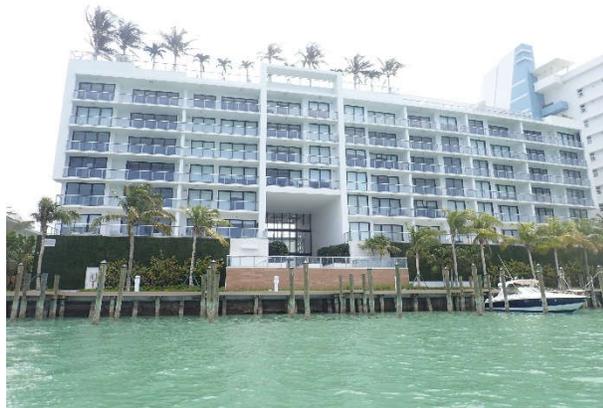
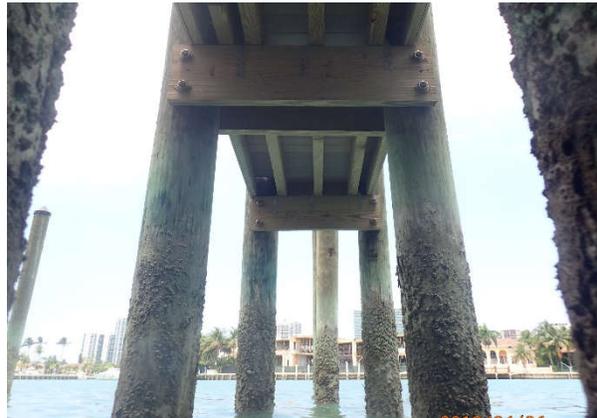
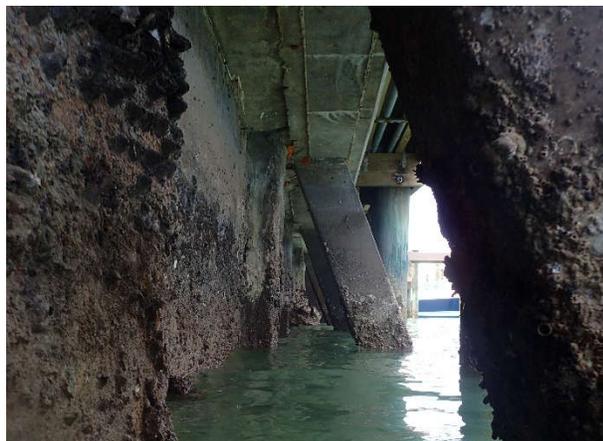
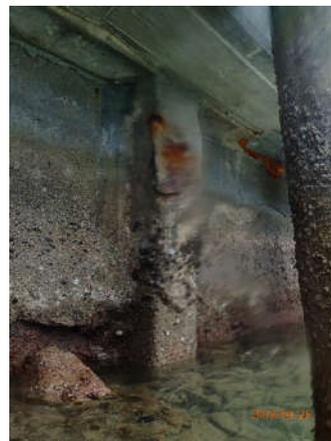
Property Address: 10201 E BAY HARBOR DR  
Bay Harbor Islands, FL 33154  
Location: S-1.1 Lot#25  
Date of Inspection: 4/26/2018 @ 2:30pm

- Wall Panels – Severe fracture and void adjacent to t-pile
- T-Pile – Severe spalling
- Dock – Minor corrosion of bolts

• Seawall Rating: Poor                      • Dock Rating: Satisfactory

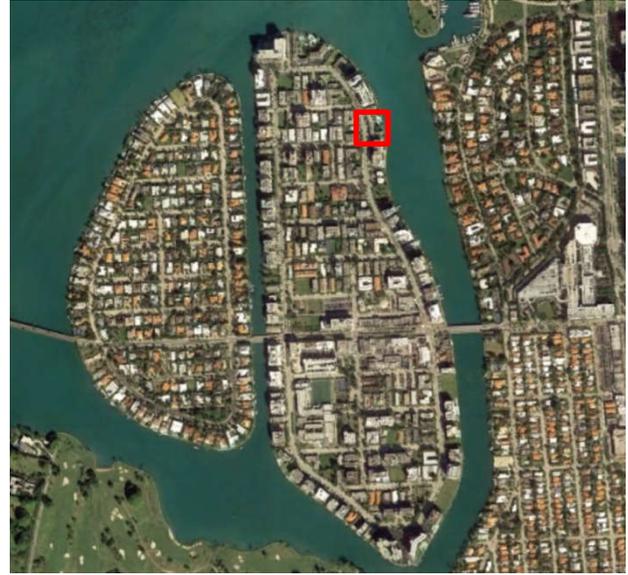
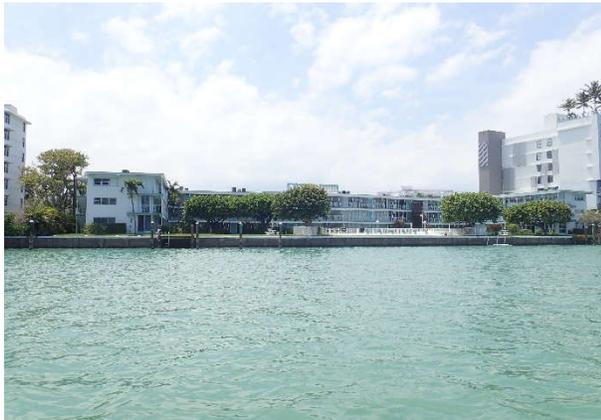
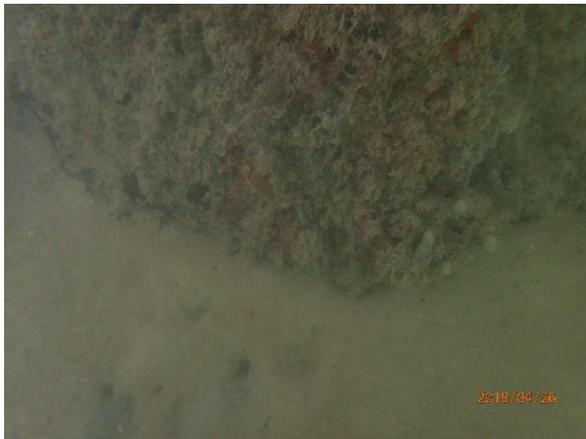
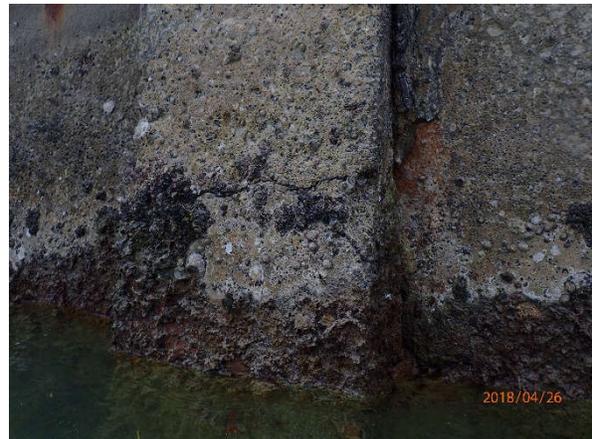
Property Address: 10141 E BAY HARBOR DR  
Bay Harbor Islands, FL 33154  
Location: S-1.1 Lot#26  
Date of Inspection: 4/26/2018 @ 2:10pm

- Cap – Moderate cracking at soffit and wet face
- Wall Panels – Moderate cracking and concrete erosion
- Wall – Panels – Moderate cracking 1ft from seabed
- T-Piles – Pile panel separation with sediment accumulation through fillets at seabed
- T-Piles – Moderate cracking and necking
- Dock – Moderate corrosion at fasteners

• Seawall Rating: Fair                  • Dock Rating: Fair

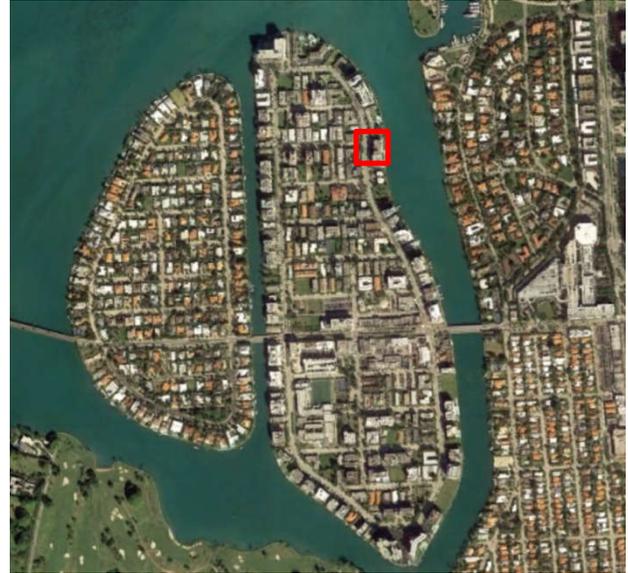
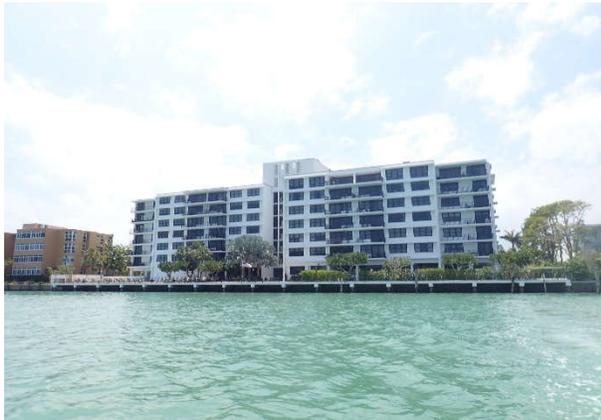
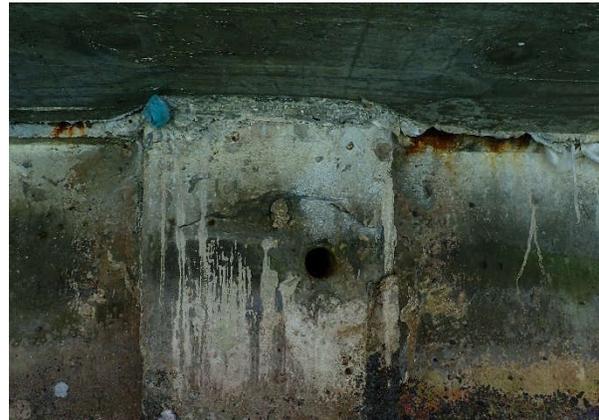
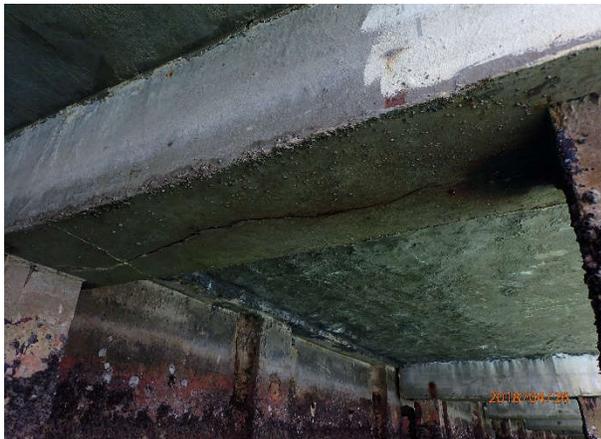
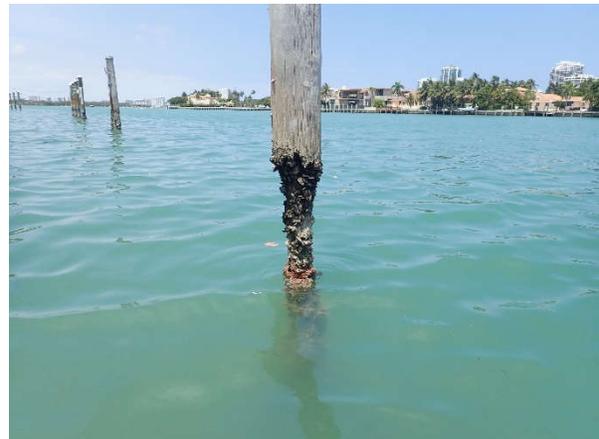
Property Address: 10101 E BAY HARBOR DR  
Bay Harbor Islands, FL 33154  
Location: S-1.1 Lot#27  
Date of Inspection: 4/26/2018 @ 2:00pm

- Cap – Minor cracking and spalling at wet face and soffit
- Wall Panels – Minor concrete erosion at wall panels
- T-Piles – Moderate cracking and necking
- Dock – Moderate cracking at pile beam caps
- Dock – Severe deterioration at timber mooring piles

• Seawall Rating: Fair      • Dock Rating: Fair

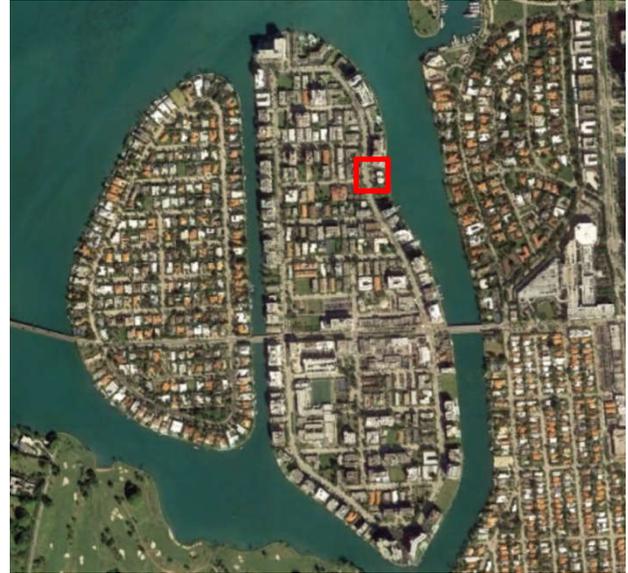
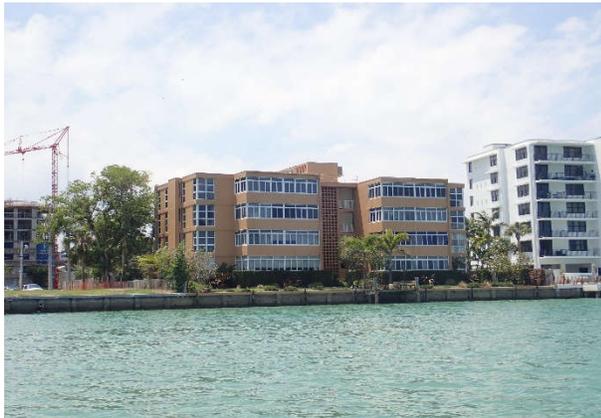
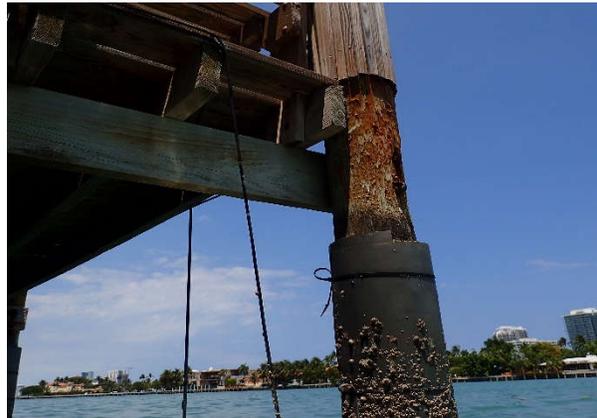
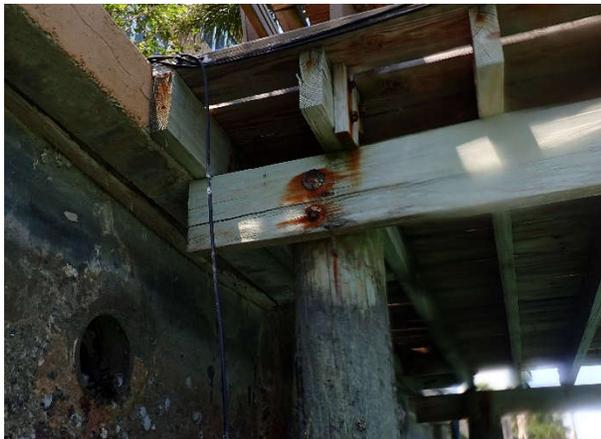
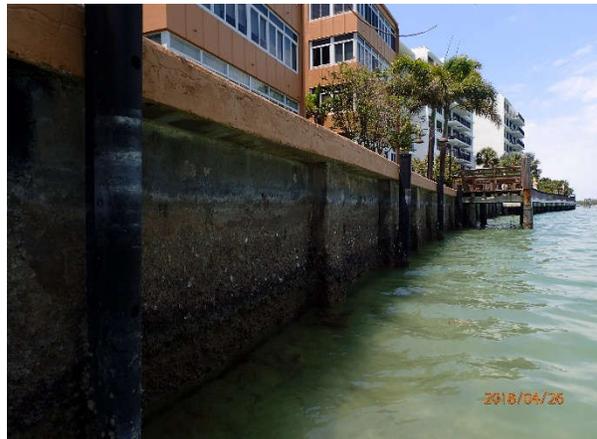
Property Address: 10001 E BAY HARBOR DR  
Bay Harbor Islands, FL 33154  
Location: S-1.1 Lot#28  
Date of Inspection: 4/26/2018 @ 2:00pm

- Cap – Minor cracking at wet face and soffit
- T-Piles – Moderate necking
- Wall Panels – Moderate concrete erosion
- Dock – Severe corrosion at fasteners

• Seawall Rating: Fair      • Dock Rating: Poor

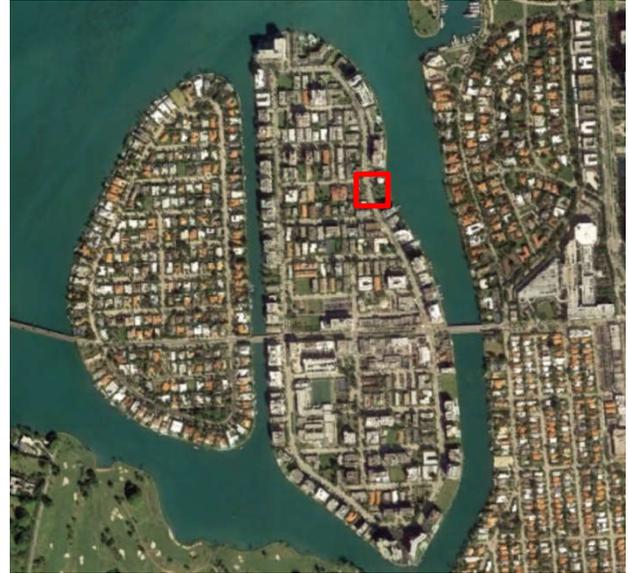
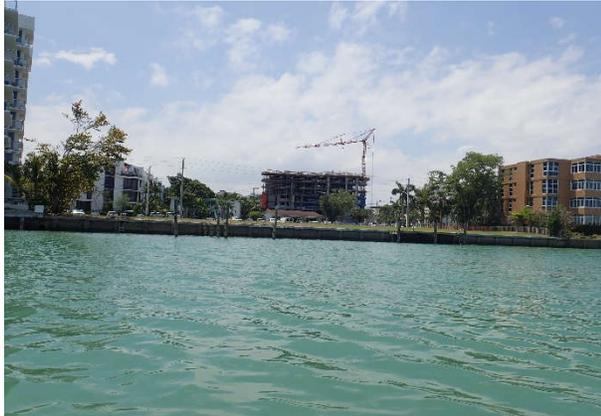
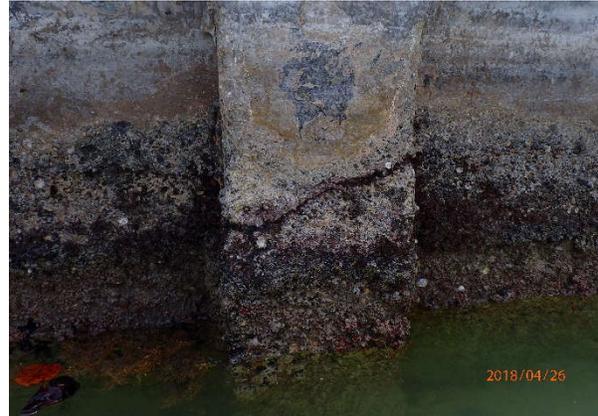
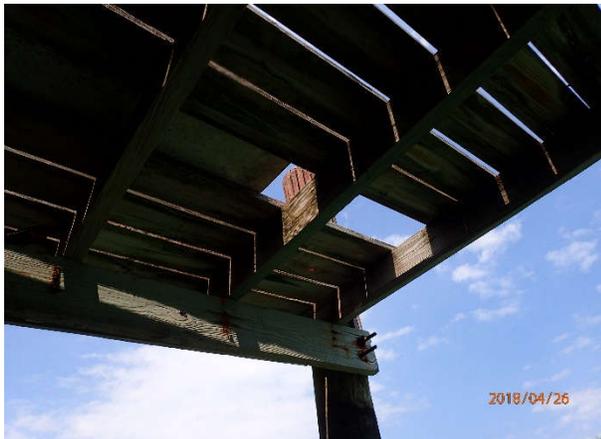
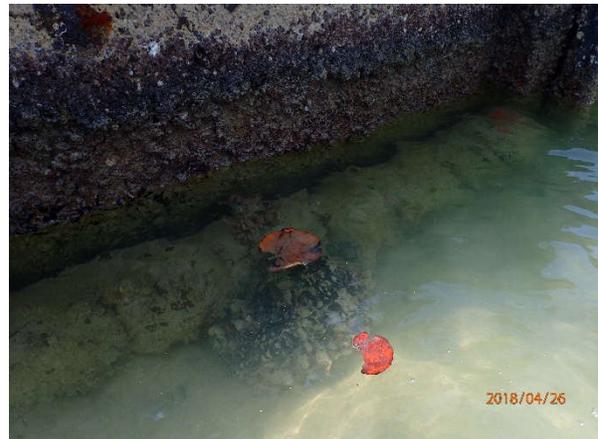
Property Address: 9955 E BAY HARBOR DR  
Bay Harbor Islands, FL 33154  
Location: S-1.1 Lot#29  
Date of Inspection: 4/26/2018 @ 1:50pm

- Cap – Moderate cracking at wet face
- Wall Panels – Moderate cracking and concrete erosion
- T-Piles – Moderate to severe cracking and necking
- Dock – Moderate to severe corrosion at fasteners
- Dock – Deck boards missing

• Seawall Rating: Fair      • Dock Rating: Poor

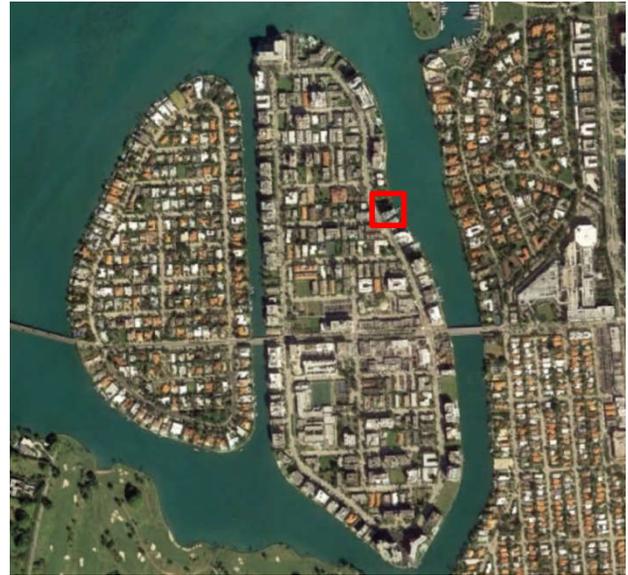
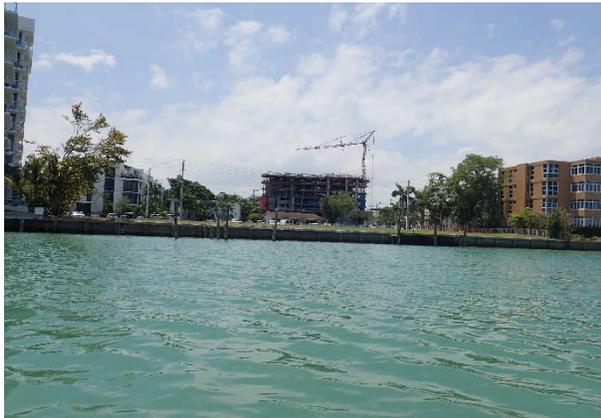
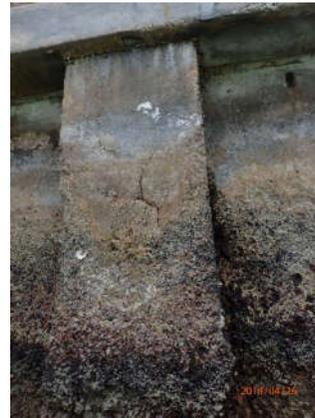
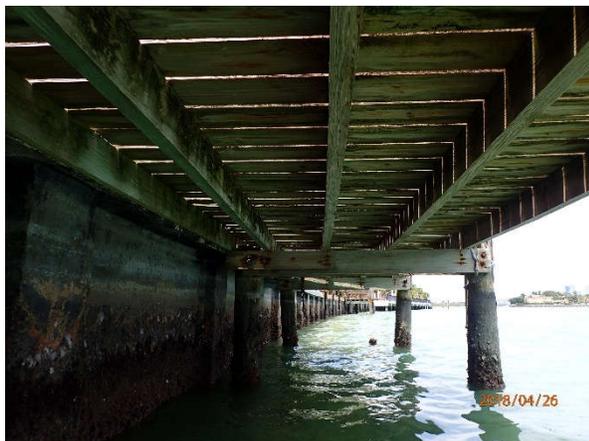
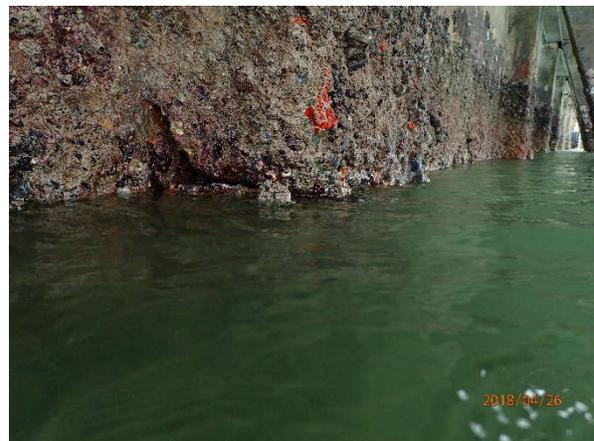
Property Address: 9927 E BAY HARBOR DR  
Bay Harbor Islands, FL 33154  
Location: S-1.1 Lot#30  
Date of Inspection: 4/26/2018 @ 1:50pm

- Cap – Moderate cracking at wet face
- Wall Panels – Moderate cracking and concrete erosion
- T-Piles – Moderate to severe cracking and necking
- Dock – Moderate to severe corrosion at fasteners
- Dock – Deck boards missing

• Seawall Rating: Fair      • Dock Rating: Fair
