# Seawall Condition and Resiliency Assessment Town of Bay Harbor Islands

October 2019 (Updated)

**Cummins Cederberg, Inc.**

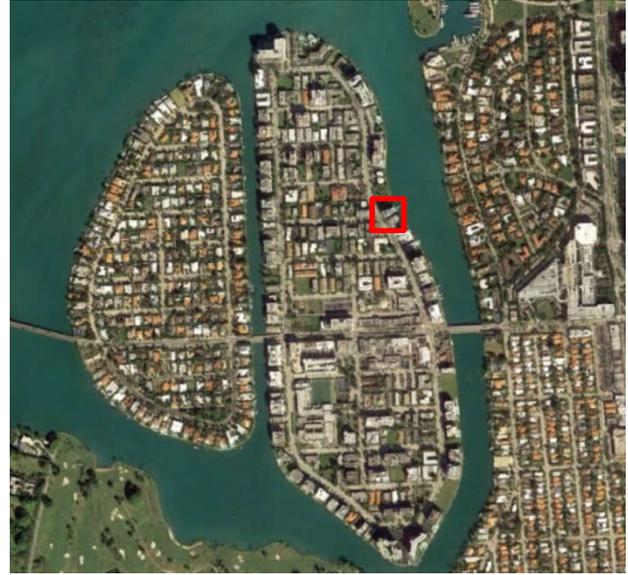
Property Address: 9901 E BAY HARBOR DR  
Bay Harbor Islands, FL 33154  
Location: S-1.1 Lot#31  
Date of Inspection: 4/26/2018 @ 1:40pm

- Wall Panels – Moderate concrete erosion and cracking
- T-Piles – Moderate to severe cracking through piles

• Seawall Rating: Fair      • Dock Rating: Satisfactory

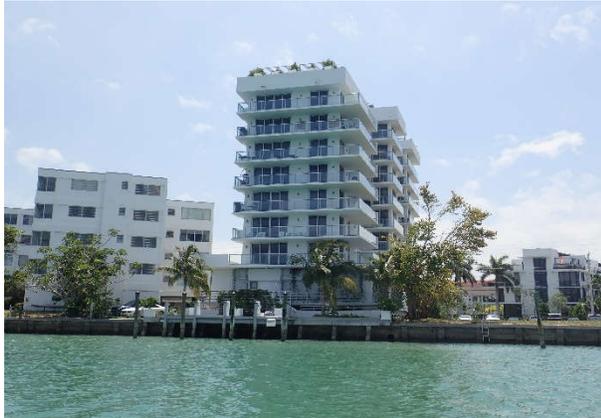
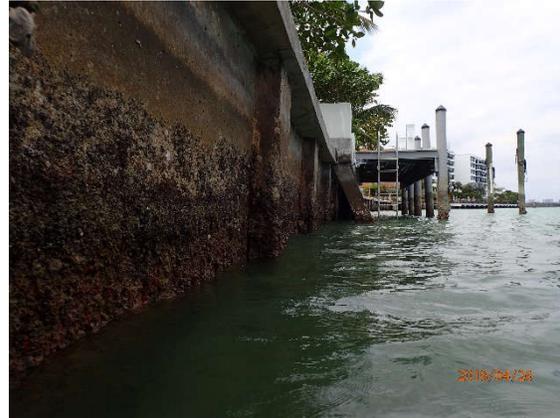
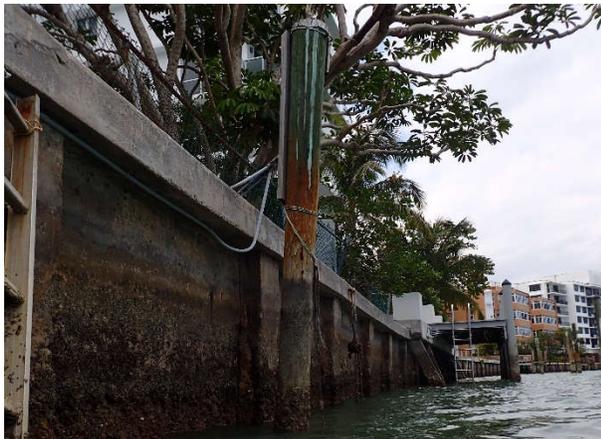
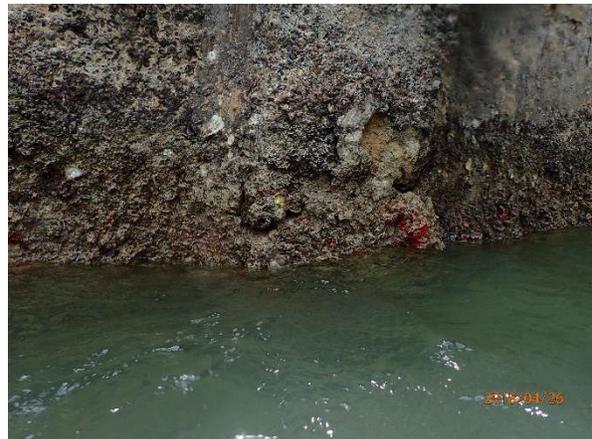
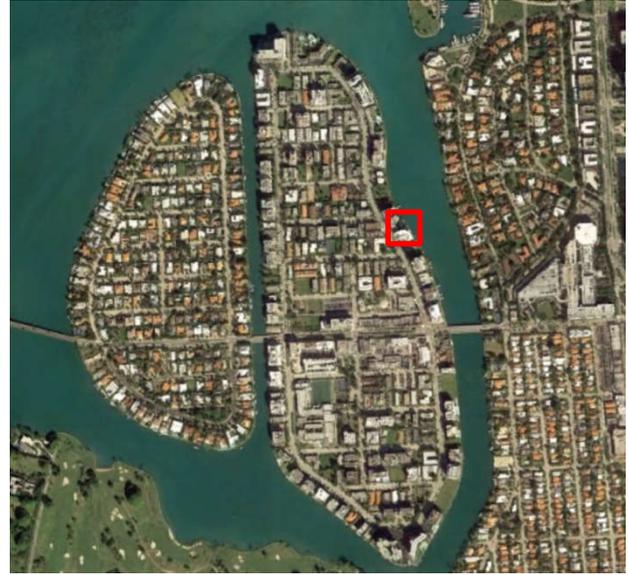
Property Address: 9881 E BAY HARBOR DR  
Bay Harbor Islands, FL 33154  
Location: S-1.1 Lot#32  
Date of Inspection: 4/26/2018 @ 1:40pm

- Cap – Moderate cracking and spalling
- Wall Panels – Moderate cracking and spalling
- T-Piles – Moderate cracking and spalling
- Upland depression adjacent to outfall

• Seawall Rating: Fair                  • Dock Rating: N/A

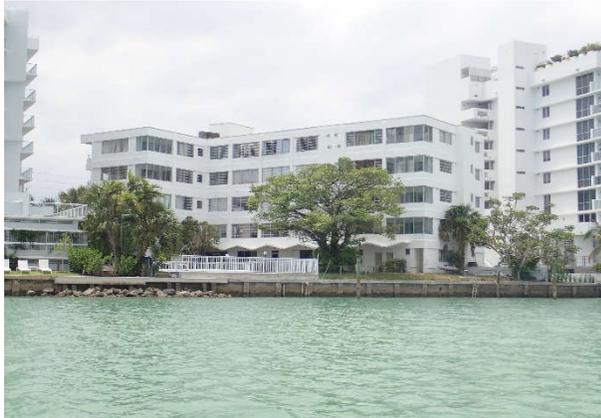
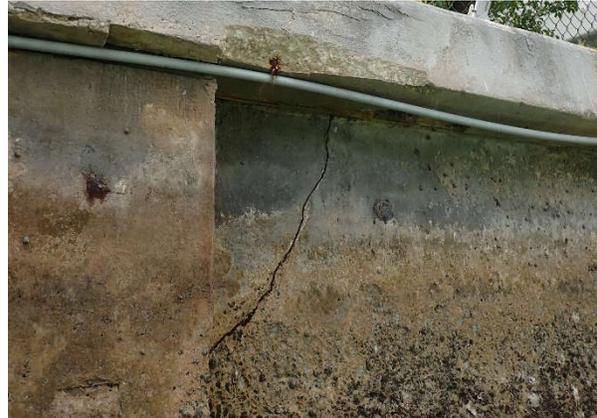
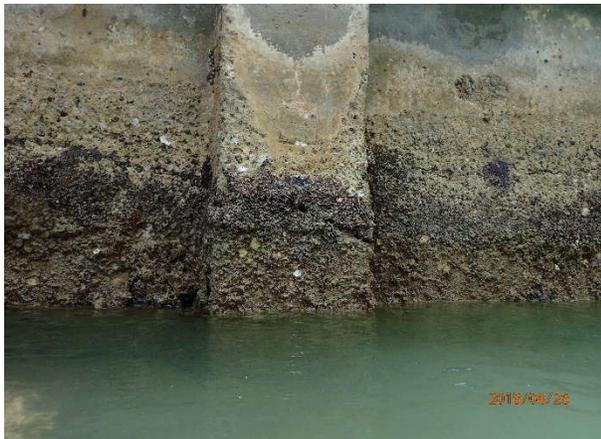
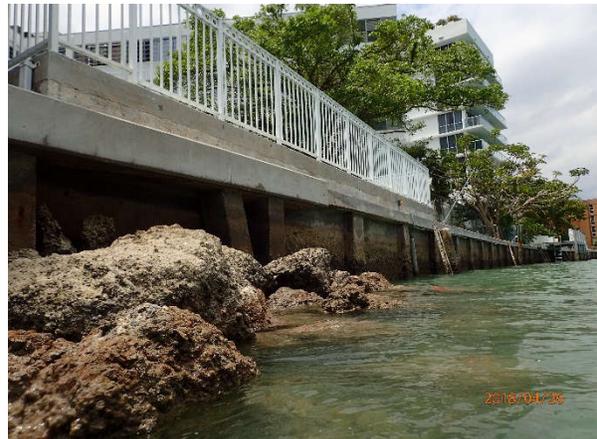
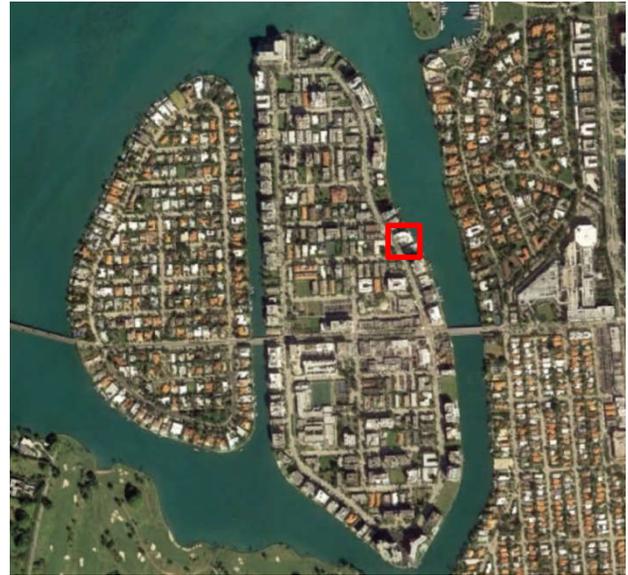
Property Address: 9821 E BAY HARBOR DR  
Bay Harbor Islands, FL 33154  
Location: S-1.1 Lot#33  
Date of Inspection: 4/26/2018 @ 1:30pm

- \*Cap – Minor cracking at wet face
- \*Wall Panels – Minor to moderate cracking
- \*T-Piles – Moderate cracking
- \*T-Piles – Two anchors at piles North of dock
- \*Batter Piles – Minor to moderate cracking with erosion
- \*Dock – Severe corrosion at fasteners

\* Seawall Rating: Fair      \* Dock Rating: Fair

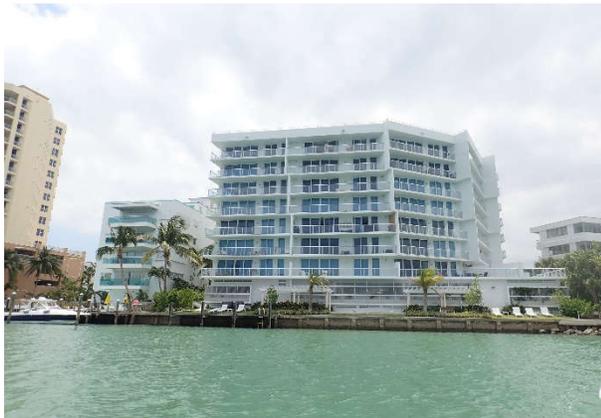
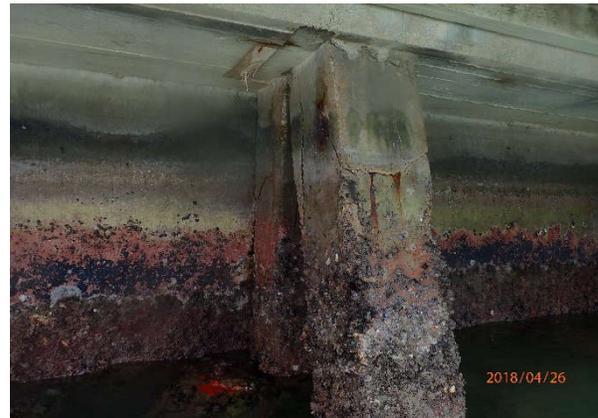
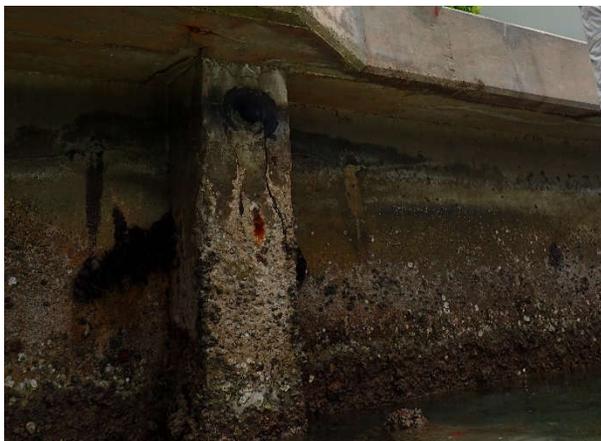
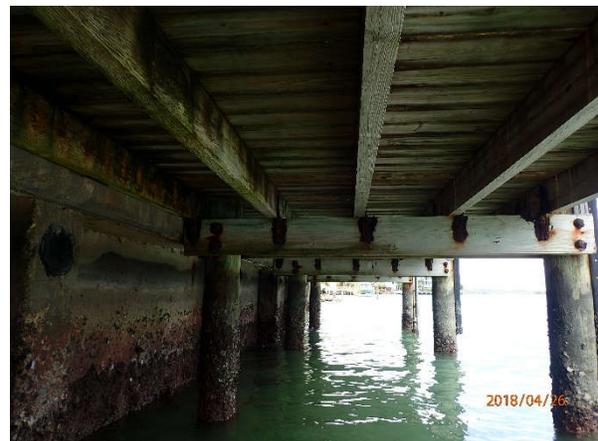
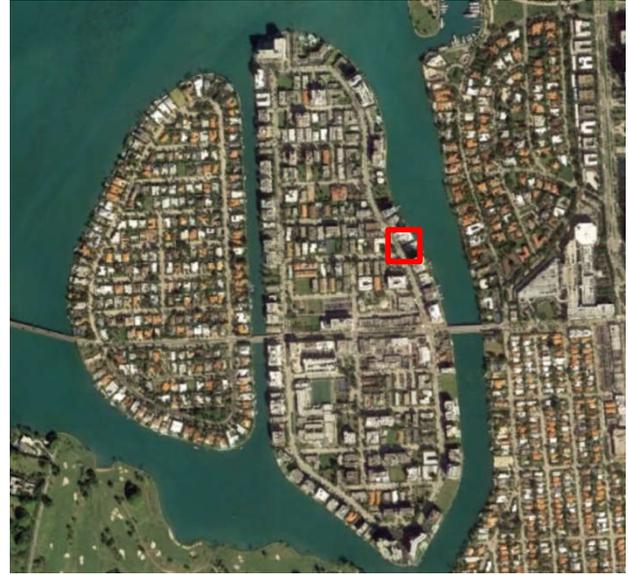
Property Address: 9801 E BAY HARBOR DR  
Bay Harbor Islands, FL 33154  
Location: S-1.1 Lot#34  
Date of Inspection: 4/26/2018 @ 1:30pm

- Wall Panels – Minor cracking along panels
- Batter Piles – Moderate cracking at the heads with erosion at the tidal zone
- Dock – Moderate corrosion at fasteners
- Dock – Timber piles decaying

• Seawall Rating: Fair      • Dock Rating: Fair

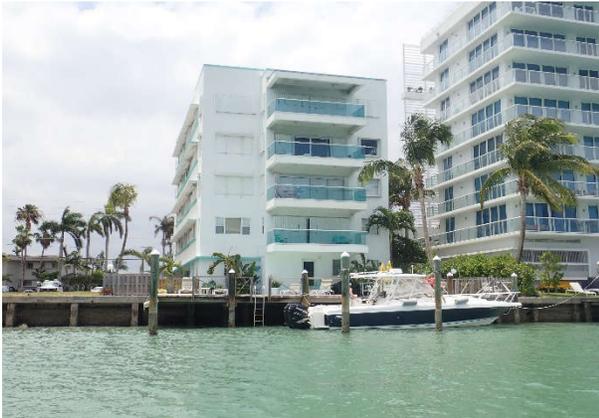
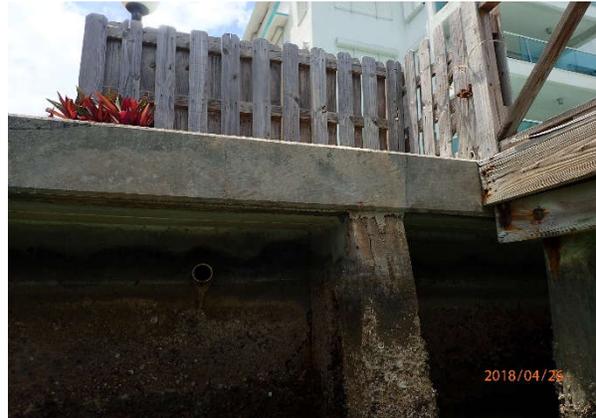
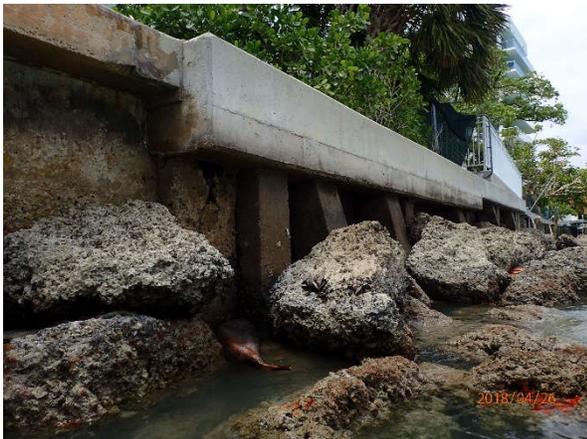
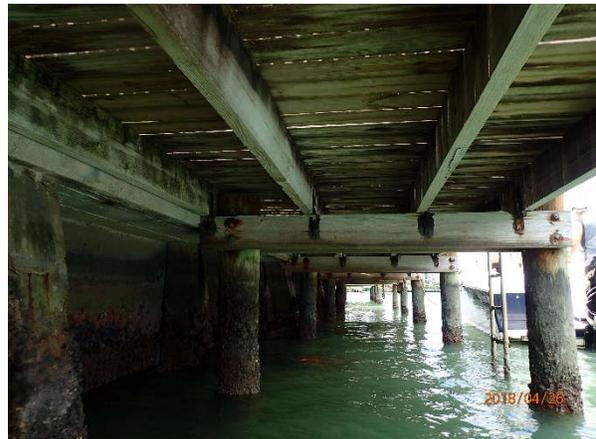
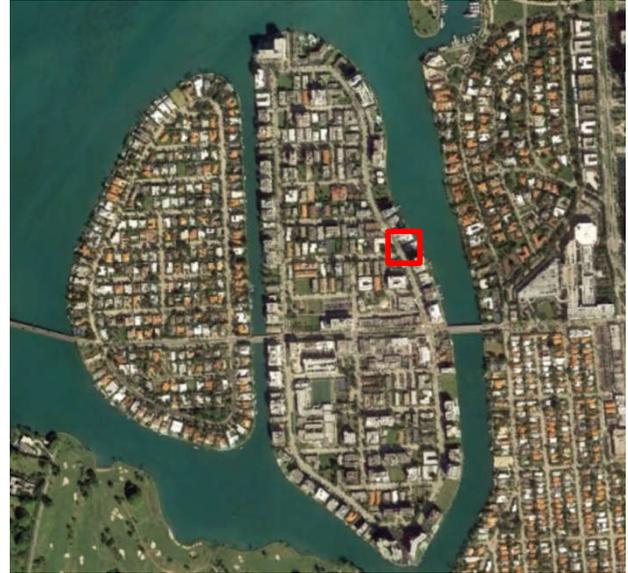
Property Address: 9781 E BAY HARBOR DR  
Bay Harbor Islands, FL 33154  
Location: S-1.1 Lot#35  
Date of Inspection: 4/26/2018 @ 1:20pm

- Cap – Moderate cracking
- Wall Panels – Moderate concrete erosion and cracking
- Batter Piles – Moderate to severe cracking
- Dock – Severe deterioration of timber piles
- Dock – Severe corrosion of fasteners

• Seawall Rating: Fair      • Dock Rating: Serious

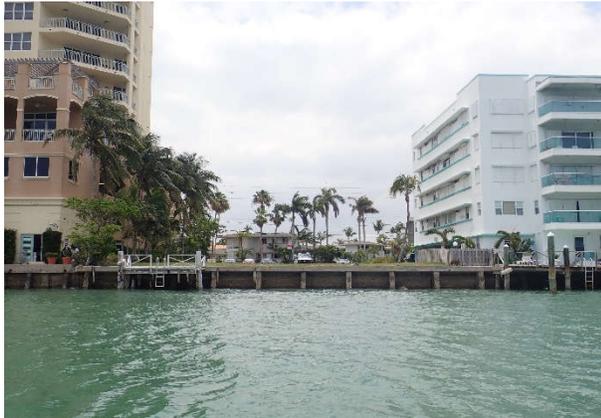
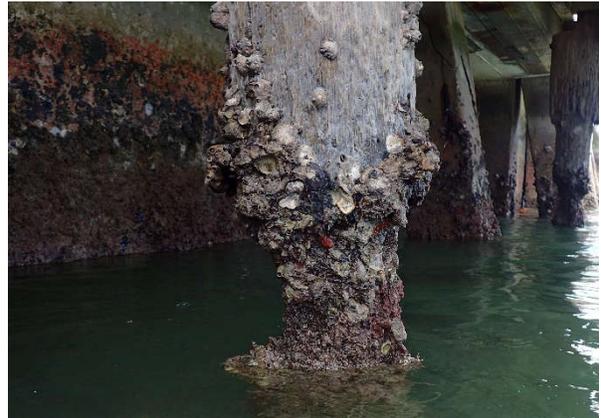
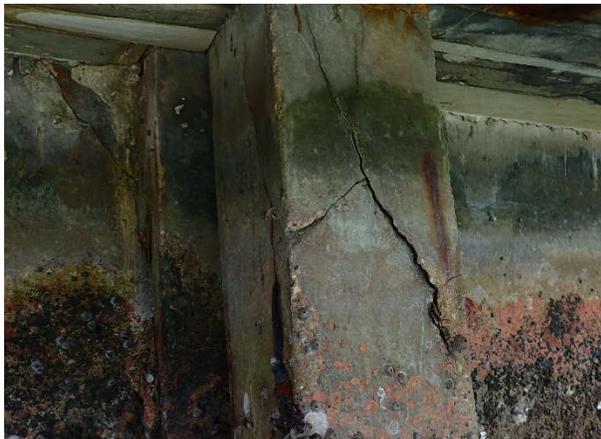
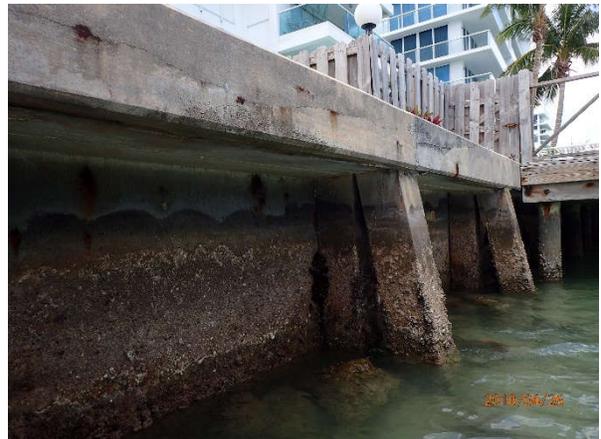
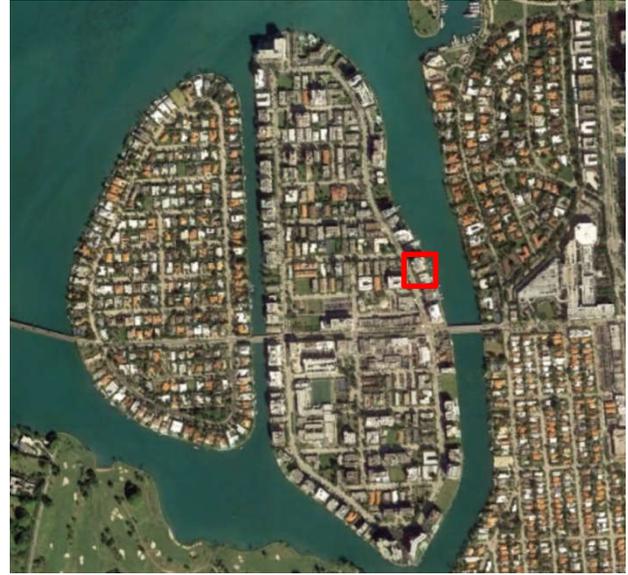
Property Address: 9751 E BAY HARBOR DR  
Bay Harbor Islands, FL 33154  
Location: S-1.1 Lot#36  
Date of Inspection: 4/26/2018 @ 1:20pm

- Cap – Moderate cracking with corrosion staining
- Wall Panels – Moderate concrete erosion and cracking
- T-Piles – Moderate cracking with concrete erosion
- Cracking at sheet pile toe wall
- Dock – Fastener corrosion

• Seawall Rating: Fair                      • Dock Rating: Fair

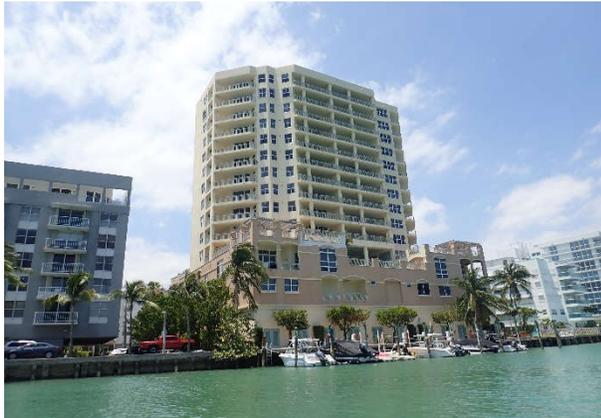
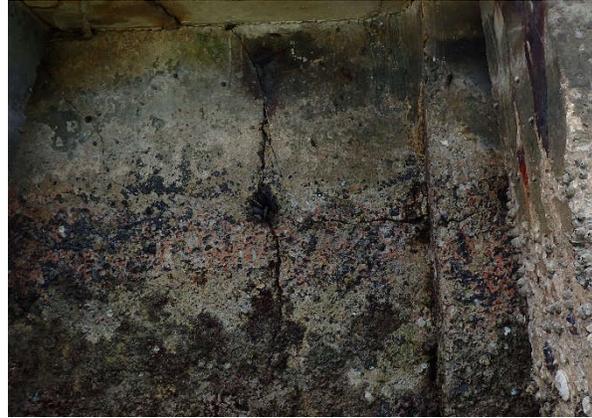
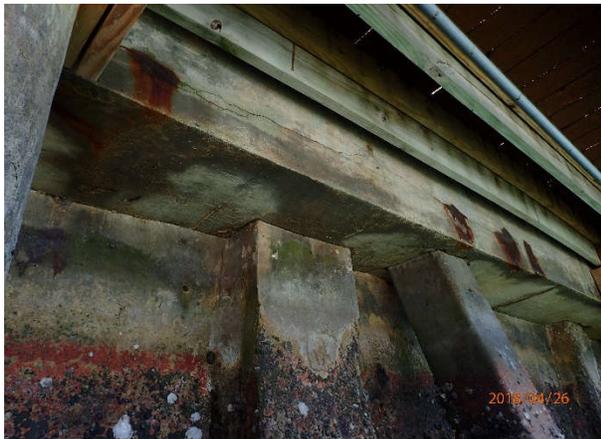
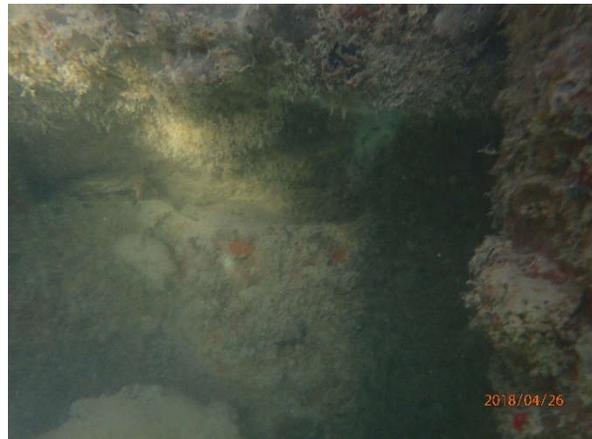
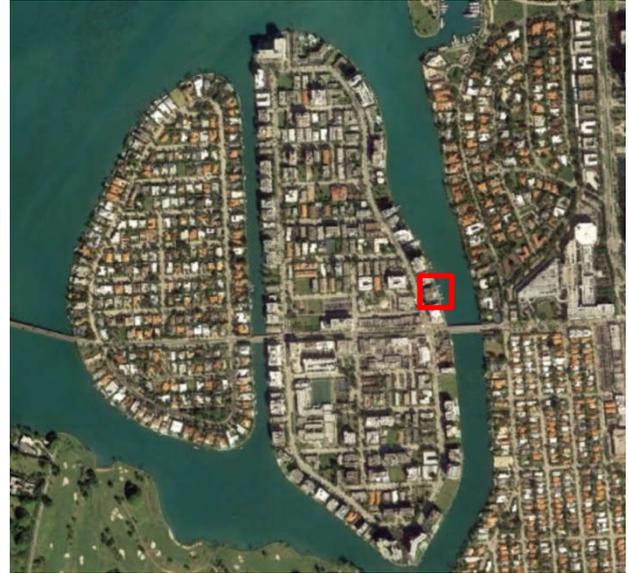
Property Address: 9721 E BAY HARBOR DR  
Bay Harbor Islands, FL 33154  
Location: S-1.1 Lot#37  
Date of Inspection: 4/26/2018 @ 1:10pm

- \*Cap – Moderate cracking with corrosion staining and exposed steel reinforcement
- \*Wall Panels – Moderate cracking and concrete erosion
- \*King Piles – Moderate concrete erosion and cracking
- \*Batter Piles – Moderate cracking

• Seawall Rating: Fair      • Dock Rating: N/A

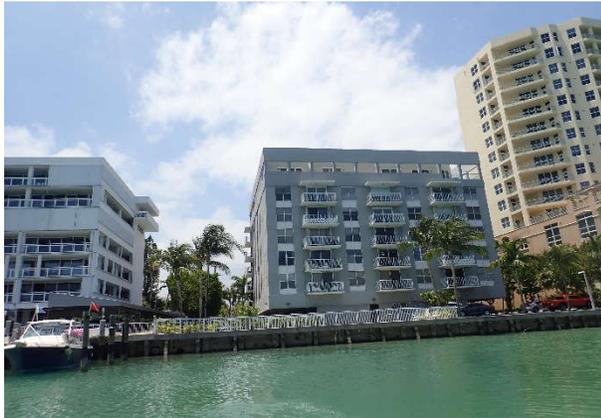
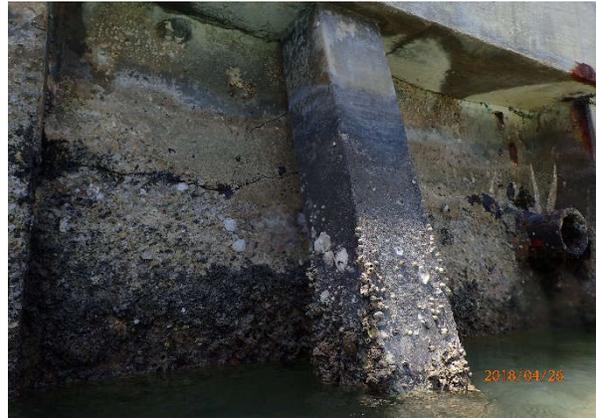
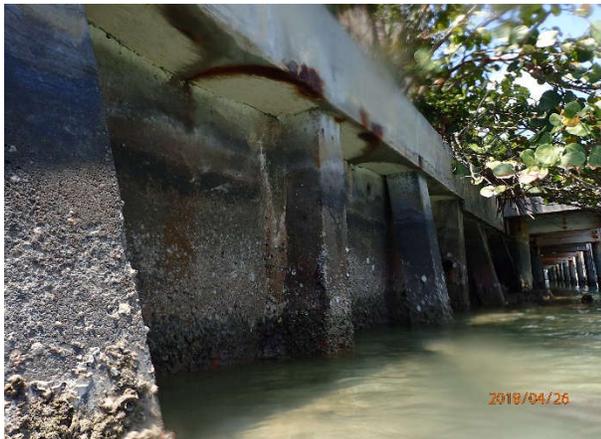
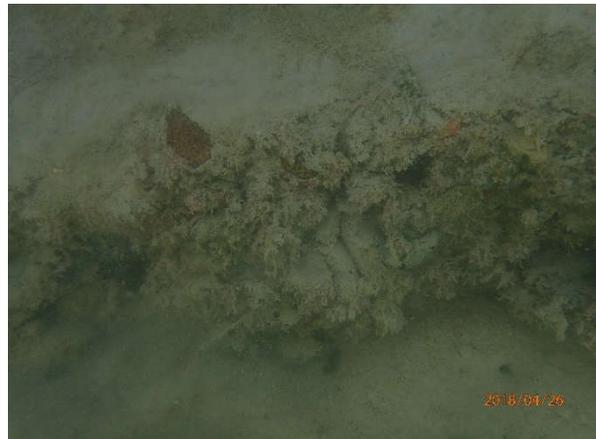
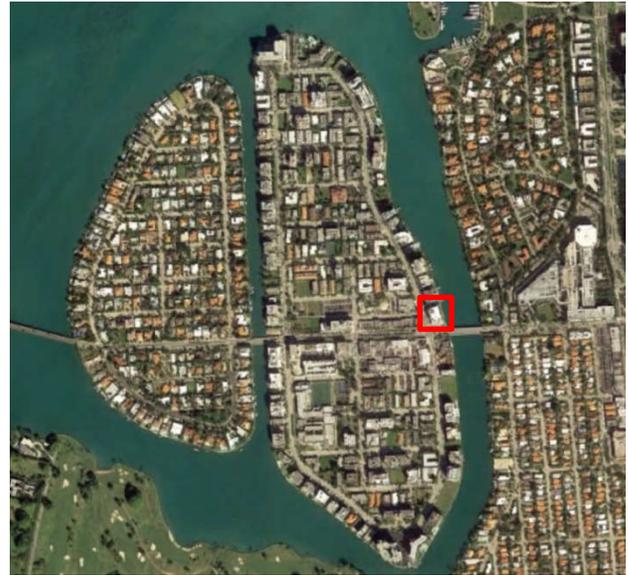
Property Address: 9655 E BAY HARBOR DR  
Bay Harbor Islands, FL 33154  
Location: S-1.1 Lot#38  
Date of Inspection: 4/26/2018 @ 1:00pm

- Wall Panels – Moderate cracking and concrete erosion
- T-Piles –Moderate cracking and necking

• Seawall Rating: Fair                      • Dock Rating: Satisfactory

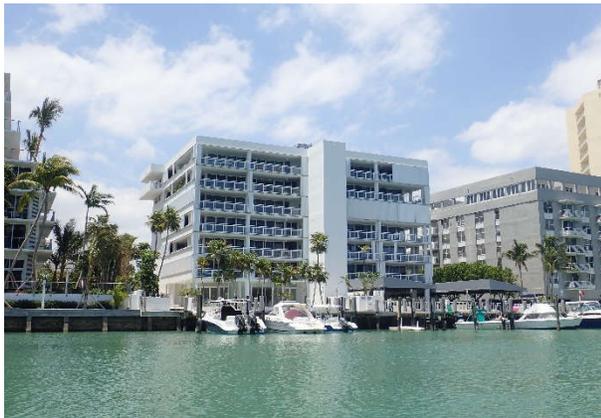
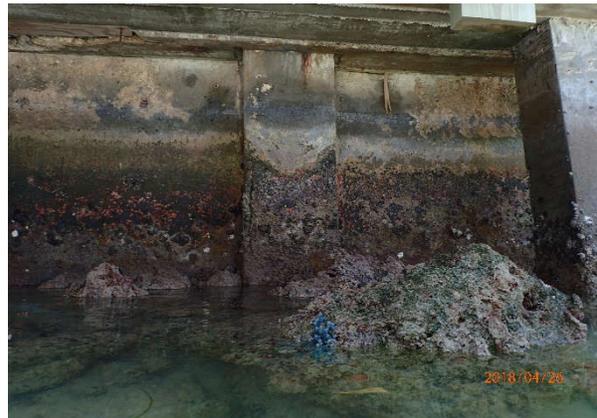
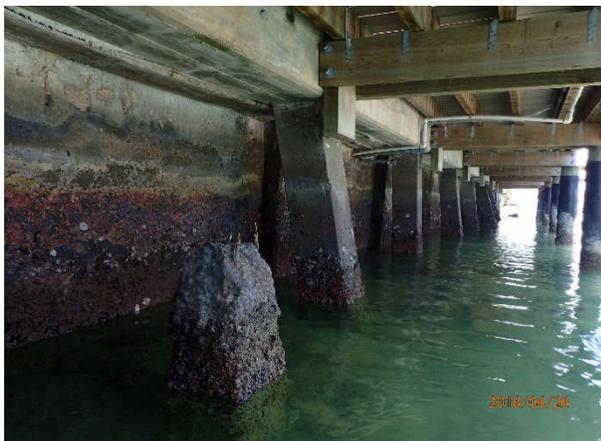
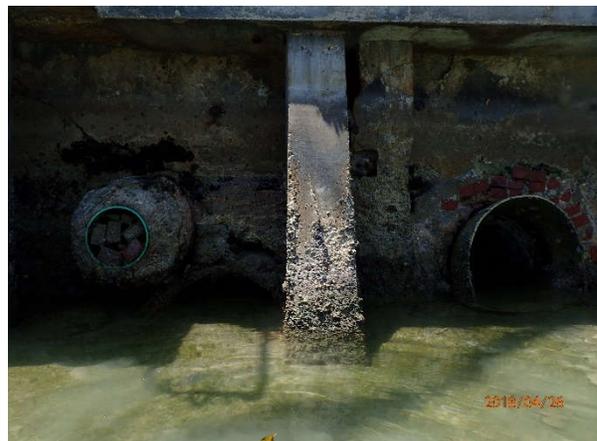
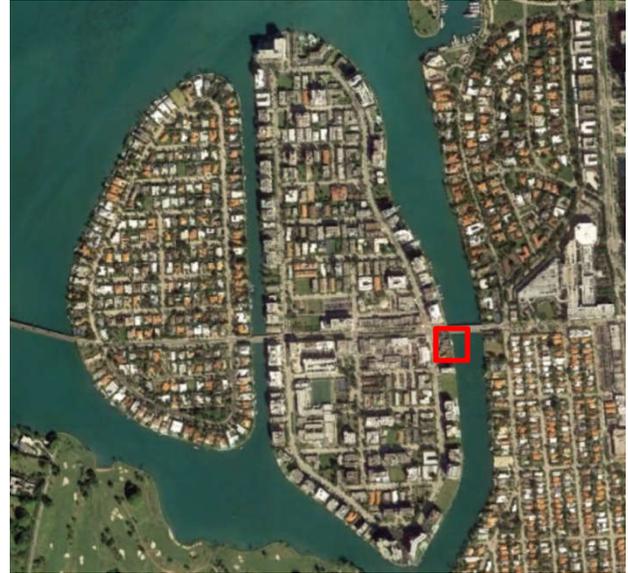
Property Address: 9601 E BAY HARBOR DR  
Bay Harbor Islands, FL 33154  
Location: S-1.1 Lot#39  
Date of Inspection: 4/26/2018 @ 12:50pm

- Wall Panels – Moderate concrete erosion and spalling
- Wall Panels – Moderate cracking below waterline with voids along seabed
- T-Piles – Pile panel separation

• Seawall Rating: Fair      • Dock Rating: N/A

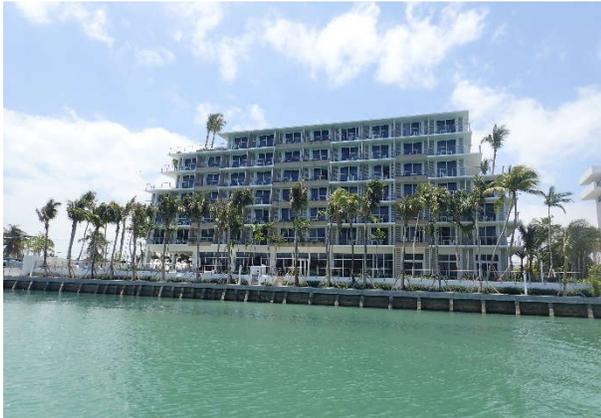
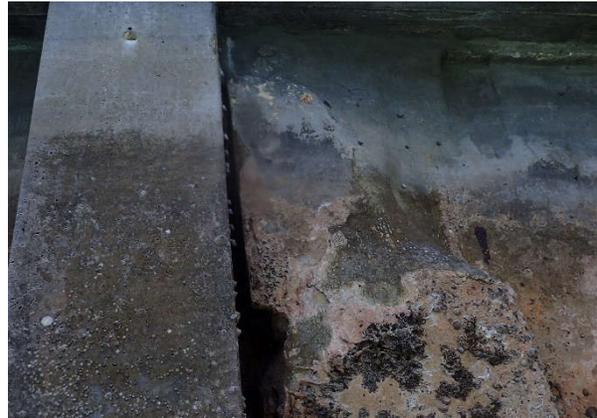
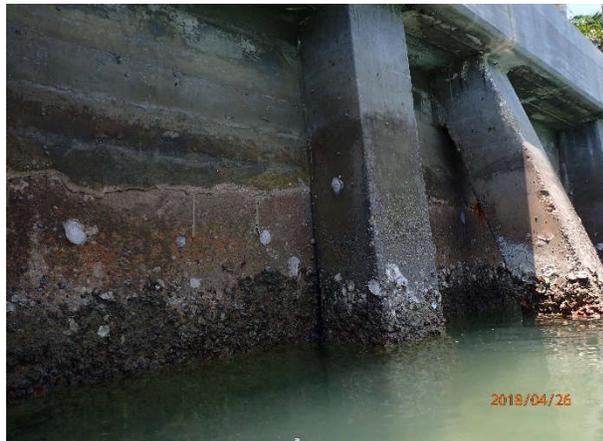
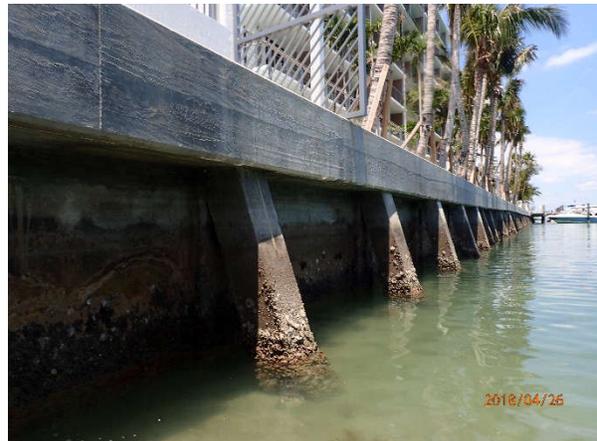
Property Address: 9551 E BAY HARBOR DR  
Bay Harbor Islands, FL 33154  
Location: S-1.1 Lot#40  
Date of Inspection: 4/26/2018 @ 12:40pm

- \*Cap – Minor to moderate cracking
- \*Wall Panels – Moderate outward rotation along wall
- \*T-Piles – Moderate concrete erosion and necking
- \*Batter Piles – Moderate cracking at pile heads
- \*Docks – Corrosion at fasteners
- \*Docks – Splitting at beam connections, missing fasteners

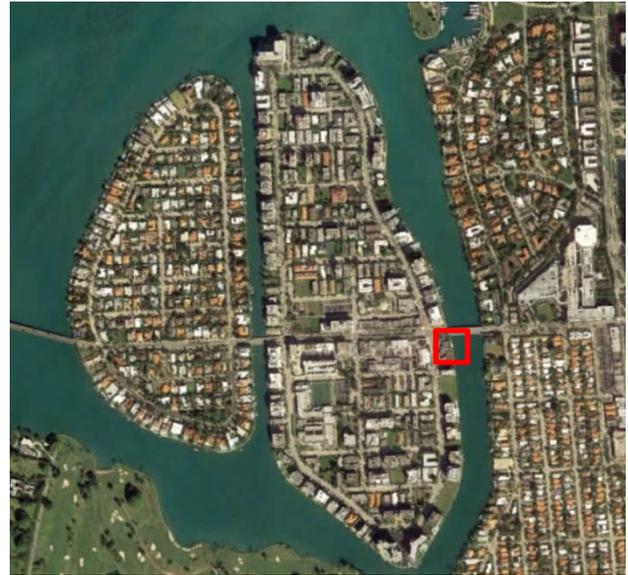
• Seawall Rating: Fair                      • Dock Rating: Poor

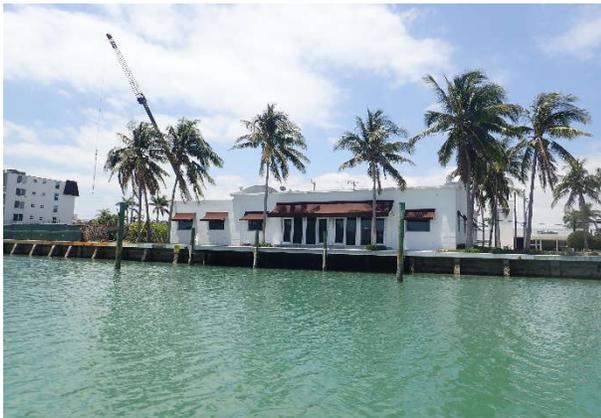
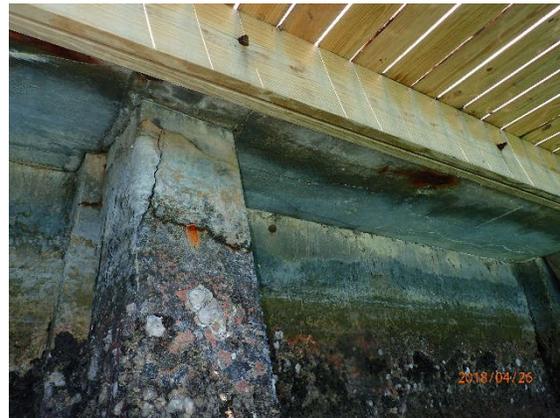
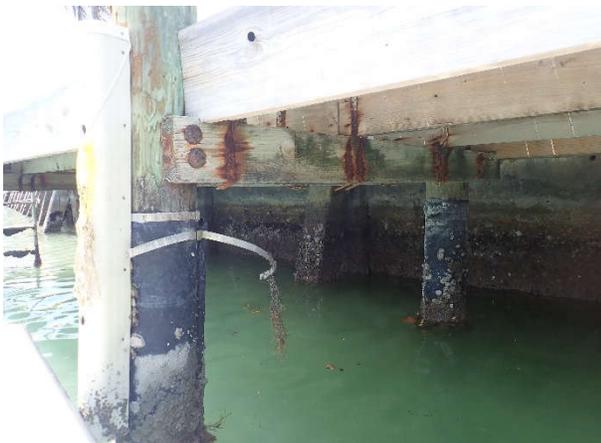
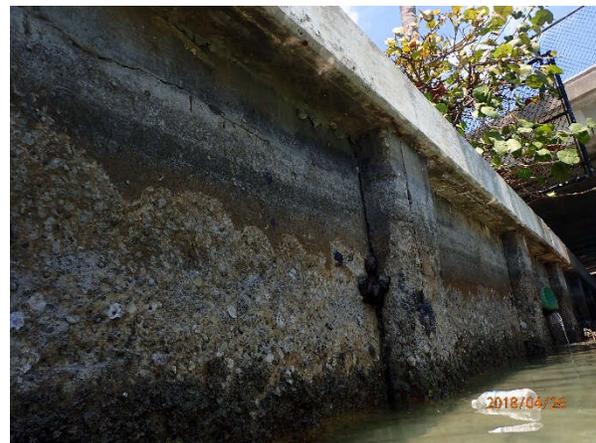
Property Address: 9541 E BAY HARBOR DR  
Bay Harbor Islands, FL 33154  
Location: S-1.1 Lot#41  
Date of Inspection: 4/26/2018 @ 12:40pm

- Wall Panels – Cracking
- Wall Panels – Cracking
- T-Piles – Severe cracking and deterioration
- Batter Piles – Cracking
- Dock – Fastener corrosion

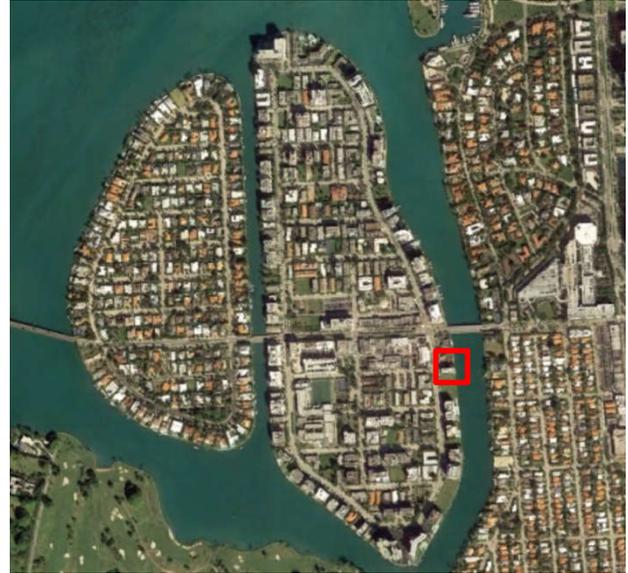
• Seawall Rating: Fair      • Dock Rating: Fair

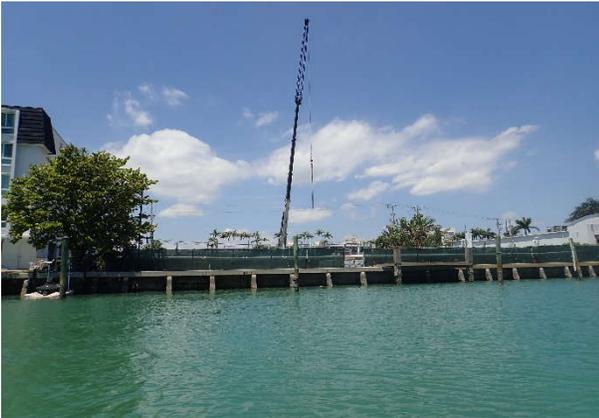
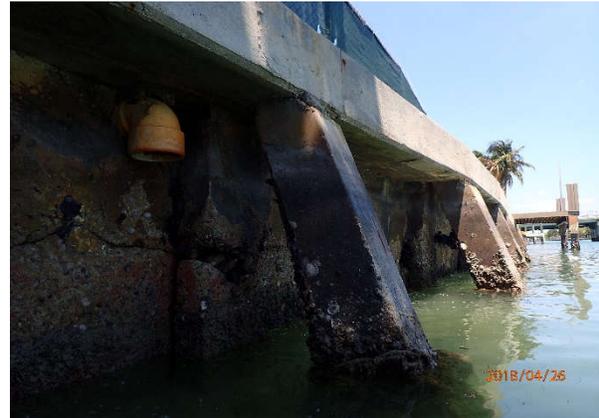
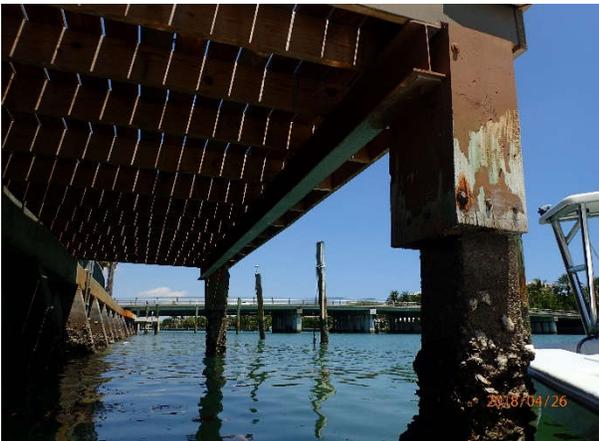
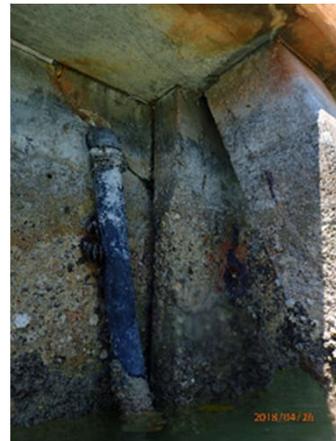
Property Address: 9521 E BAY HARBOR DR  
Bay Harbor Islands, FL 33154  
Location: S-1.1 Lot#42  
Date of Inspection: 4/26/2018 @ 12:30pm

- Wall Panels – Severe cracking and spalling South of outfall
- Wall Panels – Rotation of panels causing flexural failure
- T-Piles – Severe cracking and deterioration at South end
- Dock – Fastener corrosion

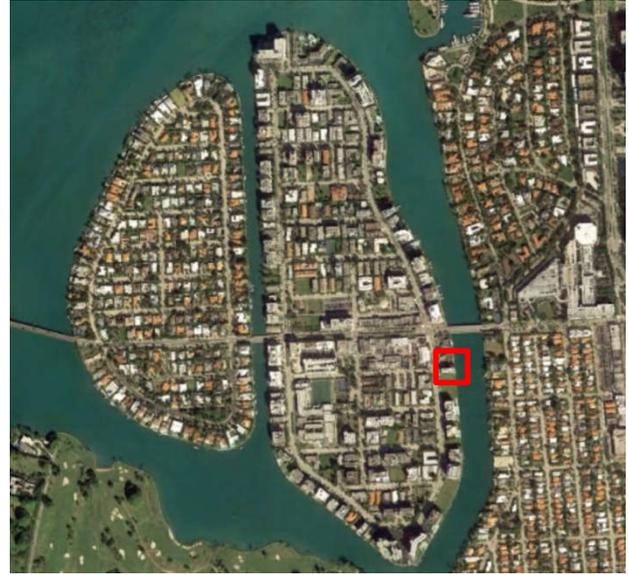
• Seawall Rating: Serious      • Dock Rating: Fair

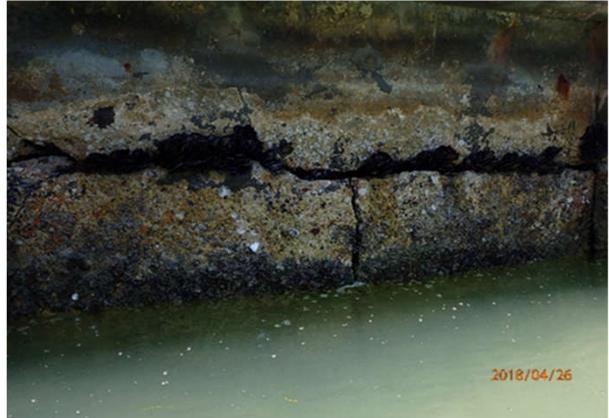
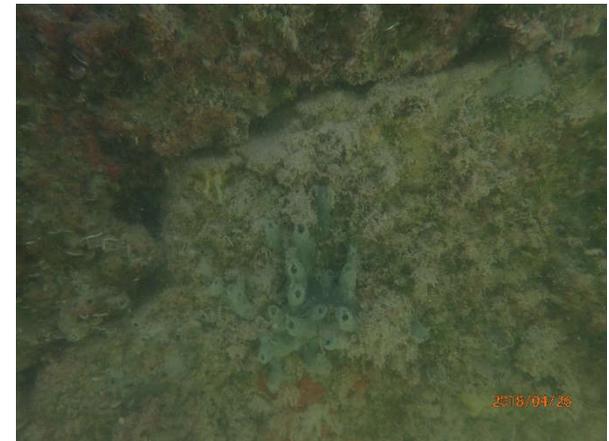
Property Address: 9501 E BAY HARBOR DR  
Bay Harbor Islands, FL 33154  
Location: S-1.1 Lot#43  
Date of Inspection: 4/26/2018 @ 12:20pm

- \*Cap – Spalling with exposed steel reinforcement
- \*Wall Panels – Minor to moderate concrete erosion
- \*King Piles – Moderate impact damage at pile heads
- \*T-Piles – Moderate concrete erosion at piles
- \*Batter Piles – Moderate spalling with cavities at spot piles
- \*Dock – Severe corrosion at fasteners

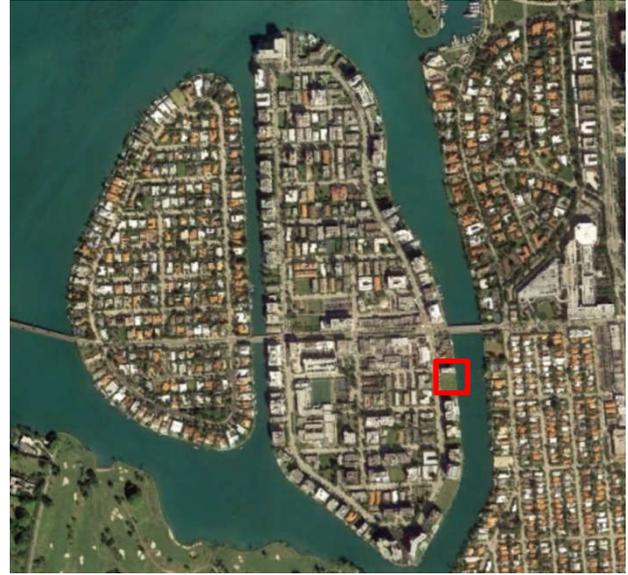
• Seawall Rating: Poor      • Dock Rating: Poor

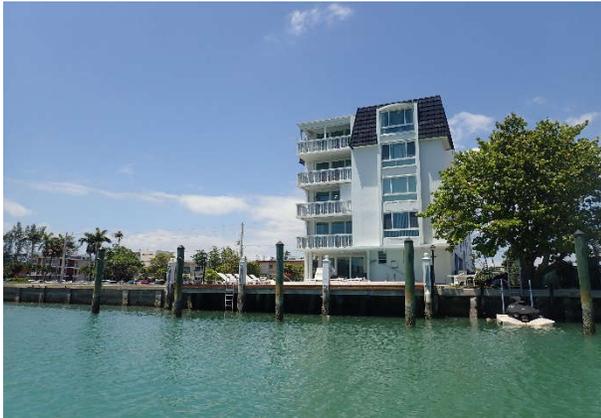
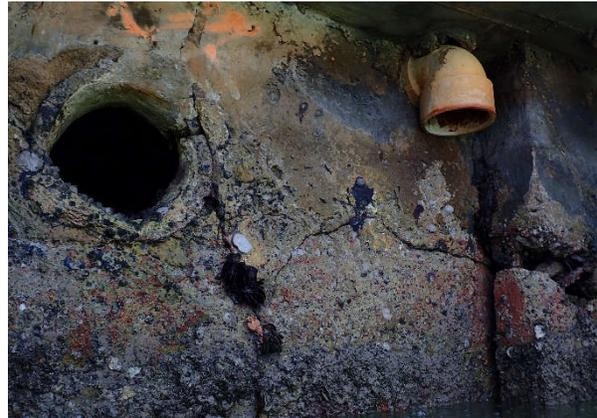
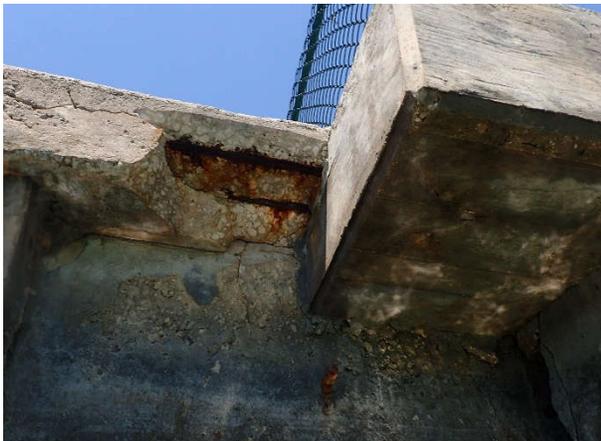
Property Address: 9481 E BAY HARBOR DR  
Bay Harbor Islands, FL 33154  
Location: S-1.1 Lot#44  
Date of Inspection: 4/26/2018 @ 12:20pm

- Cap – Moderate cracking and concrete erosion
- Cap – Spalling with exposed reinforcement
- Wall Panels – Severe rotation and cracking along panels
- T-Piles – Severe deterioration at splash zone
- Dock – Deck demolished
- Upland depressions along wall

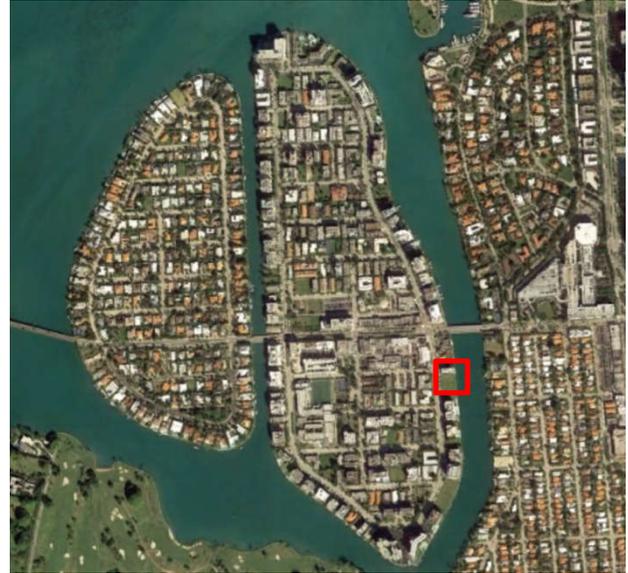
• Seawall Rating: Poor      • Dock Rating: N/A

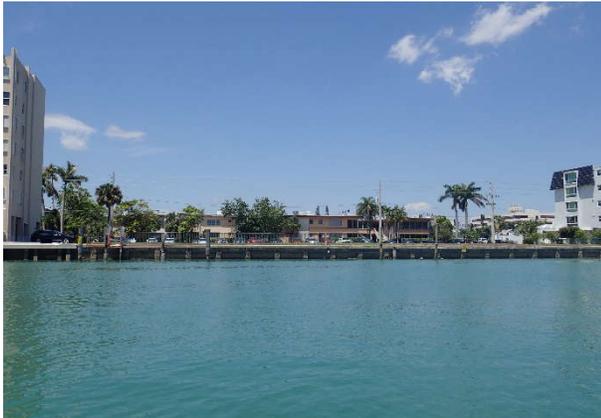
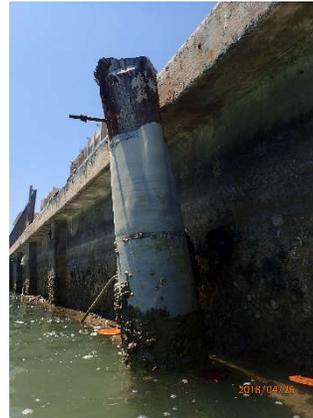
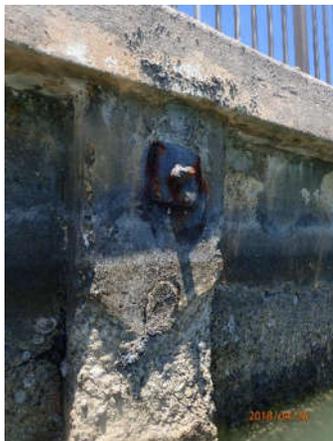
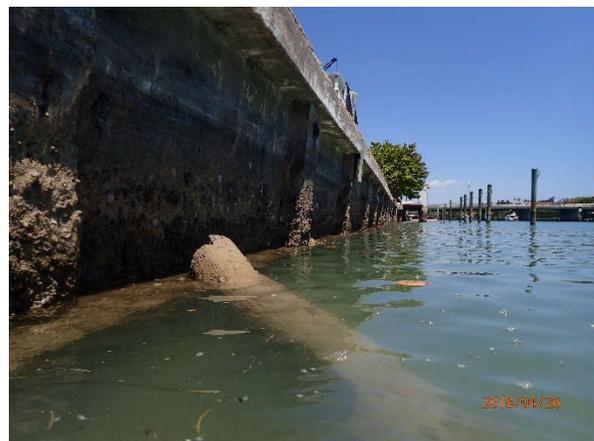
Property Address: 9461 E BAY HARBOR DR  
Bay Harbor Islands, FL 33154  
Location: S-1.1 Lot#45  
Date of Inspection: 4/26/2018 @ 12:20pm

- Cap – Moderate cracking and concrete erosion
- Cap – Spalling with exposed reinforcement
- Wall Panels – Severe rotation and cracking along panels
- T-Piles – Severe deterioration at splash zone
- Dock – Deck demolished
- Upland depressions along wall

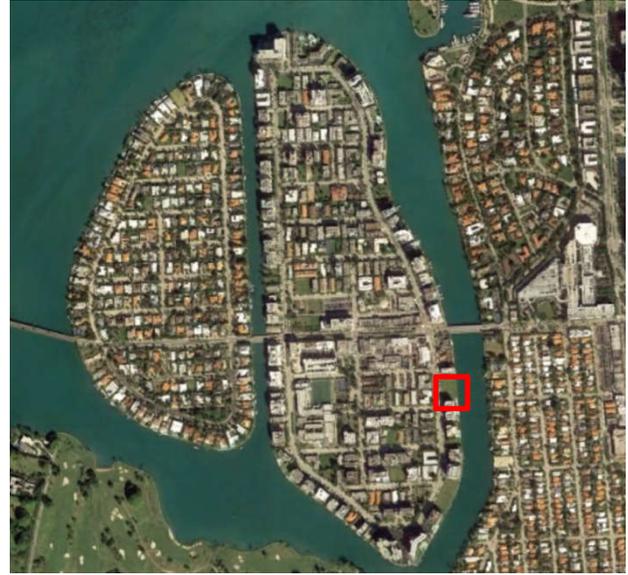
• Seawall Rating: Poor      • Dock Rating: N/A

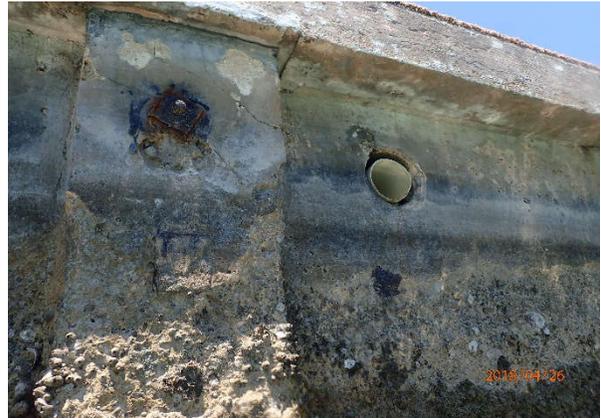
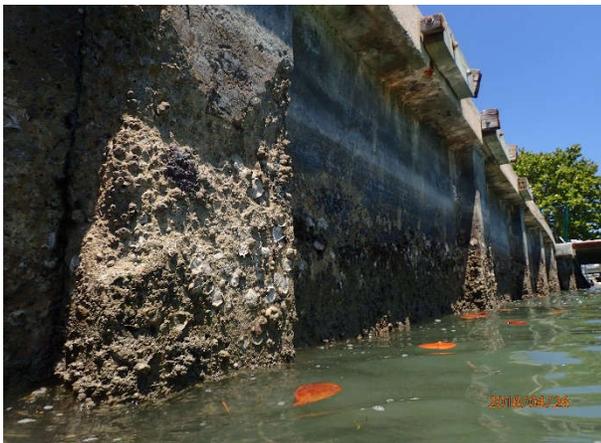
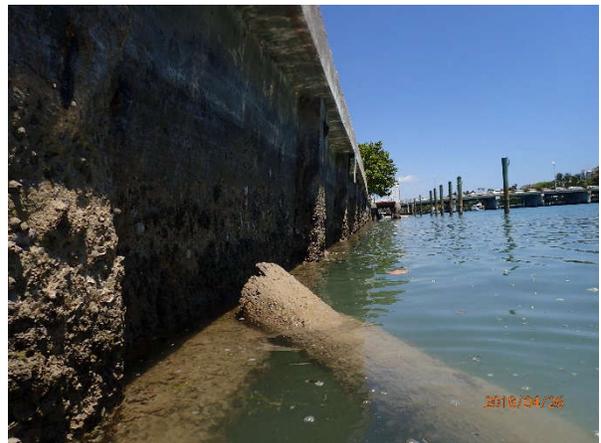
Property Address: 9431 E BAY HARBOR DR  
Bay Harbor Islands, FL 33154  
Location: S-1.1 Lot#46  
Date of Inspection: 4/26/2018 @ 12:10pm

- Cap – Moderate cracking and concrete erosion
- Cap – Spalling with exposed reinforcement
- Wall Panels – Severe rotation and cracking along panels
- T-Piles – Severe deterioration at splash zone
- Dock – Severe deterioration at dock framing
- Dock – Severe deterioration at dock piles
- Upland depressions along wall

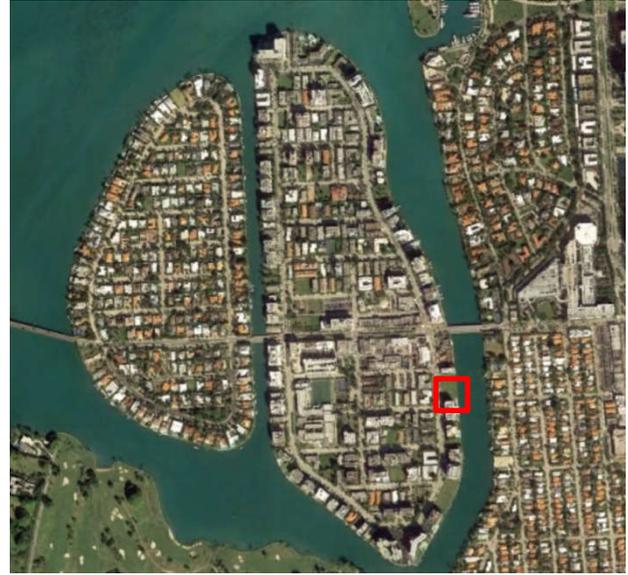
• Seawall Rating: Poor      • Dock Rating: Serious

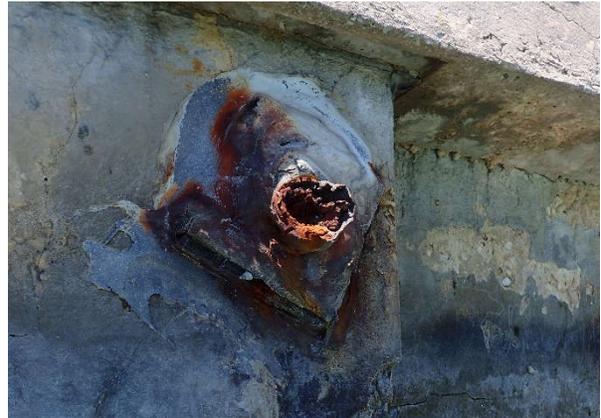
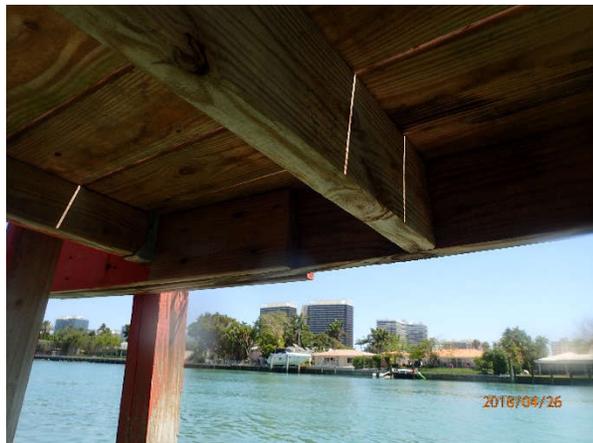
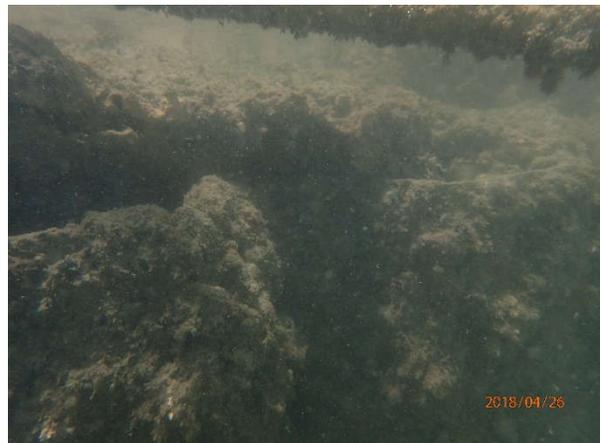
Property Address: 9381 E BAY HARBOR DR  
Bay Harbor Islands, FL 33154  
Location: S-1.1 Lot#47  
Date of Inspection: 4/26/2018 @ 12:00pm

- Wall Panels – Moderate concrete erosion
- T-Piles – Severe necking and concrete erosion
- T-Piles – Pile panel separation with sediment washout
- Dock – Severe corrosion at fasteners
- Dock – Missing decking and splitting at beams
- Dock – Collapsed beam

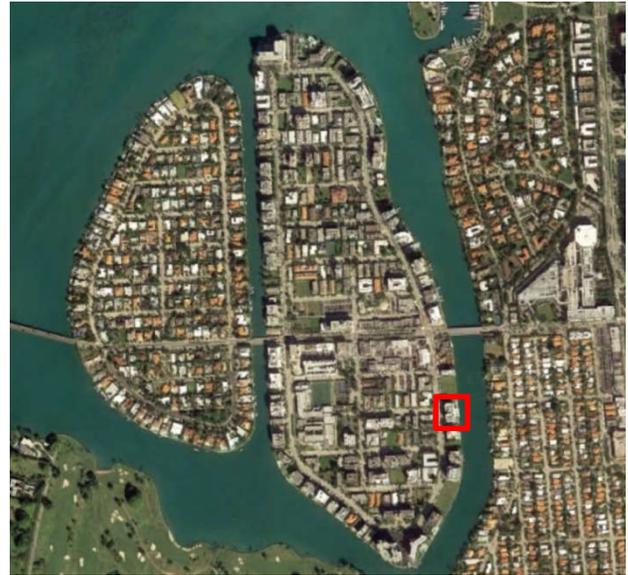
• Seawall Rating: Poor                  • Dock Rating: Critical
