# Seawall Condition and Resiliency Assessment Town of Bay Harbor Islands

October 2019 (Updated)

**Cummins Cederberg, Inc.**

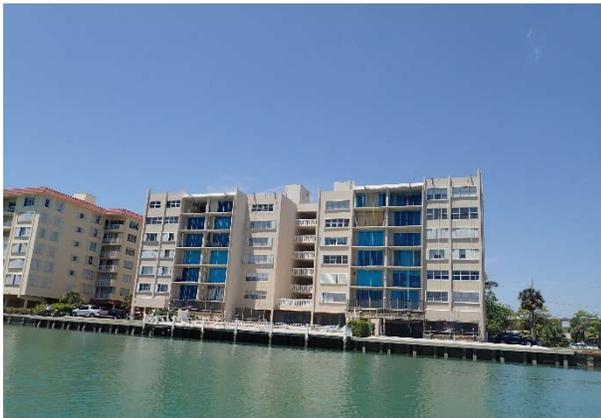
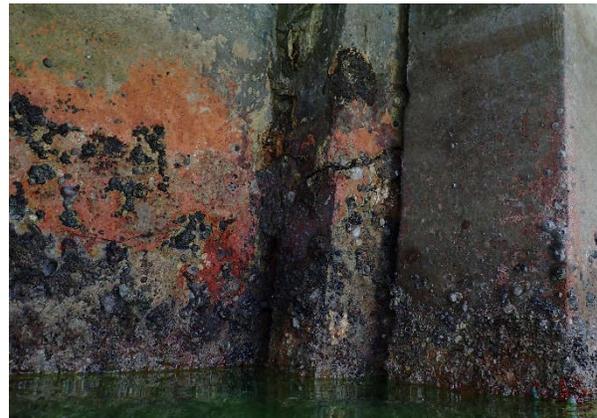
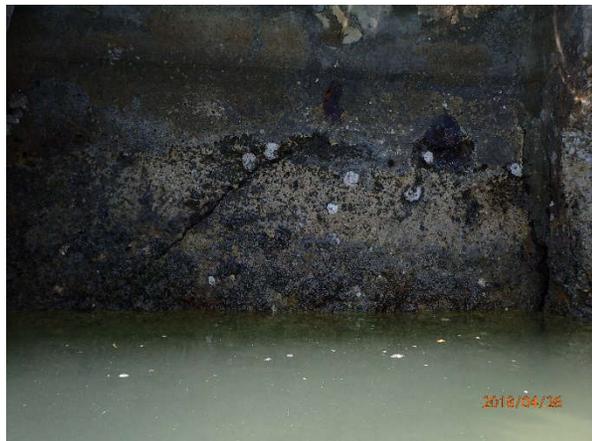
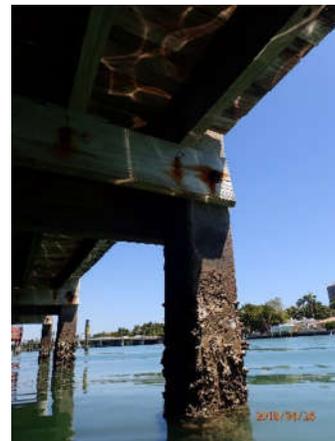
Property Address: 9341 E BAY HARBOR DR  
Bay Harbor Islands, FL 33154  
Location: S-1.1 Lot#48  
Date of Inspection: 4/26/2018 @ 11:50am

- Cap – Moderate cracking at soffit and wet face
- Wall Panels – Undermining and cracking at footing
- Wall Panels – Spalling adjacent to outfall
- King Piles – Moderate concrete erosion and necking
- Dock – Fastener corrosion

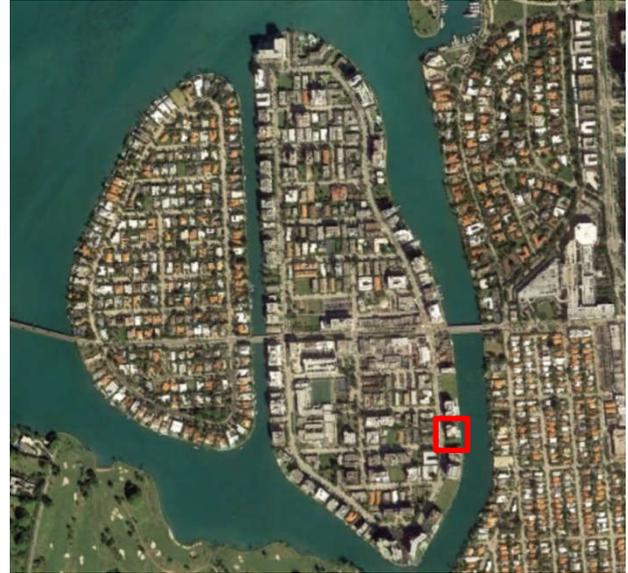
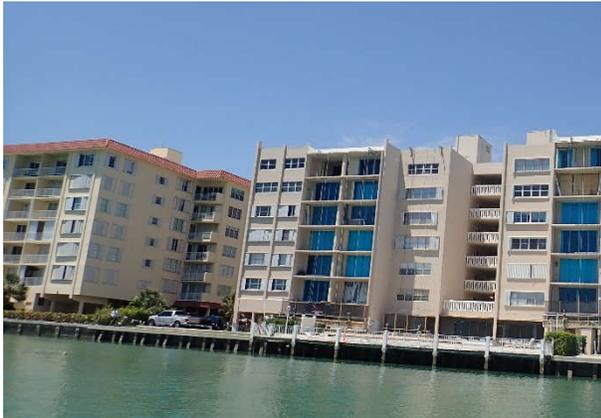
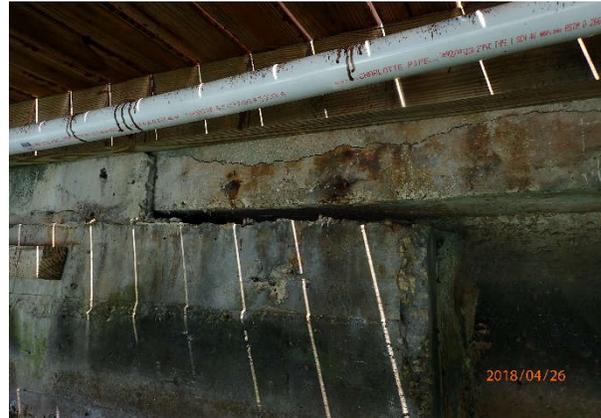
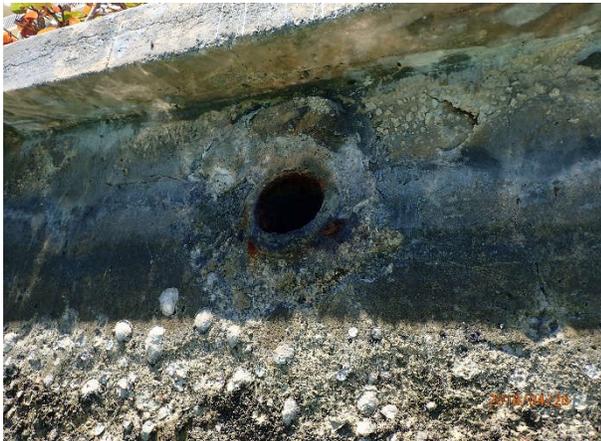
• Seawall Rating: Fair                  • Dock Rating: Satisfactory

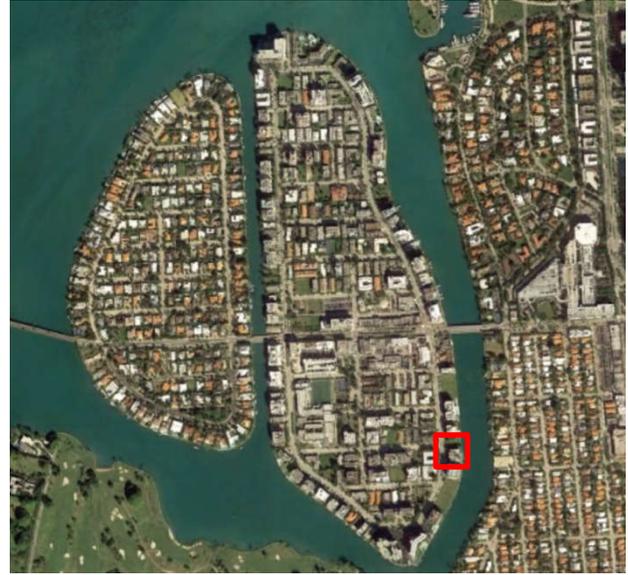
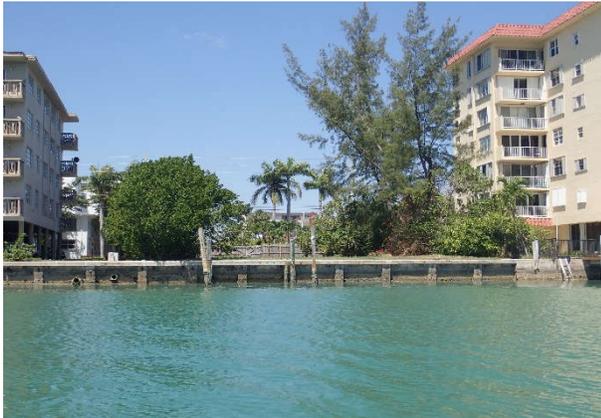
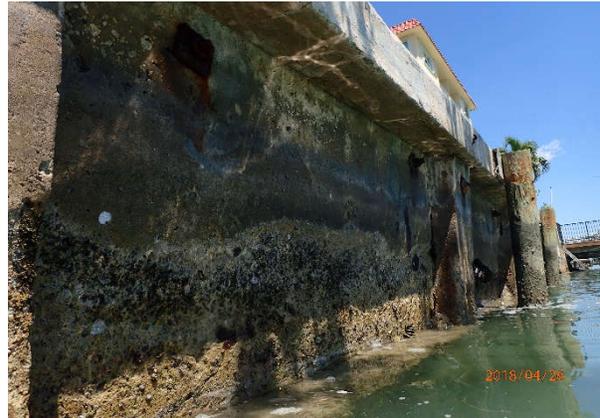
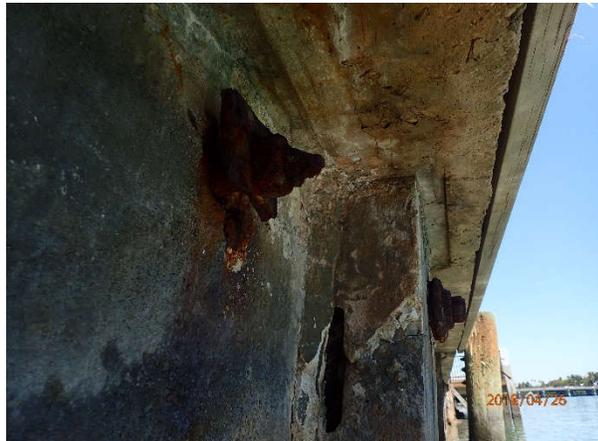
Property Address: 9301 E BAY HARBOR DR  
Bay Harbor Islands, FL 33154  
Location: S-1.1 Lot#49  
Date of Inspection: 4/26/2018 @ 11:40am

- Cap – Moderate cracking with exposed steel reinforcement
- Wall Panels – Moderate to severe wall rotation
- Wall Panels – Moderate concrete erosion at tidal zone
- T-Piles – Moderate concrete erosion at tidal zone
- Dock – Deck demolished, mooring pile deterioration and failure
- Upland depressions along South wall

• Seawall Rating: Poor                  • Dock Rating: N/A

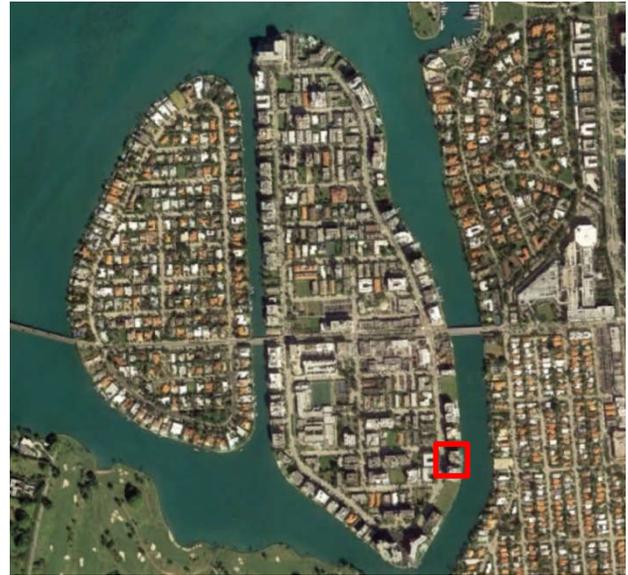
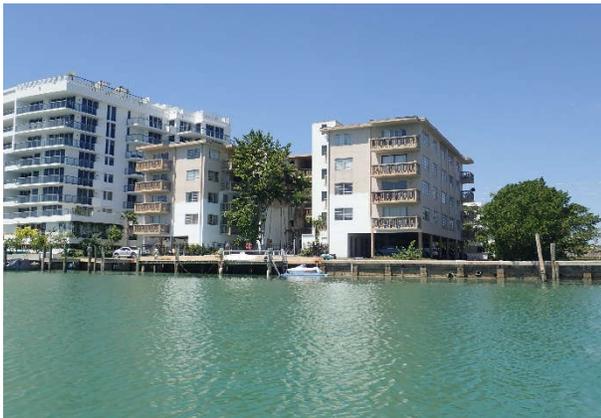
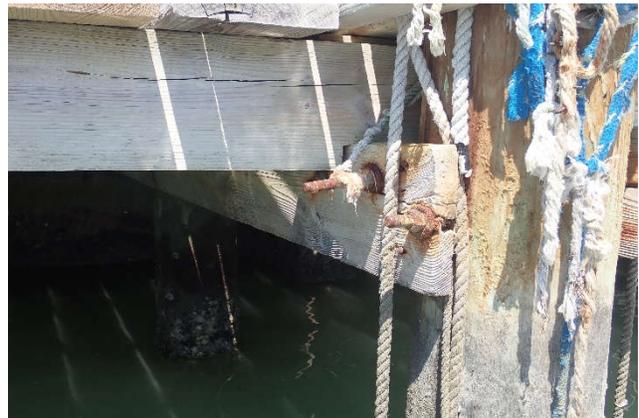
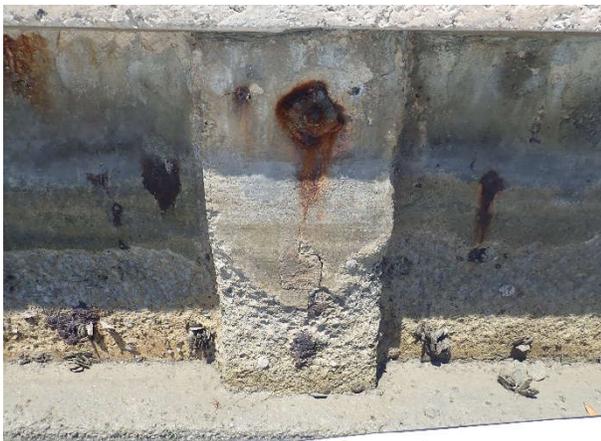
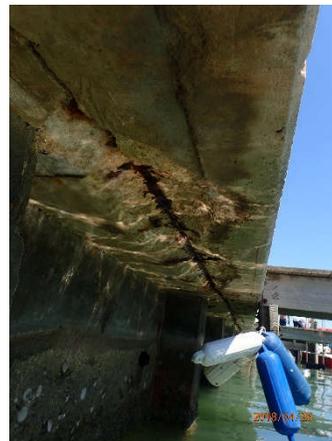
Property Address: 9291 E BAY HARBOR DR  
Bay Harbor Islands, FL 33154  
Location: S-1.1 Lot#50  
Date of Inspection: 4/26/2018 @ 11:30am

- Cap – Severe spalling along length of wall
- Cap – Moderate cracking at wet face North of dock
- Wall Panels – Severe diagonal cracking with moderate concrete erosion at tidal zone
- T-Piles – Severe corrosion at pile anchors
- Dock – Severe corrosion and rupture at fasteners, beams splitting at bolts

• Seawall Rating: Poor                  • Dock Rating: Serious

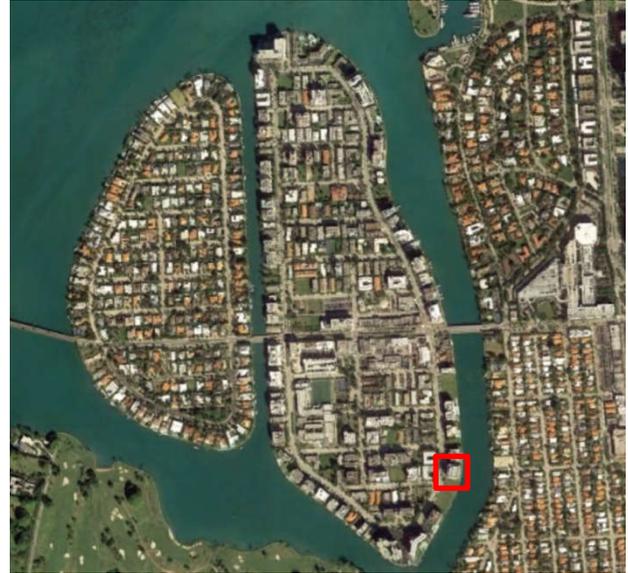
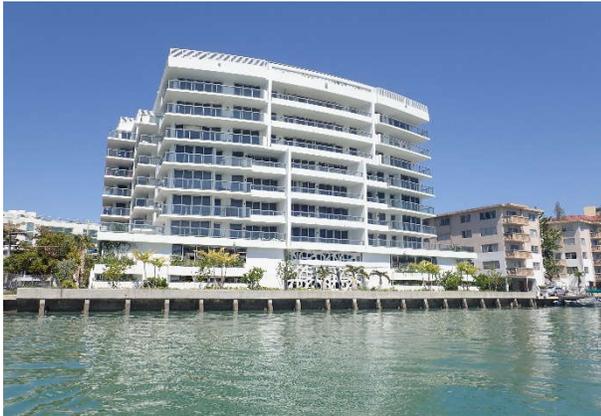
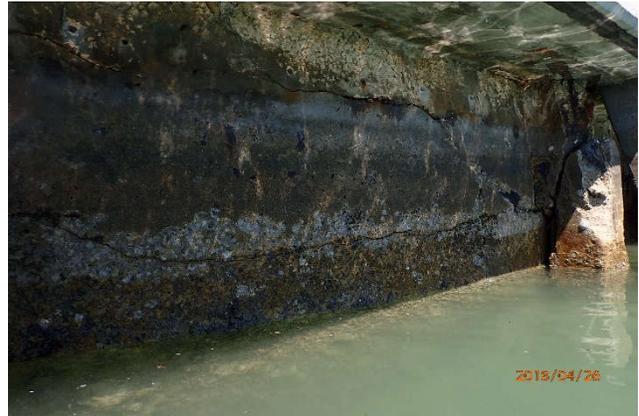
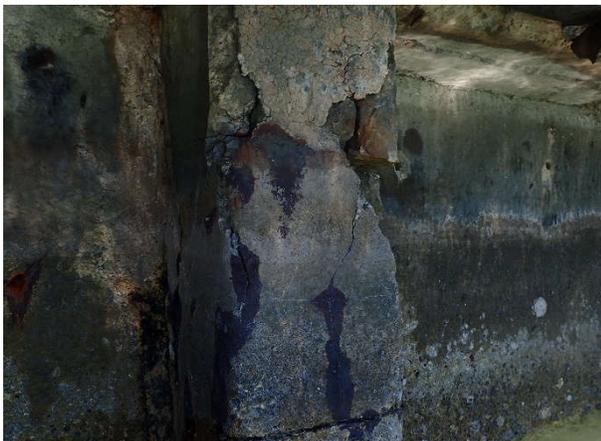
Property Address: 9261 E BAY HARBOR DR  
Bay Harbor Islands, FL 33154  
Location: S-1.1 Lot#51  
Date of Inspection: 4/26/2018 @ 11:20am

- Cap – Concrete overpour along cap with moderate cracking
- Wall Panels – Severe cracking and concrete erosion
- T-Piles – Moderate to severe cracking and necking
- T-Piles – Severe corrosion at anchors providing minimal support
- T-Piles – North end T-Piles necking and cracking causing snapping

• Seawall Rating: Critical                      • Dock Rating: N/A

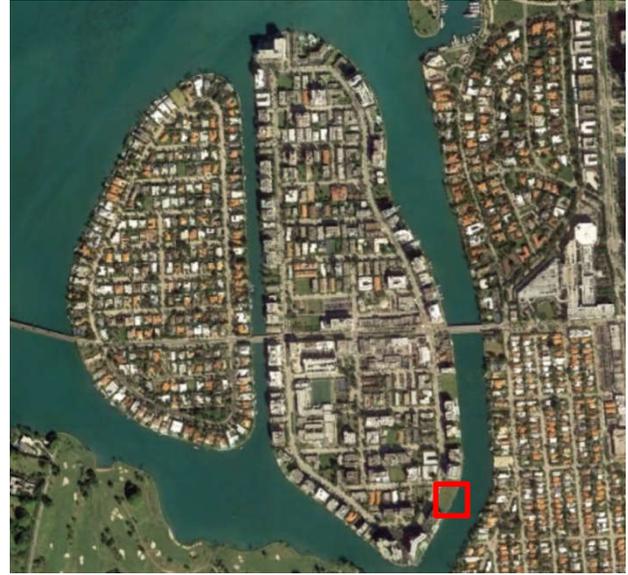
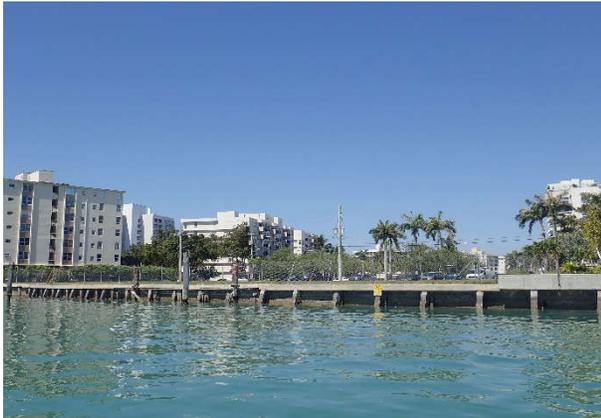
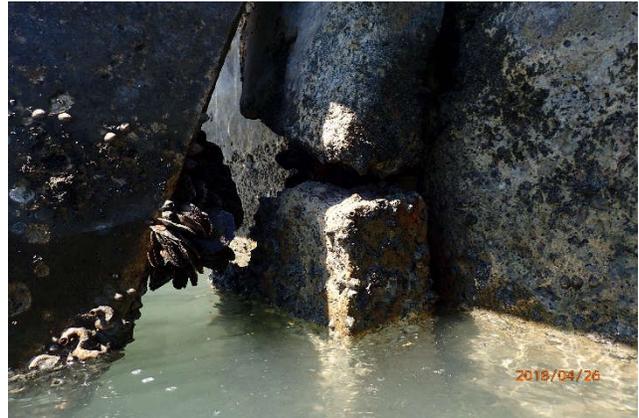
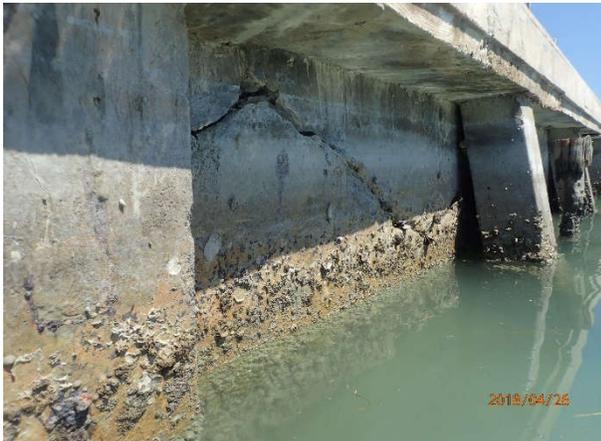
Property Address: 9201 E BAY HARBOR DR  
Bay Harbor Islands, FL 33154  
Location: S-1.1 Lot#52  
Date of Inspection: 4/26/2018 @ 11:00am

- \*Cap – Minor to moderate cracking and concrete erosion
- \*Wall Panels – Critical cracking with concrete erosion and rotation of wall
- \*King Piles – Critical fractures and flexural failure
- \*King Piles – Grouted fillets with re-cracking and failure
- \*Dock – Deck demolished

• Seawall Rating: Critical                      • Dock Rating: N/A

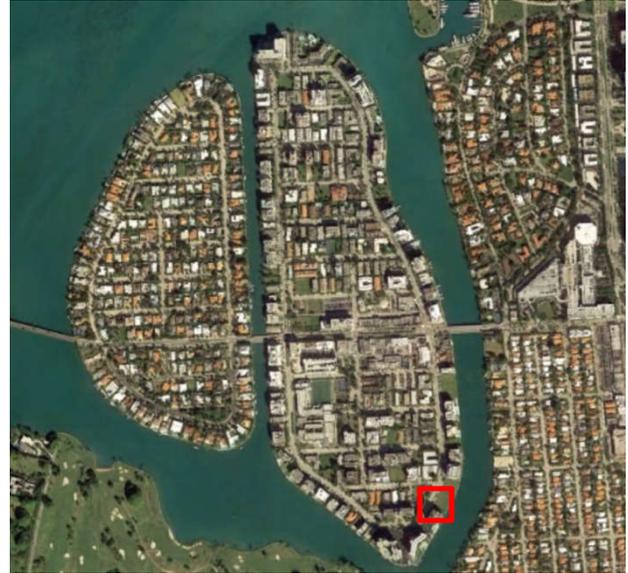
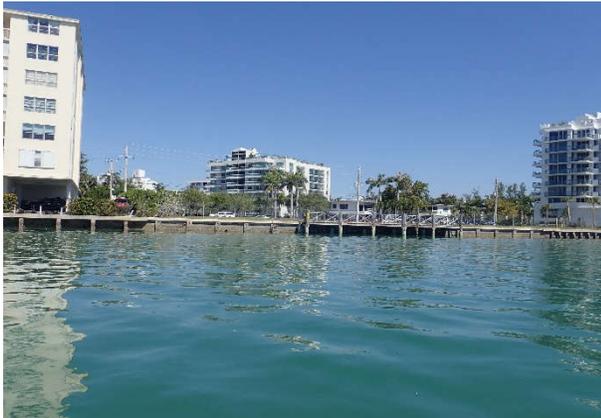
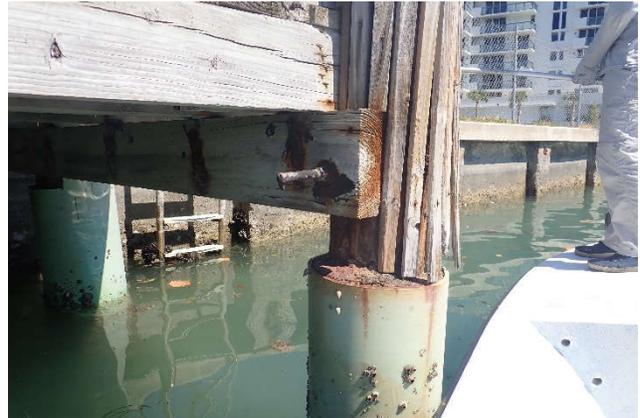
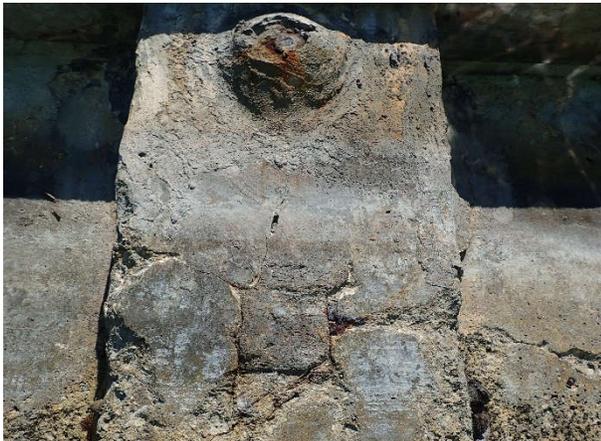
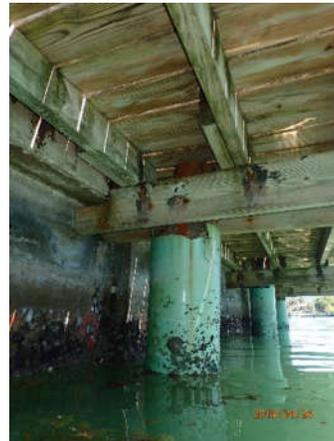
Property Address: 9161 E BAY HARBOR DR  
Bay Harbor Islands, FL 33154  
Location: S-1.1 Lot#53  
Date of Inspection: 4/26/2018 @ 10:50am

- \*Cap – Moderate cracking
- \*Wall Panels – Minor cracking and concrete erosion
- \*T-Piles – Moderate cracking and concrete erosion
- \*Dock – Severe corrosion at fasteners and straps
- \*Dock – Deterioration at piles

• Seawall Rating: Fair      • Dock Rating: Poor

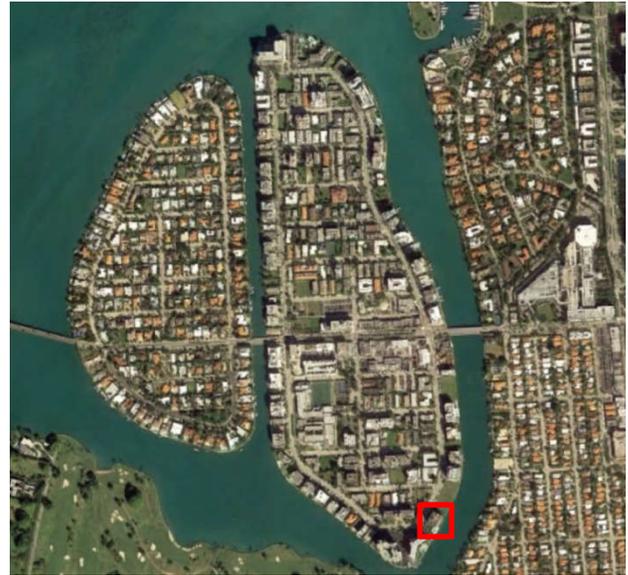
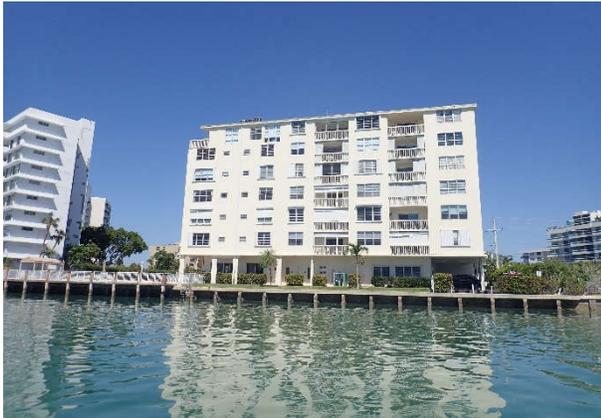
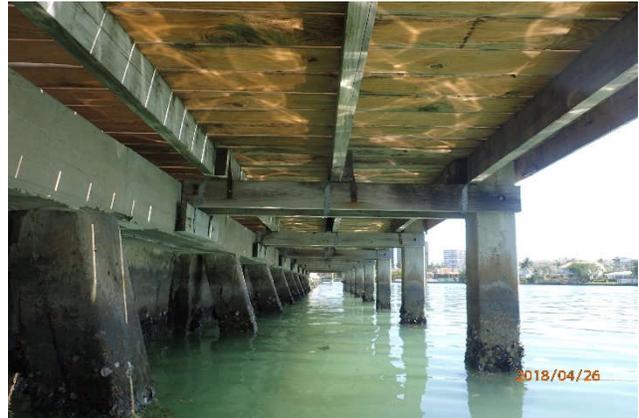
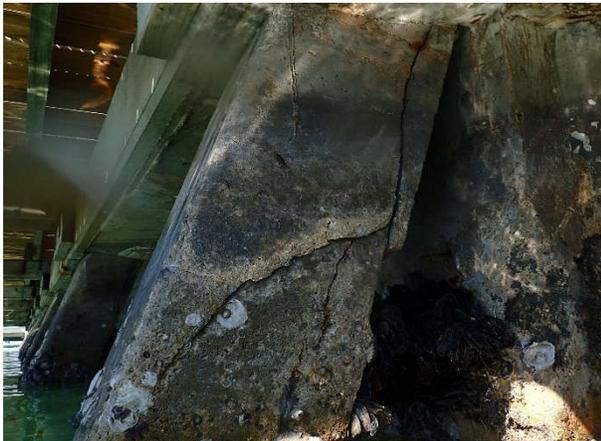
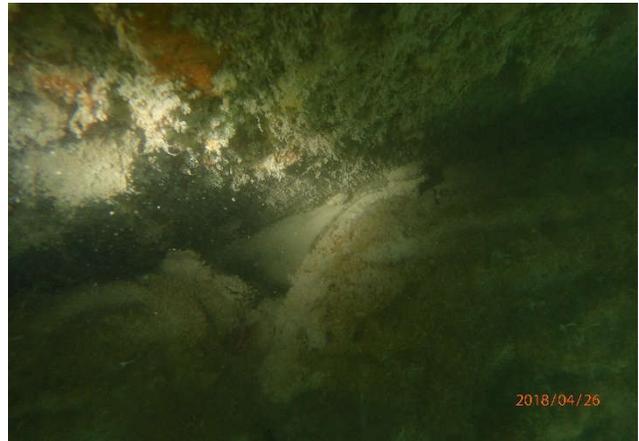
Property Address: 9111 E BAY HARBOR DR  
Bay Harbor Islands, FL 33154  
Location: S-1.1 Lot#54  
Date of Inspection: 4/26/2018 @ 10:30am

- Cap – Severe cracking and spalling along North wet face and soffit
- Wall Panels – Moderate to severe cracking mid-panels
- Wall Panels – Moderate concrete erosion at tidal zone
- T-Piles – Necking at tidal zones
- Batter Piles – Severe cracking
- Dock – Minor erosion of piles in tidal zones
- Dock – Fastener corrosion

• Seawall Rating: Poor                      • Dock Rating: Fair

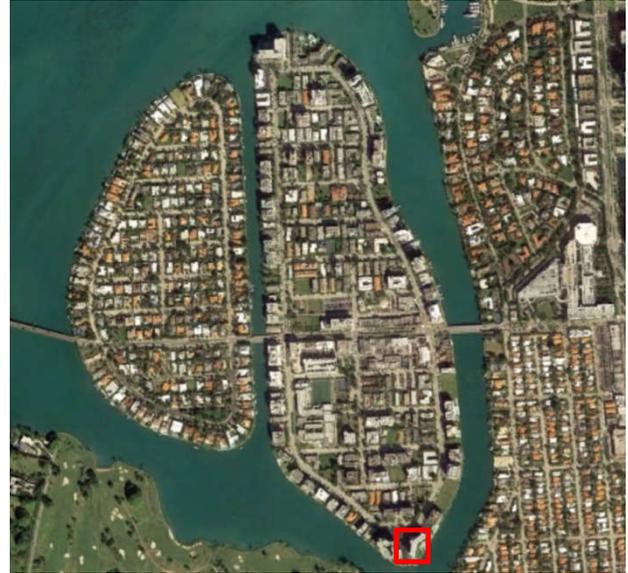
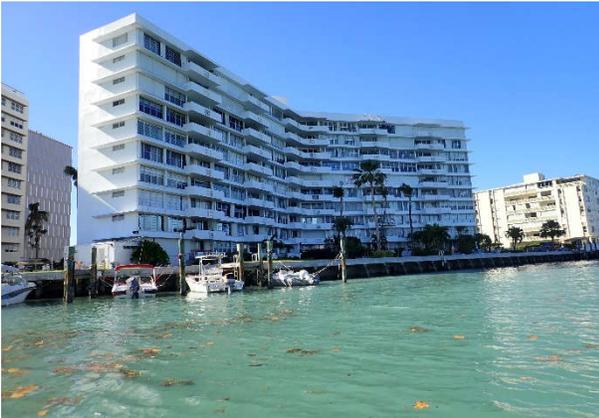
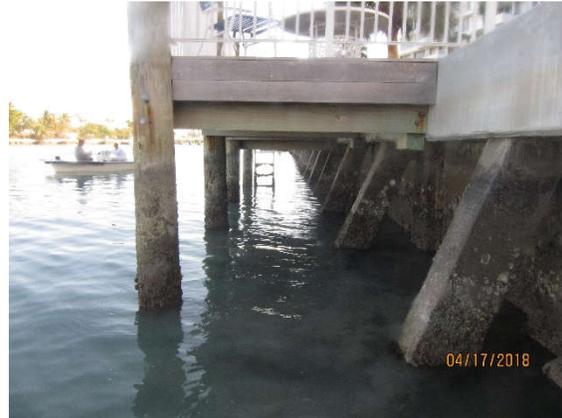
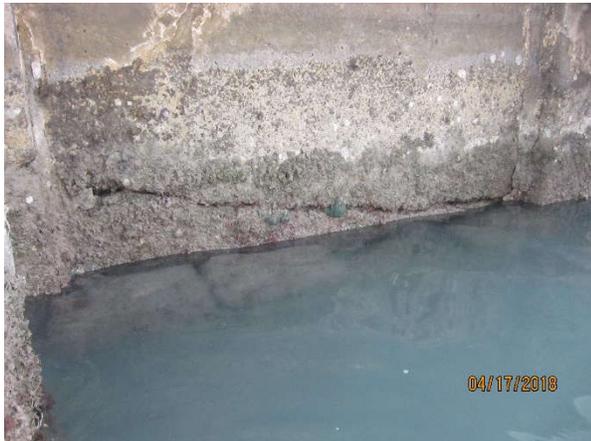
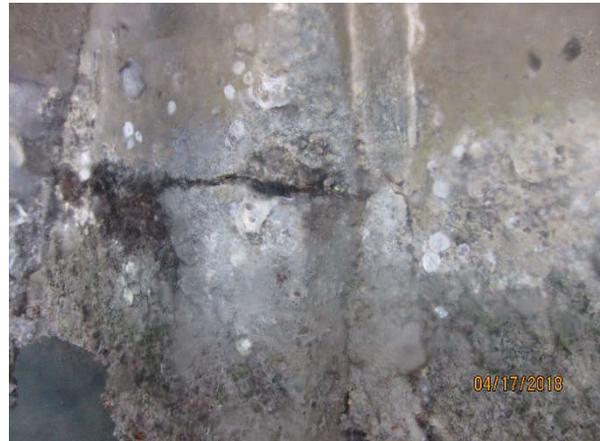
Property Address: 9101 E BAY HARBOR DR  
Bay Harbor Islands, FL 33154  
Location: S-1.1 Lot#55  
Date of Inspection: 4/17/2018 @ 5:05pm

- Wall Panels – Moderate cracking along panels
- T-Piles – Moderate corrosion and deterioration at anchors
- T-Piles – Flexural cracking at piles

• Seawall Rating: Poor                  • Dock Rating: Satisfactory

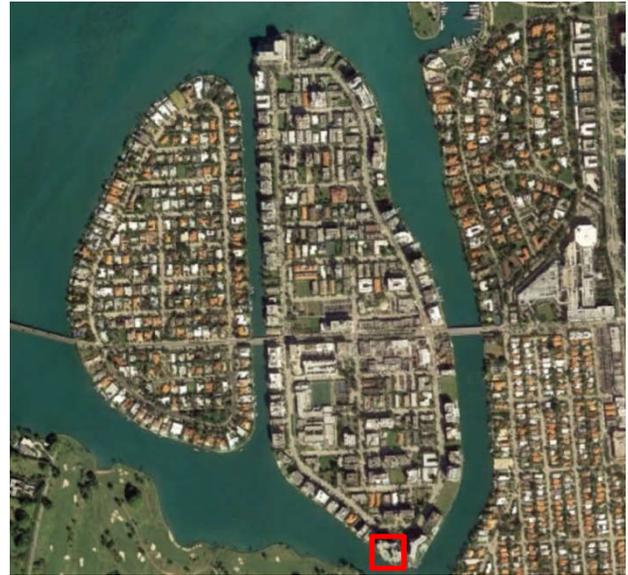
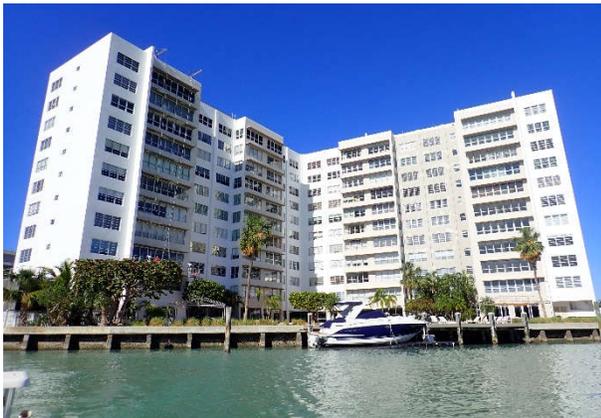
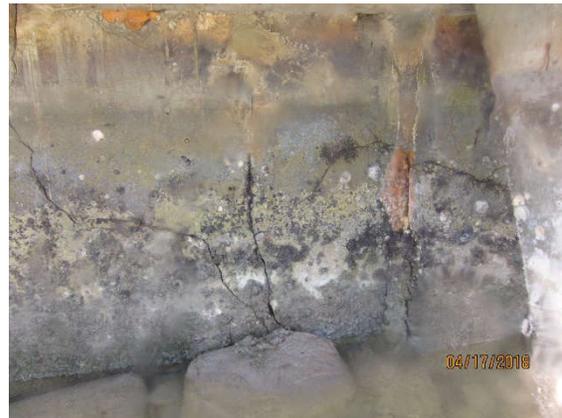
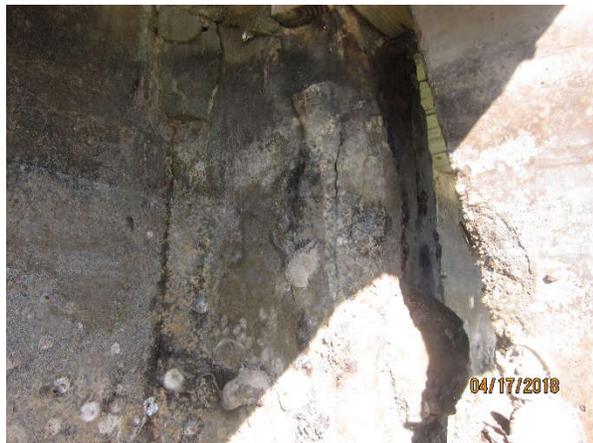
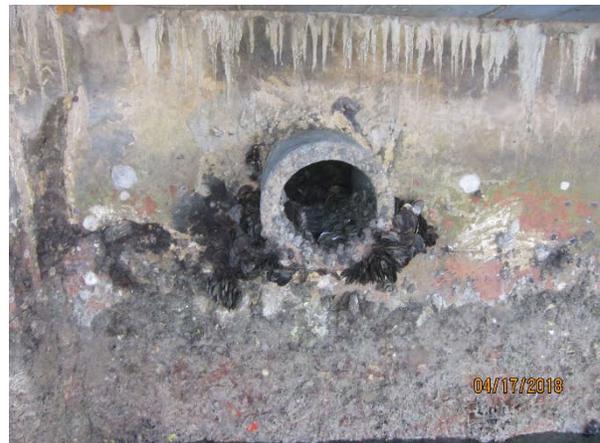
- Wall Panels – Moderate cracking throughout panels
- T-Piles – Moderate deterioration with sediment accumulation through fillets at seabed
- Batter Piles – Moderate cracking
- Dock – Failed boat lift
- Dock – Corrosion staining on concrete

• Seawall Rating: Poor                      • Dock Rating: Fair

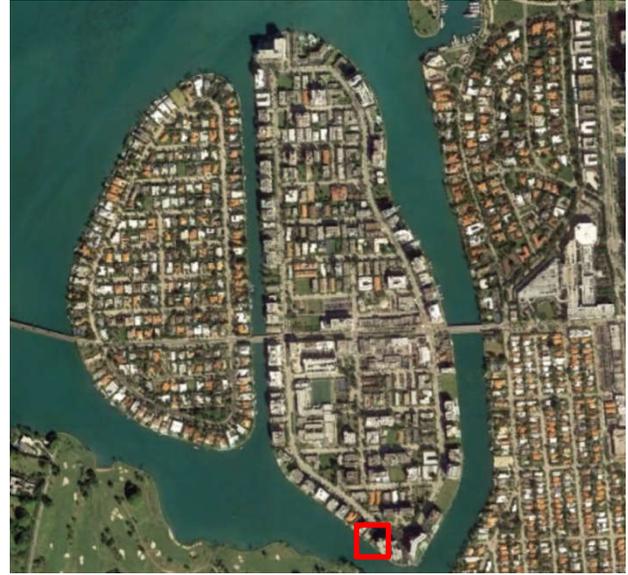
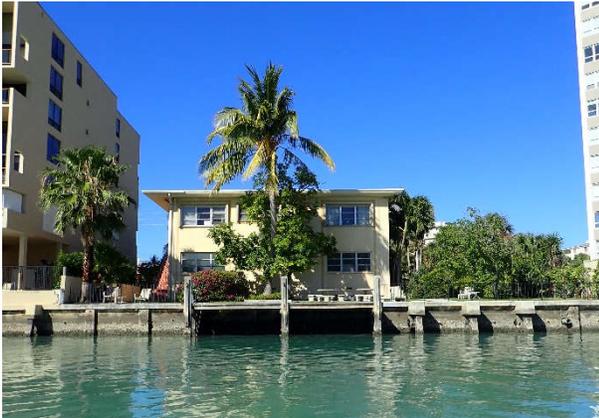
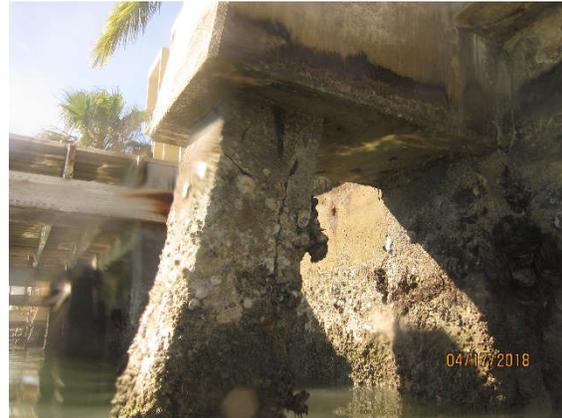
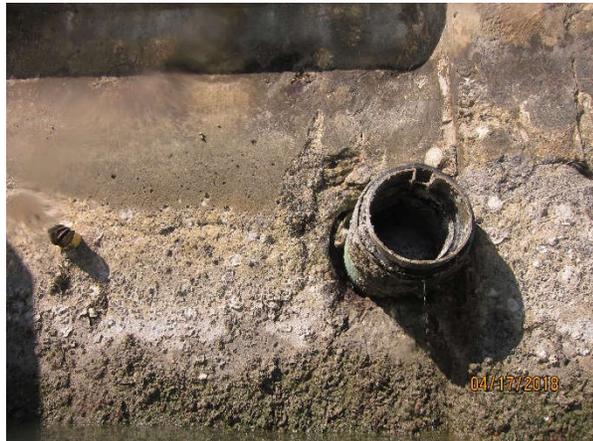
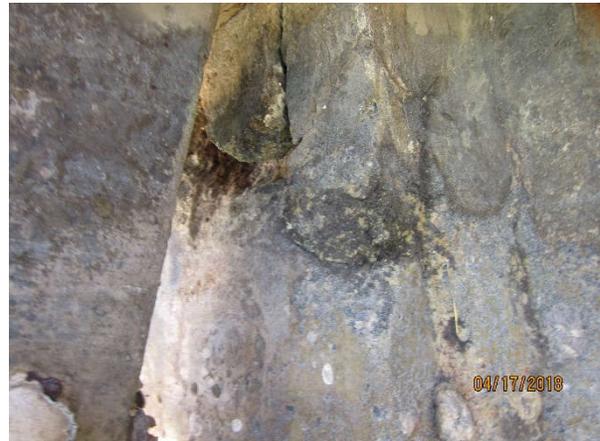
Property Address: 9110 W BAY HARBOR DR  
Bay Harbor Islands, FL 33154  
Location: S-1.1 Lot#57  
Date of Inspection: 4/17/2018 @ 4:55pm

- Wall Panels – Moderate concrete erosion at tidal zone
- Batter Piles – Moderate cracking and deterioration

- Seawall Rating: Poor
- Dock Rating: Satisfactory

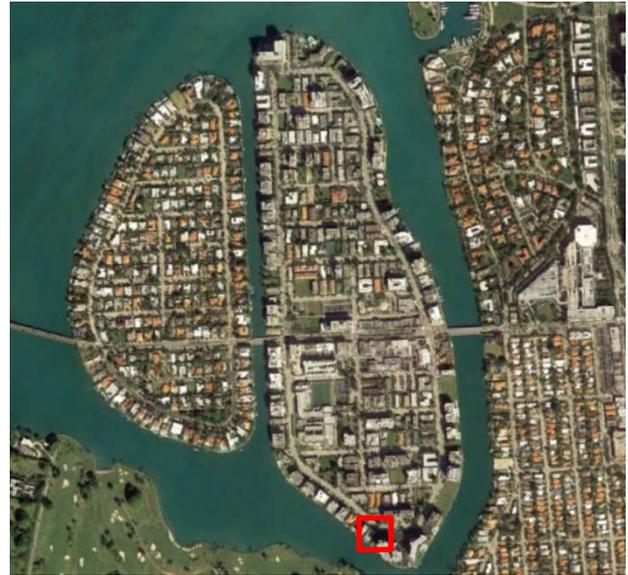
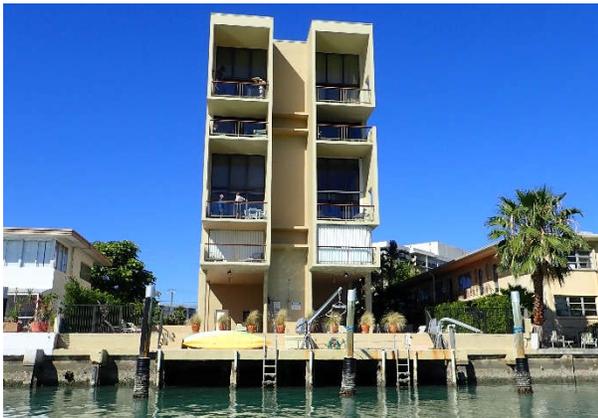
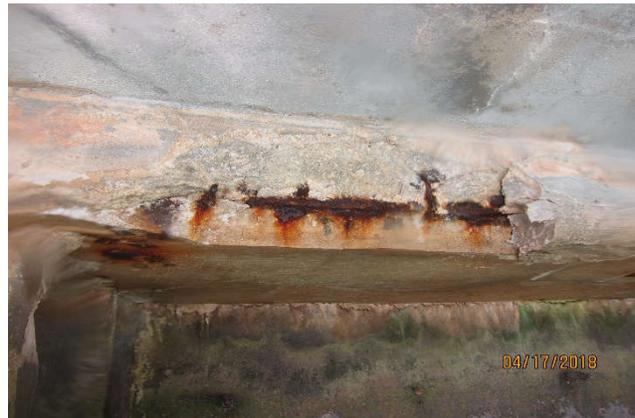
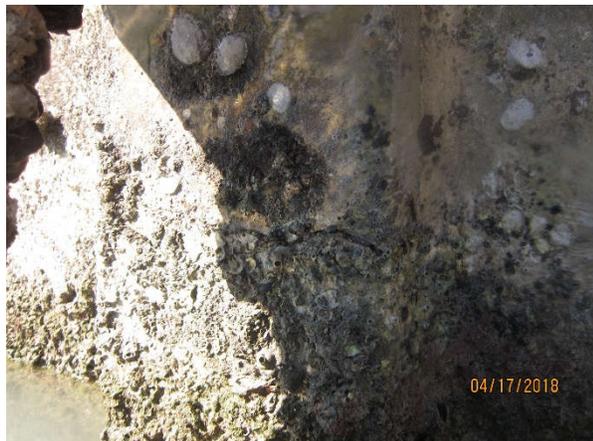
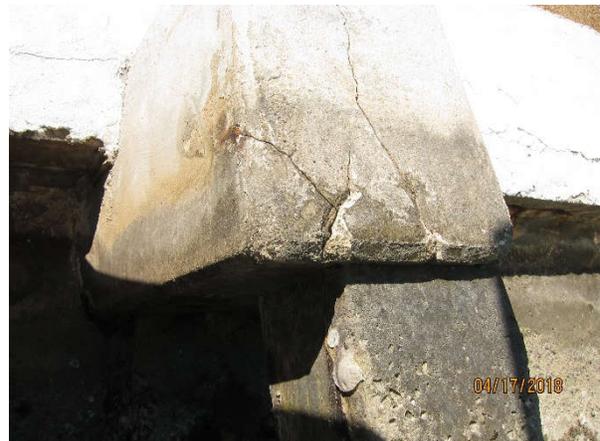
Property Address: 9120 W BAY HARBOR DR  
Bay Harbor Islands, FL 33154  
Location: S-1.1 Lot#58  
Date of Inspection: 4/17/2018 @ 4:50pm

- Cap – Severe spalling with exposed steel reinforcement
- Wall Panels – Moderate cracking and concrete erosion
- Dock – Spalling at beams

• Seawall Rating: Poor      • Dock Rating: Poor

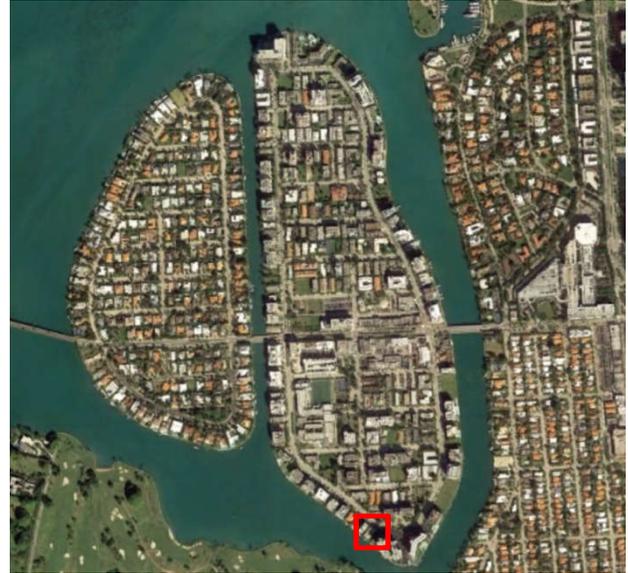
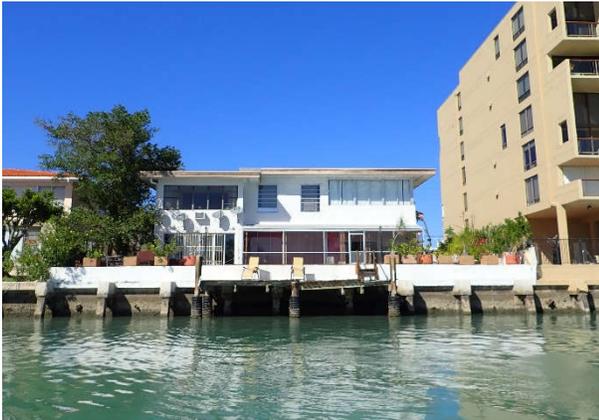
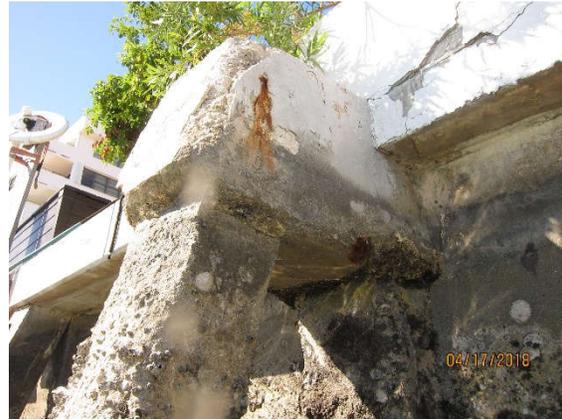
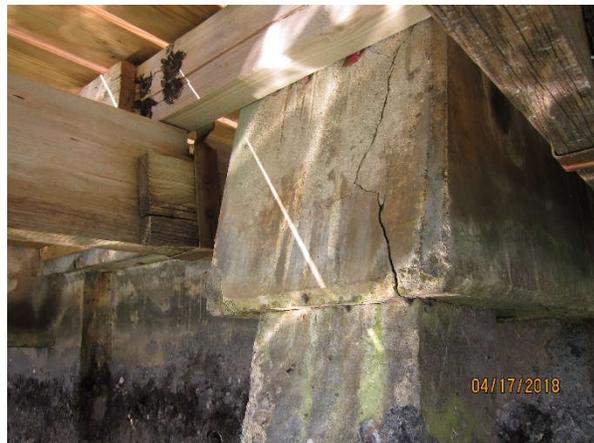
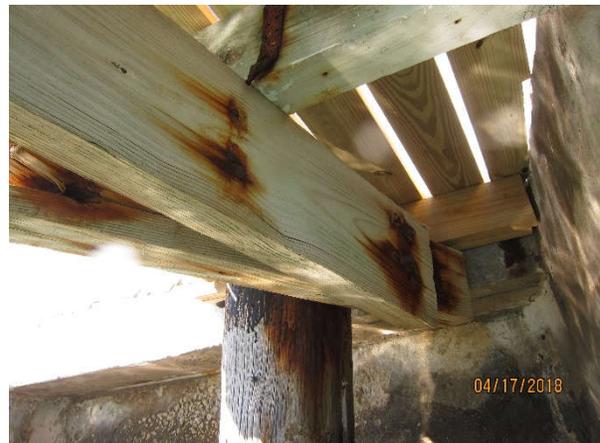
Property Address: 9140 W BAY HARBOR DR  
Bay Harbor Islands, FL 33154  
Location: S-1.1 Lot#59  
Date of Inspection: 4/17/2018 @ 4:50pm

- Cap – Cracking and spalling
- Piles – Moderate cracking and deterioration
- Dock – Severe corrosion at fasteners and straps
- Dock – Wood splitting
- Dock – Unsupported beams

• Seawall Rating: Poor      • Dock Rating: Critical

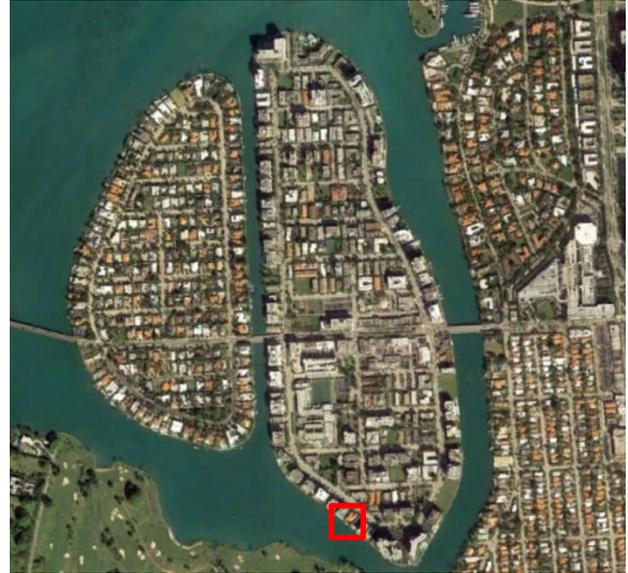
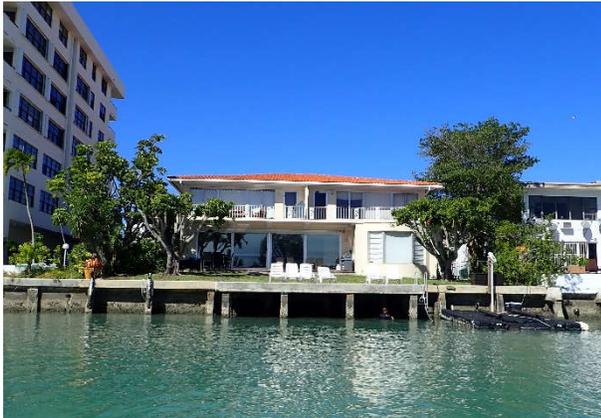
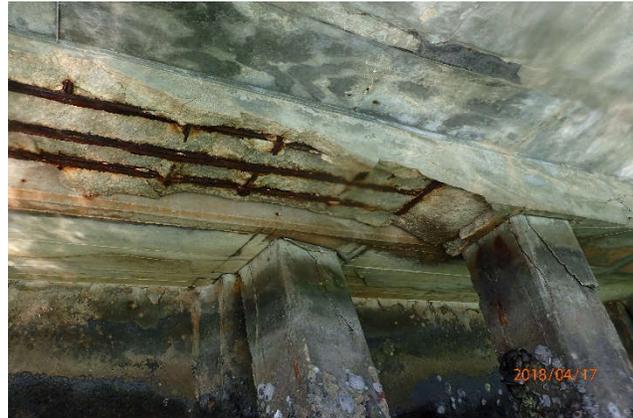
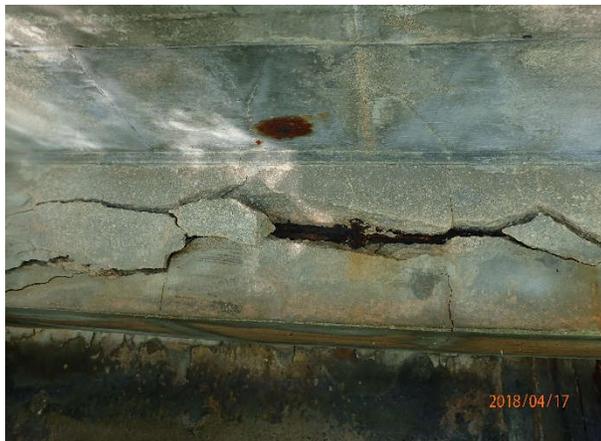
Property Address: 9160 W BAY HARBOR DR  
Bay Harbor Islands, FL 33154  
Location: S-1.1 Lot#60  
Date of Inspection: 4/17/2018 @ 4:45pm

- Cap – Moderate cracking along soffit
- T-Piles – Moderate cracking
- Batter Piles – Moderate cracking
- Dock – Severe cracking and spalling at slab at beams with exposed steel reinforcement
- Dock Piles – Advanced spalling

• Seawall Rating: Fair      • Dock Rating: Serious

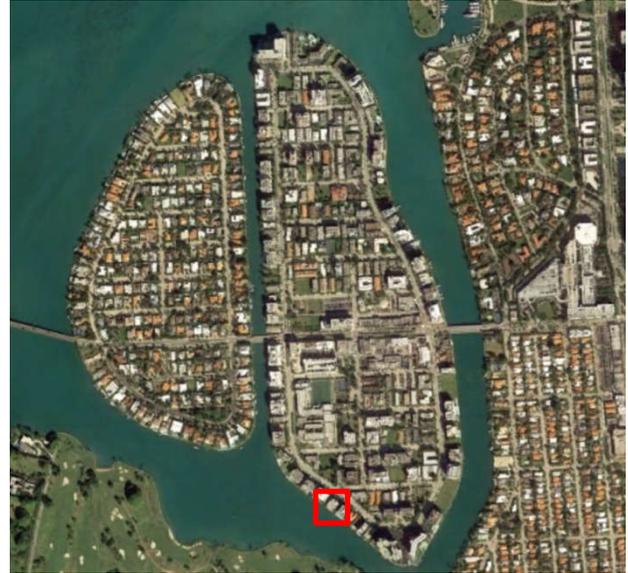
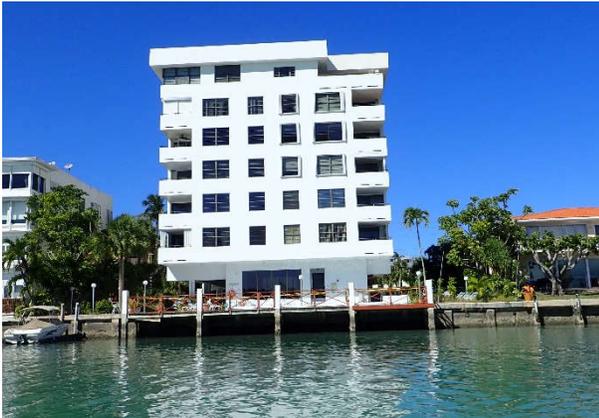
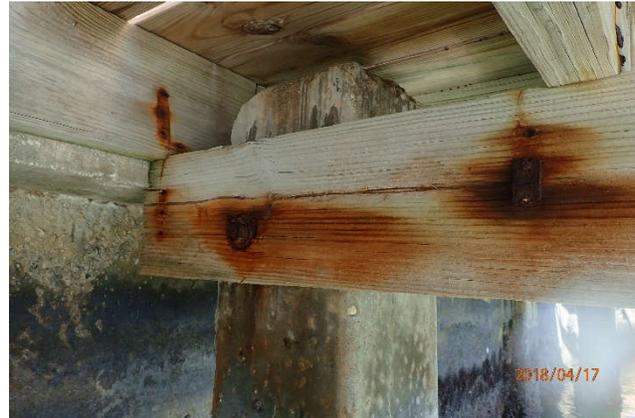
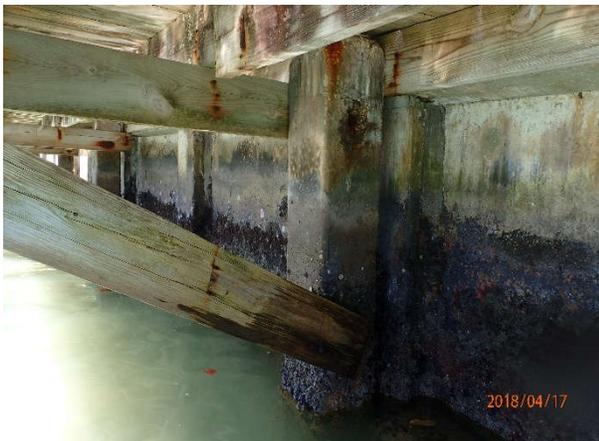
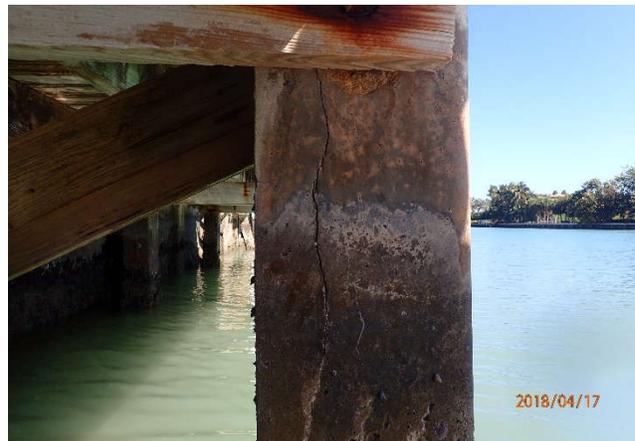
Property Address: 9180 W BAY HARBOR DR  
Bay Harbor Islands, FL 33154  
Location: S-1.1 Lot#61  
Date of Inspection: 4/17/2018 @ 4:40pm

- T-Piles – Moderate cracking
- Dock – Severe corrosion at fasteners
- Dock – Moderate to severe cracking at piles
- Dock – Collapsed beam
- Dock – Moderate to severe corrosion at fasteners and bolts

• Seawall Rating: Fair      • Dock Rating: Critical

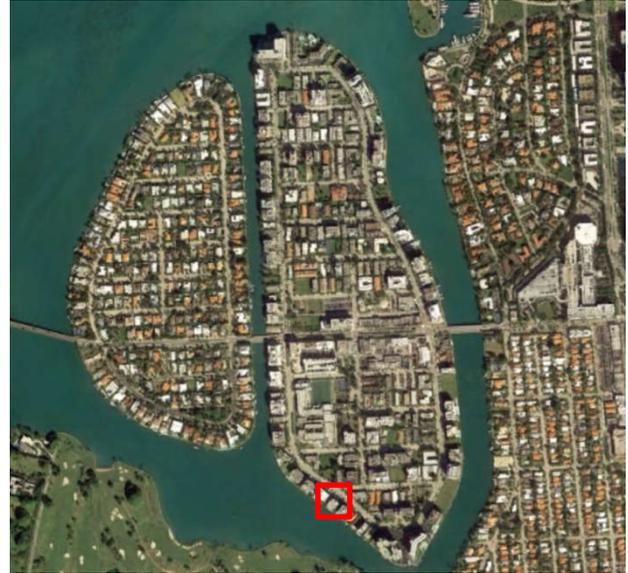
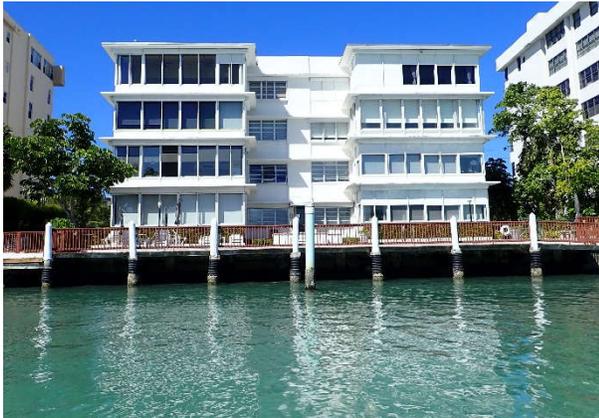
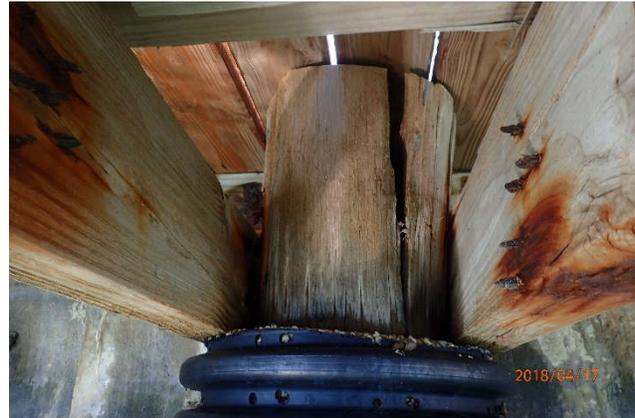
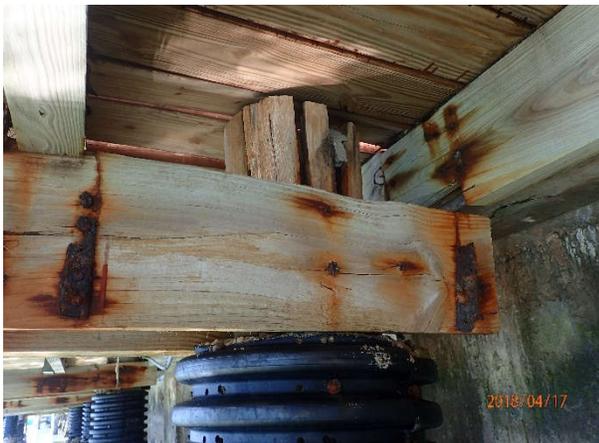
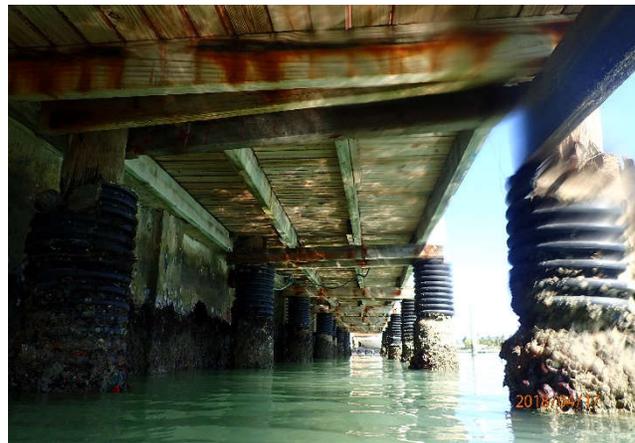
Property Address: 9200 W BAY HARBOR DR  
Bay Harbor Islands, FL 33154  
Location: S-1.1 Lot#62  
Date of Inspection: 4/17/2018 @ 4:35pm

- Cap – Moderate cracking at the soffit, spalling
- Wall Panels – Moderate concrete erosion
- T-Piles – Moderate concrete erosion
- Dock – Severe corrosion at fasteners, missing fasteners
- Dock – Splitting at beams and piles

• Seawall Rating: Fair      • Dock Rating: Serious
