# Seawall Condition and Resiliency Assessment Town of Bay Harbor Islands

October 2019 (Updated)

**Cummins Cederberg, Inc.**

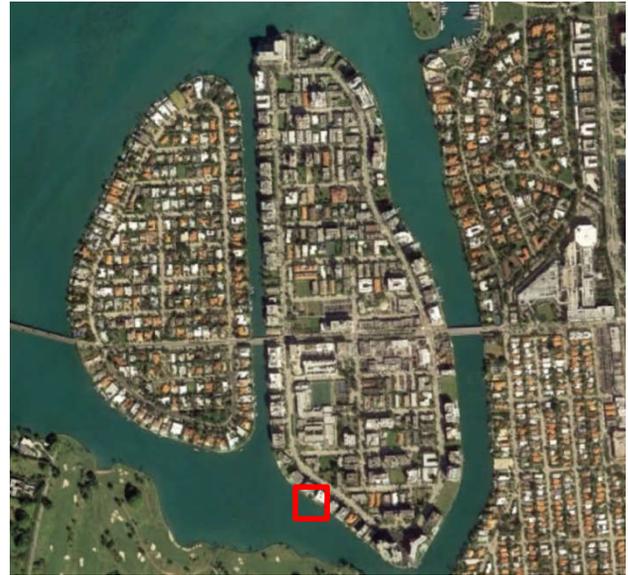
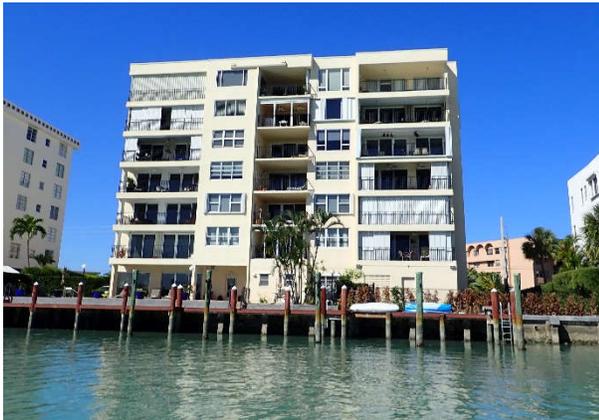
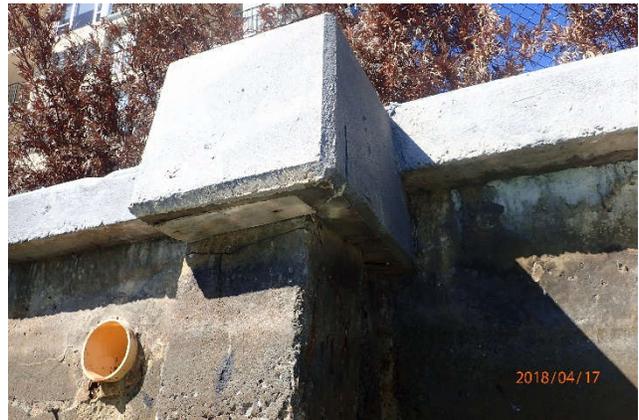
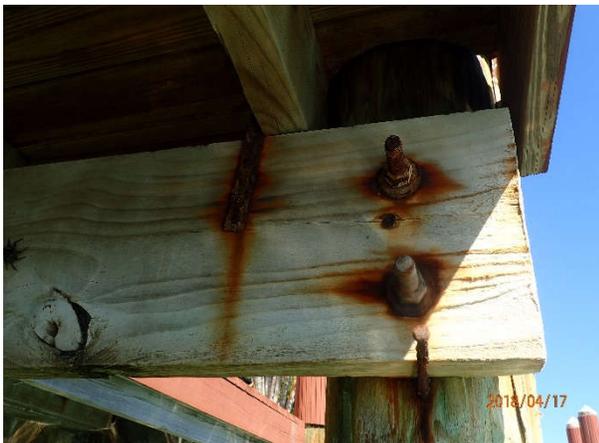
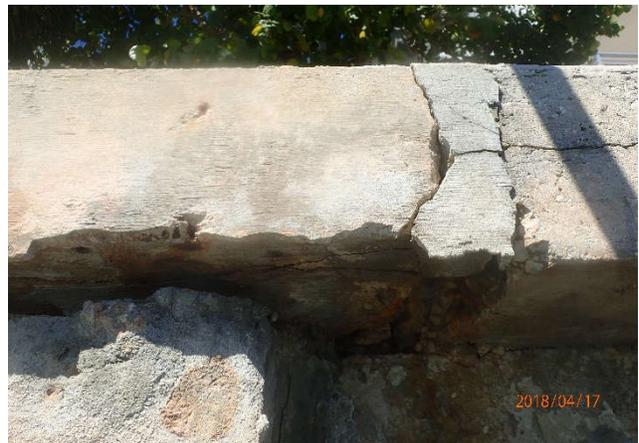
Property Address: 9240 W BAY HARBOR DR  
Bay Harbor Islands, FL 33154  
Location: S-1.1 Lot#63  
Date of Inspection: 4/17/2018 @ 4:30pm

- Wall Panels – Moderate spalling and cracking
- T-Piles – Moderate cracking
- Batter Piles – Moderate cracking
- Dock – Moderate corrosion at fasteners

• Seawall Rating: Fair      • Dock Rating: Fair

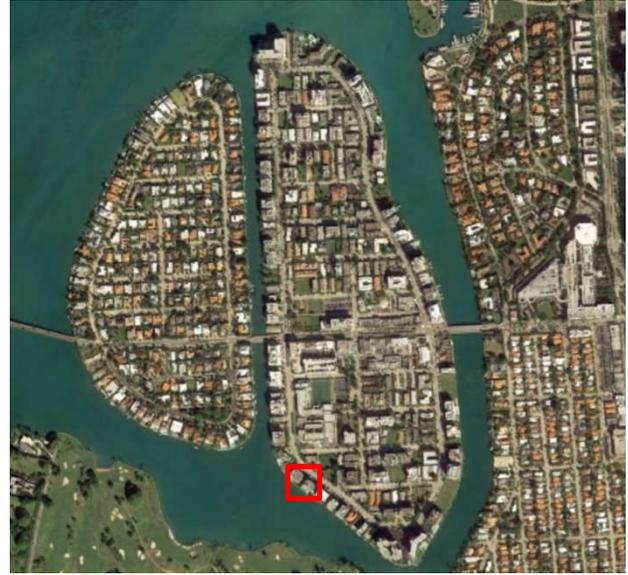
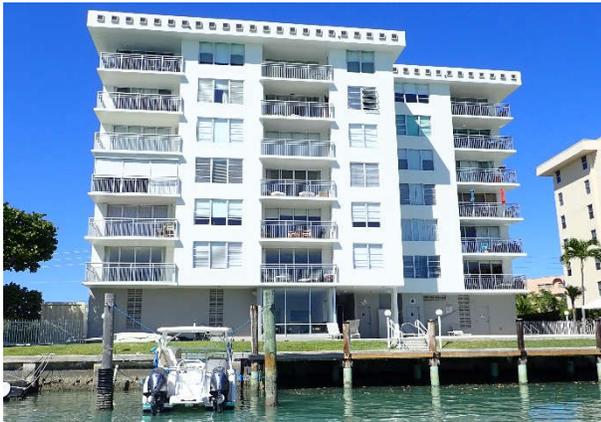
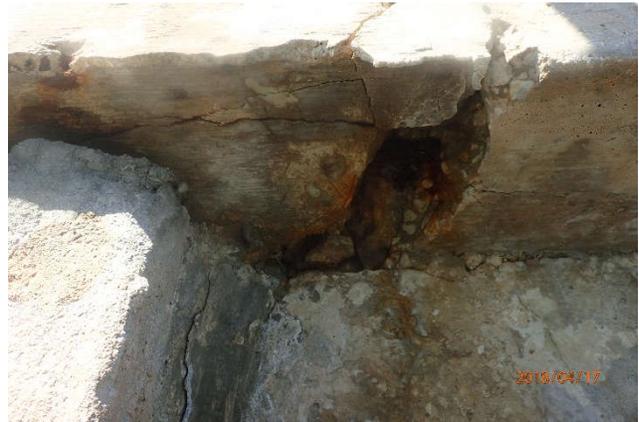
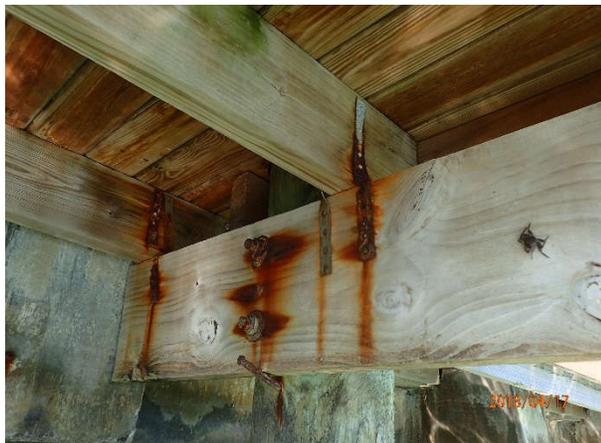
- Cap – Cracking and spalling at wet face and soffit
- Wall Panels – Moderate cracking
- T-Piles – Moderate cracking
- Batter Piles – Cracking
- Dock – Advanced corrosion at fasteners, missing fasteners
- Dock – Wood splitting, wood decay

• Seawall Rating: Poor                      • Dock Rating: Poor

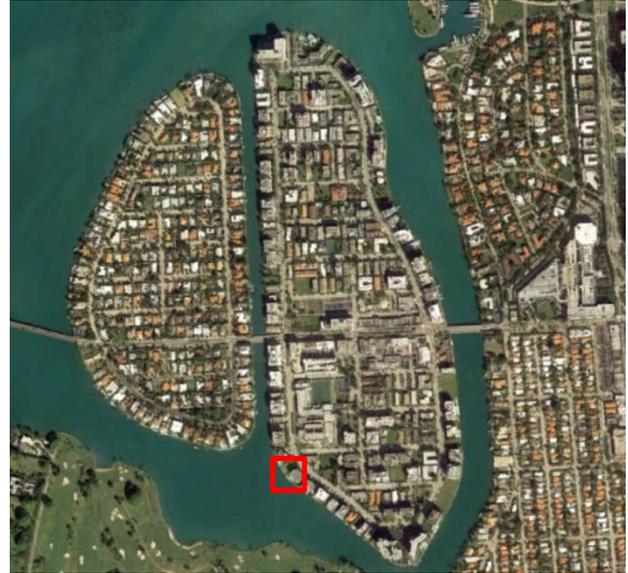
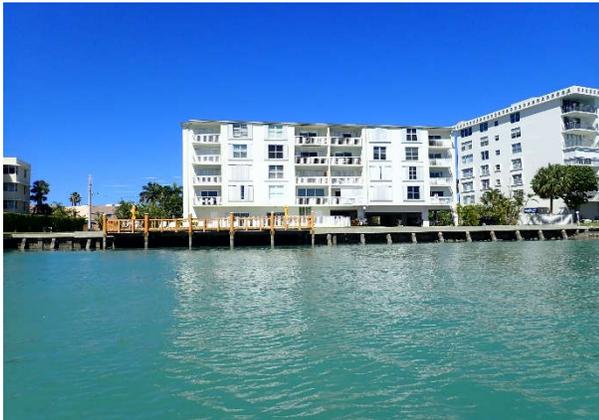
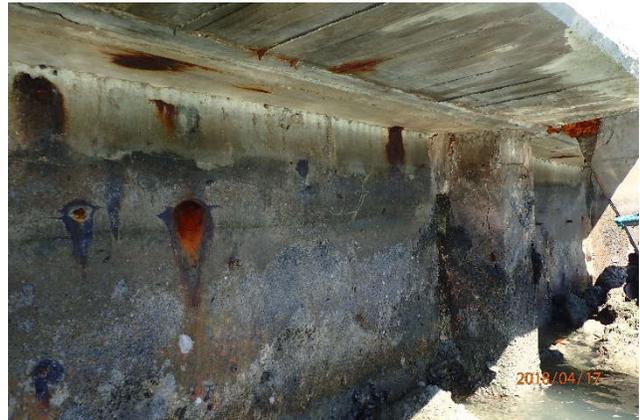
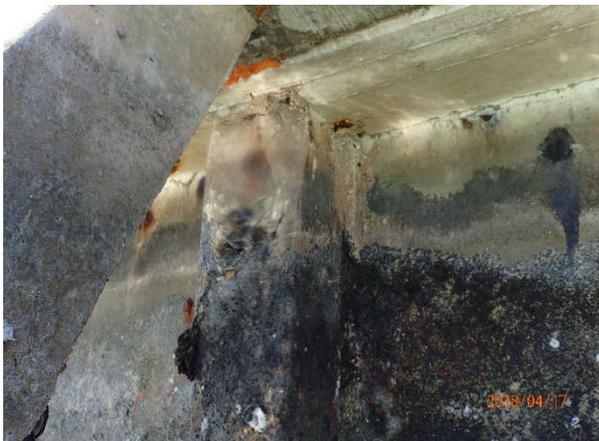
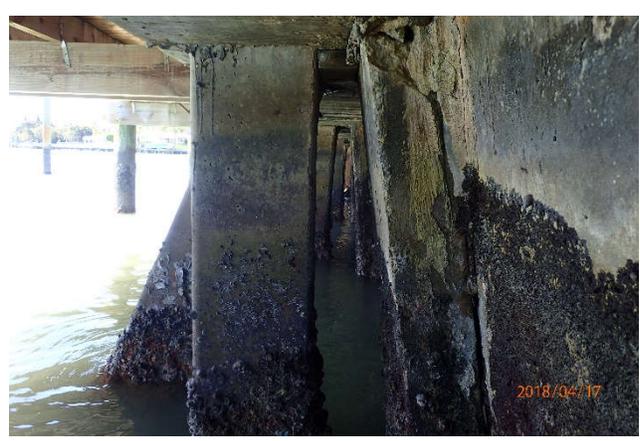
Property Address: 9270 W BAY HARBOR DR  
Bay Harbor Islands, FL 33154  
Location: S-1.1 Lot#65  
Date of Inspection: 4/17/2018 @ 4:20pm

- Wall Panels – Moderate cracking along tops of panels with wall rotation
- King Piles – Moderate cracking
- T-Piles – Necking with moderate to severe cracking
- Dock – Fastener corrosion

• Seawall Rating: Poor      • Dock Rating: Fair

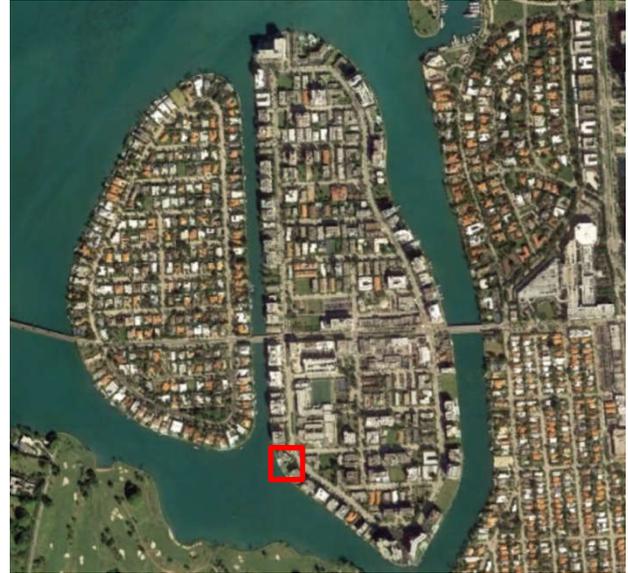
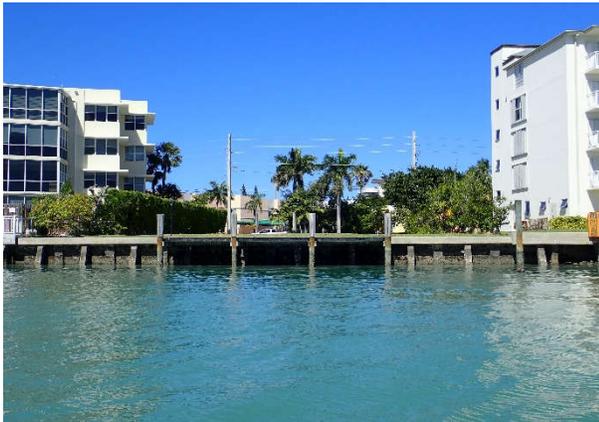
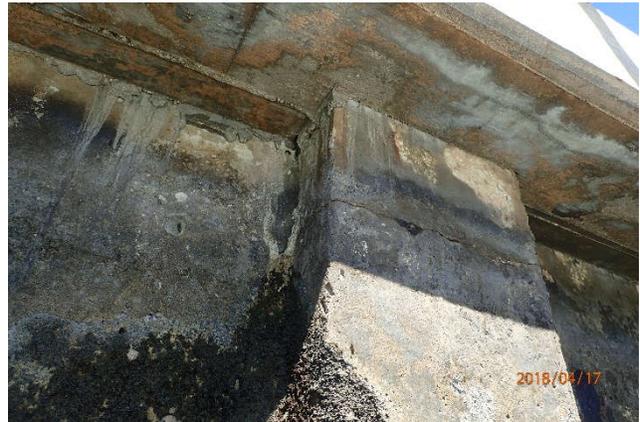
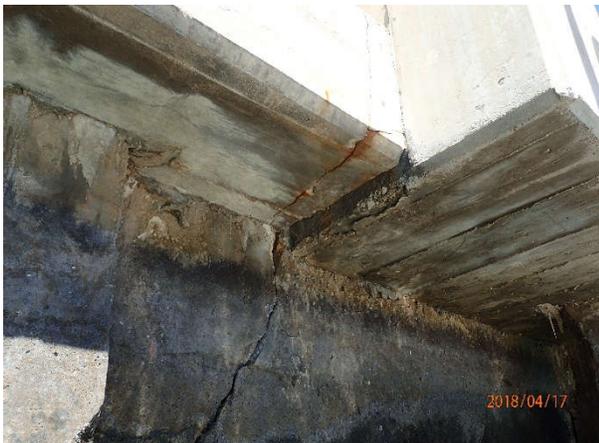
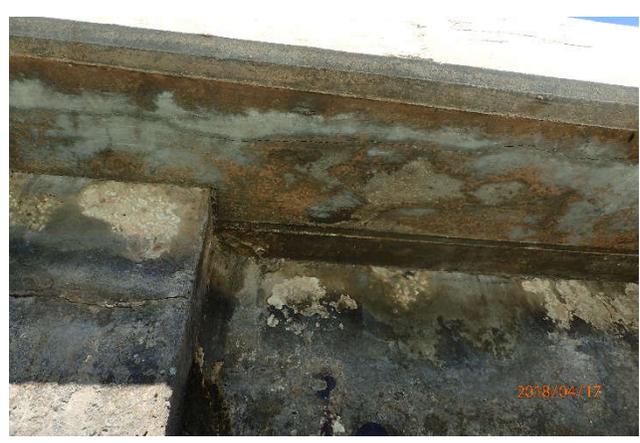
Property Address: 9290 W BAY HARBOR DR  
Bay Harbor Islands, FL 33154  
Location: S-1.1 Lot#66  
Date of Inspection: 4/17/2018 @ 4:10pm

- \*Cap – Cracking at the soffit
- \*Wall Panels – Moderate cracking at soffit
- \*Dock – Moderate to severe corrosion at fasteners

• Seawall Rating: Fair      • Dock Rating: Fair

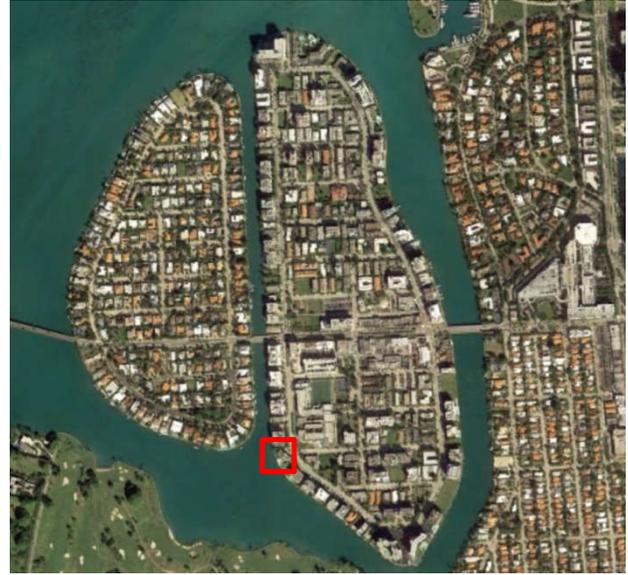
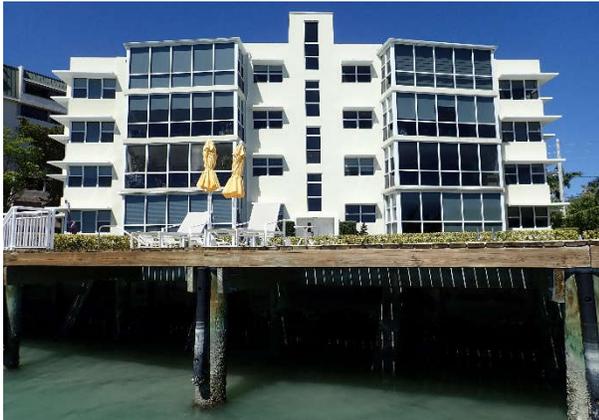
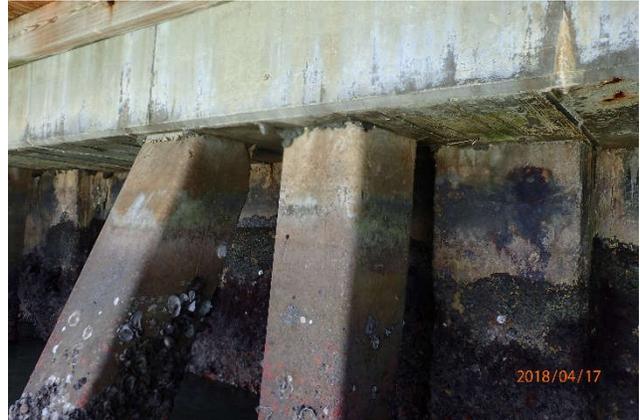
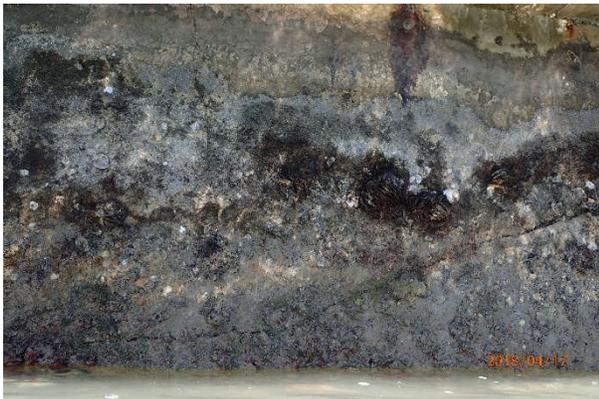
Property Address: 9300 W BAY HARBOR DR  
Bay Harbor Islands, FL 33154  
Location: S-1.1 Lot#67  
Date of Inspection: 4/17/2018 @ 4:00pm

- Batter Piles – Moderate cracking
- Wall Panels – Moderate cracking

• Seawall Rating: Fair      • Dock Rating: Satisfactory

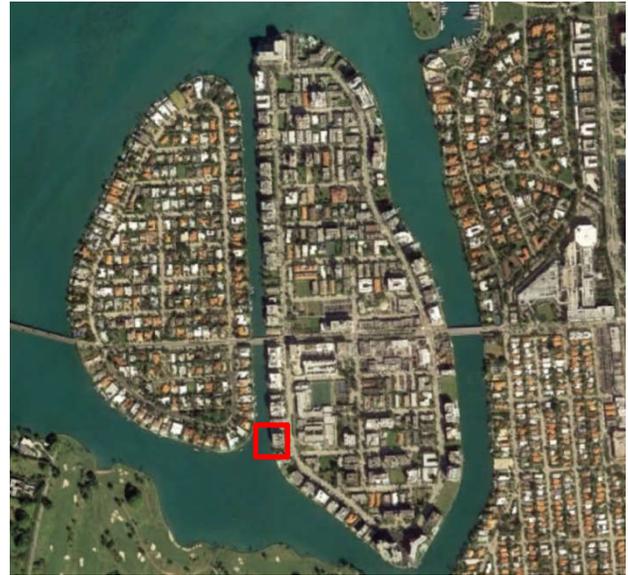
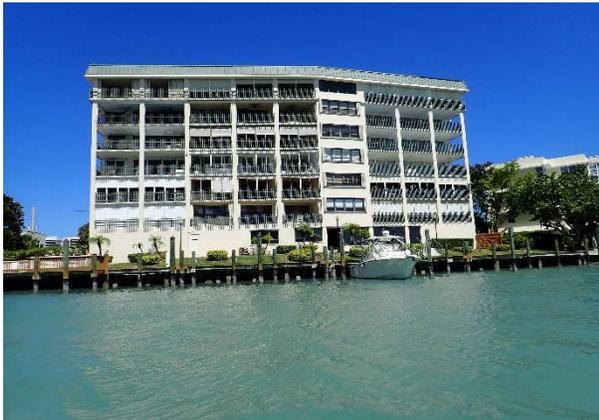
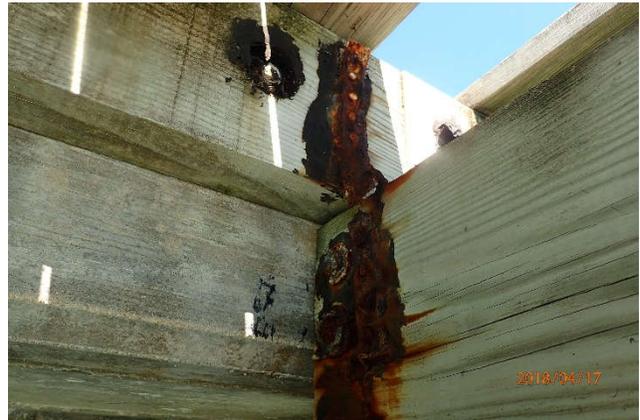
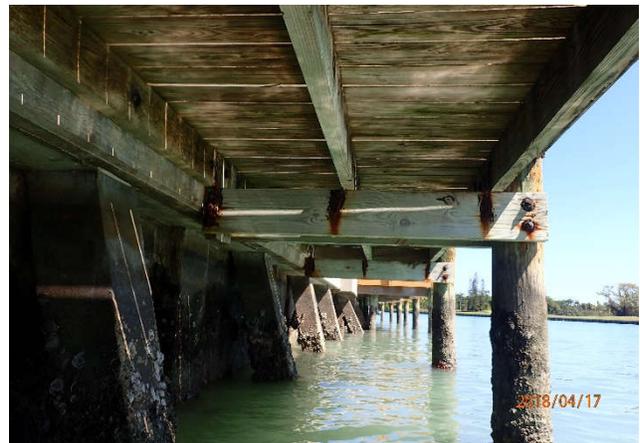
Property Address: 9350 W BAY HARBOR DR  
Bay Harbor Islands, FL 33154  
Location: S-1.1 Lot#68  
Date of Inspection: 4/17/2018 @ 3:50pm

- \*Cap – Cracking at the soffit
- \*Wall Panels – Moderate diagonal cracking along top panels
- \*Dock – Advanced corrosion at fasteners

• Seawall Rating: Fair      • Dock Rating: Poor

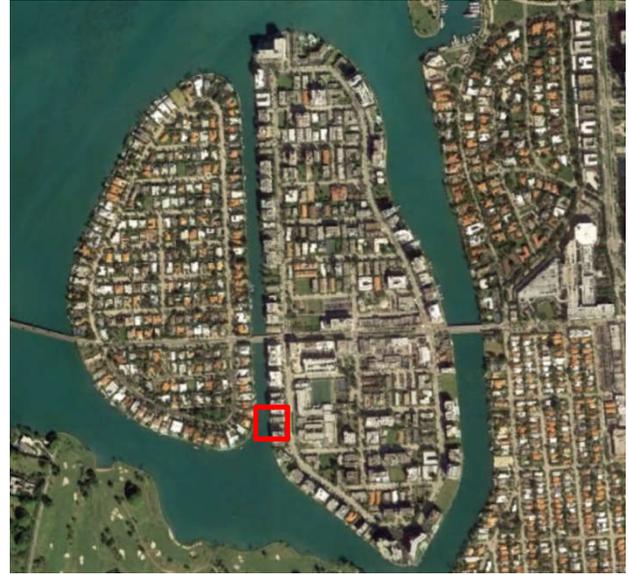
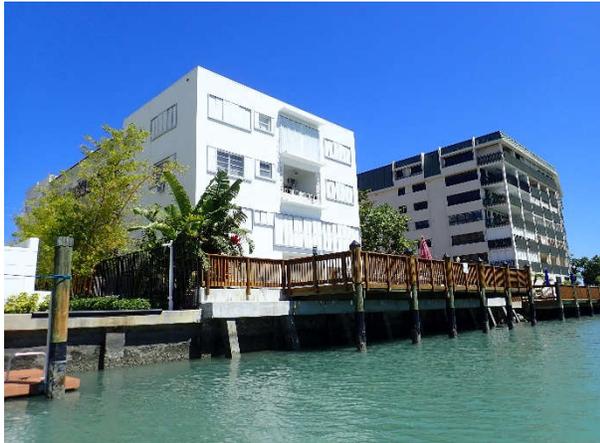
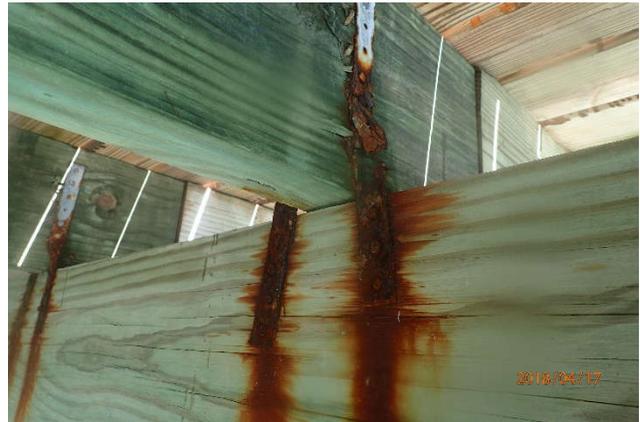
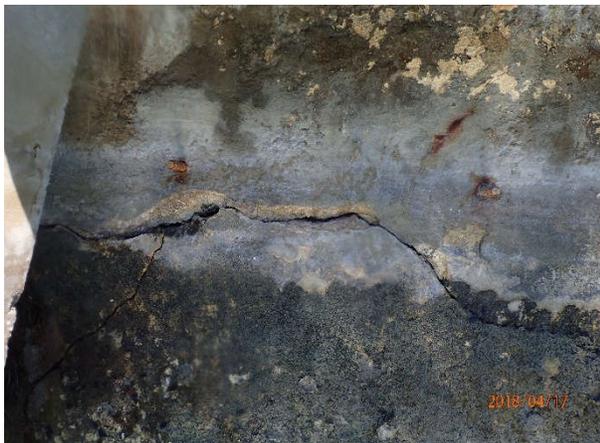
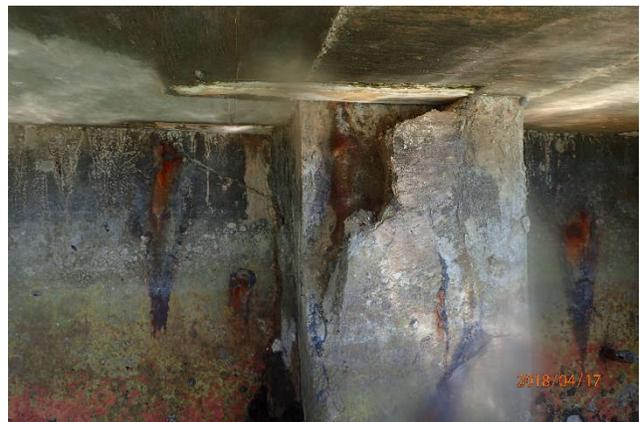
Property Address: 9370 W BAY HARBOR DR  
Bay Harbor Islands, FL 33154  
Location: S-1.1 Lot#69  
Date of Inspection: 4/17/2018 @ 3:50pm

- Wall Panels – Spalling adjacent to outfall
- Wall Panels – Severe cracking at South end
- T-Piles – Moderate cracking at South piles
- T-Piles – Spalling with exposed reinforcement at tops
- Docks: Severe corrosion at straps

• Seawall Rating: Poor      • Dock Rating: Fair

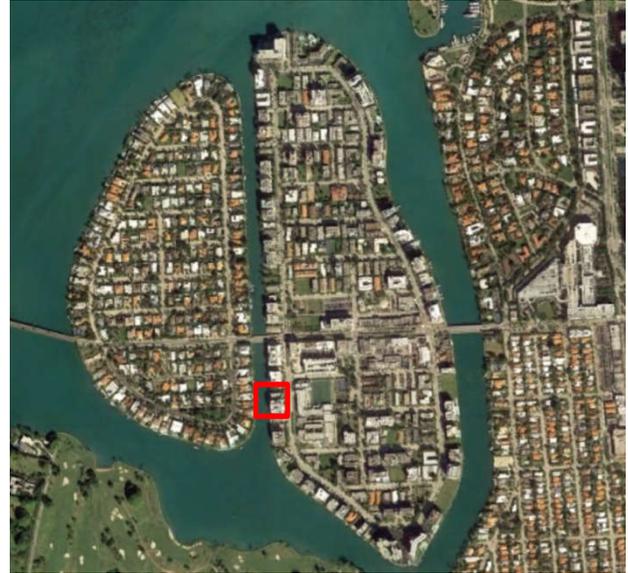
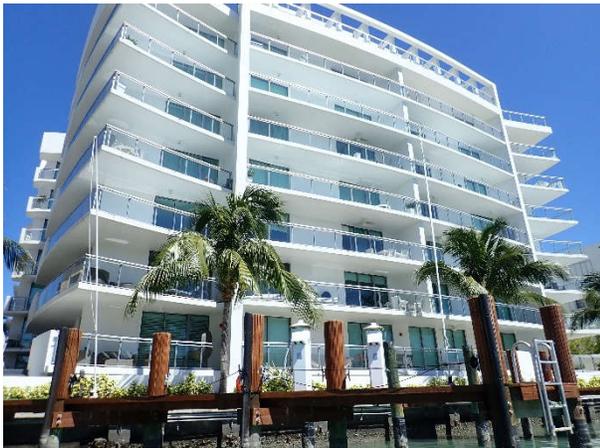
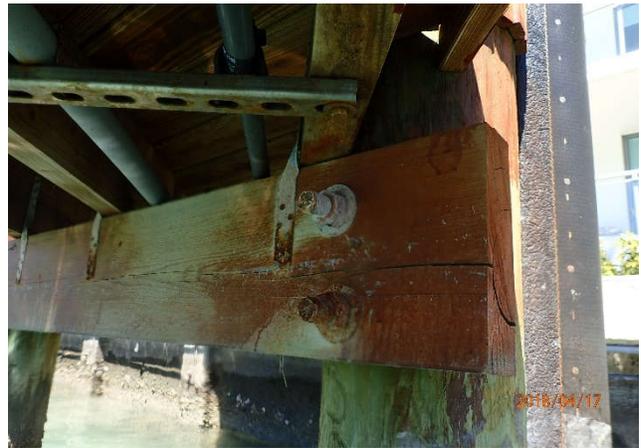
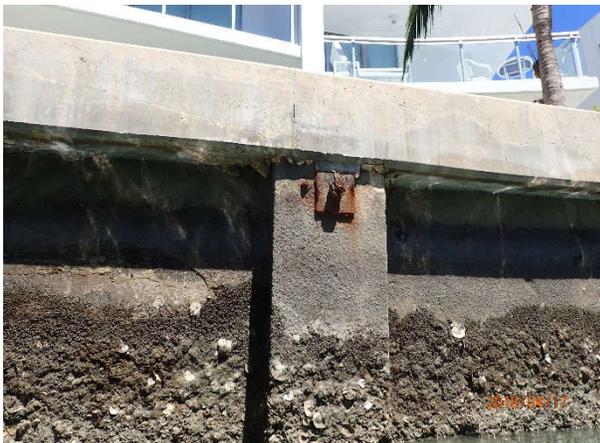
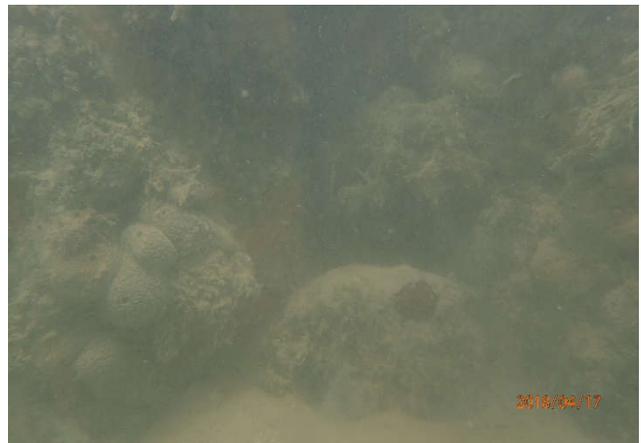
Property Address: 9420 W BAY HARBOR DR  
Bay Harbor Islands, FL 33154  
Location: S-1.1 Lot#70  
Date of Inspection: 4/17/2018 @ 3:40pm

- T-Piles – Moderate deterioration at tidal zone
- Docks – Minor splitting at end connections
- Docks – Hardware corrosion

• Seawall Rating: Fair                      • Dock Rating: Satisfactory

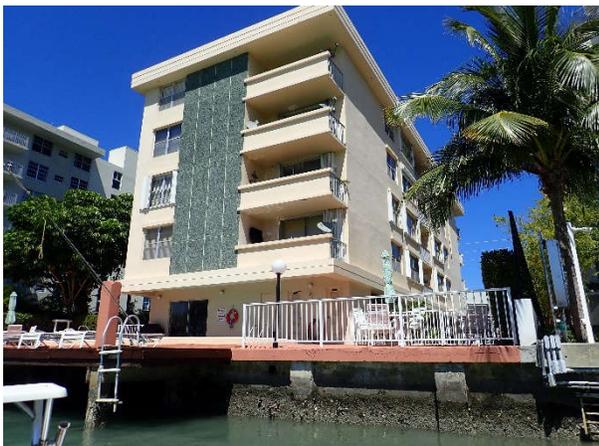
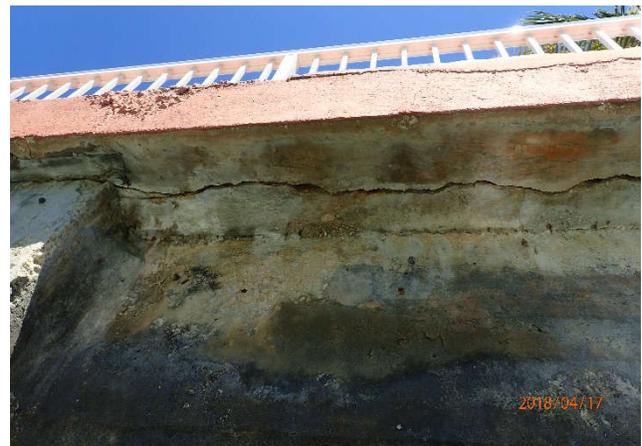
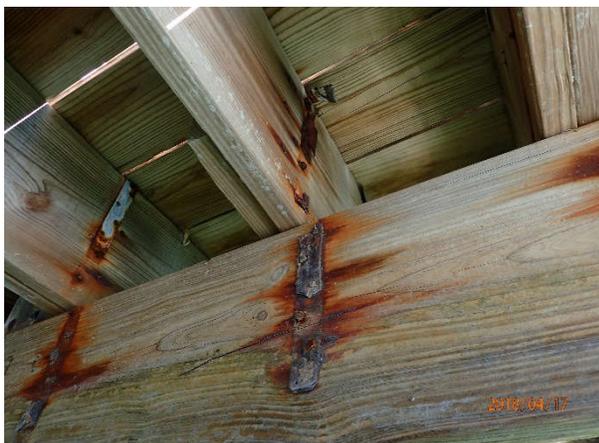
- Cap – Moderate cracking at South soffit
- T-Piles – Sediment accumulation through fillets at seabed
- Docks – Severe corrosion at straps
- Upland depression along North wall

• Seawall Rating: Fair                      • Dock Rating: Fair

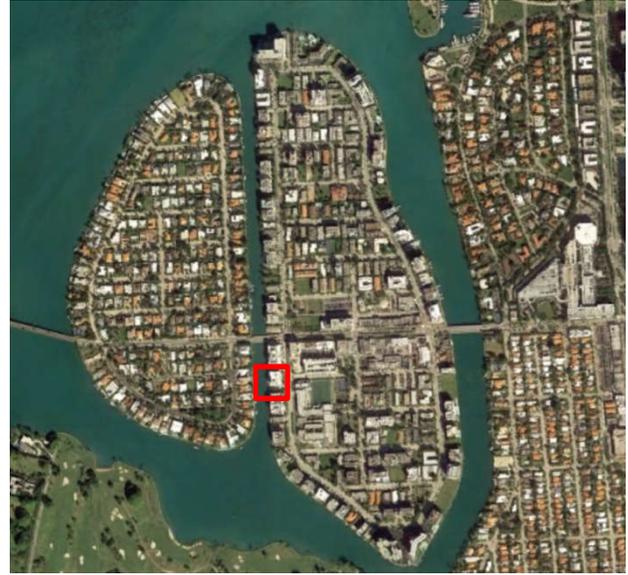
Property Address: 9500 W BAY HARBOR DR  
Bay Harbor Islands, FL 33154  
Location: S-1.1 Lot#72  
Date of Inspection: 4/17/2018 @ 3:00pm

- \*Cap – Minor spalling along cap
- \*Wall Panels – Moderate cracking and spalling along panels
- \*T-Piles – Necking with moderate cracking and spalling
- \*Dock – Severe cracking and deterioration at piles
- \*Dock – Moderate cracking with exposed reinforcement

\* Seawall Rating: Fair                  \* Dock Rating: Poor

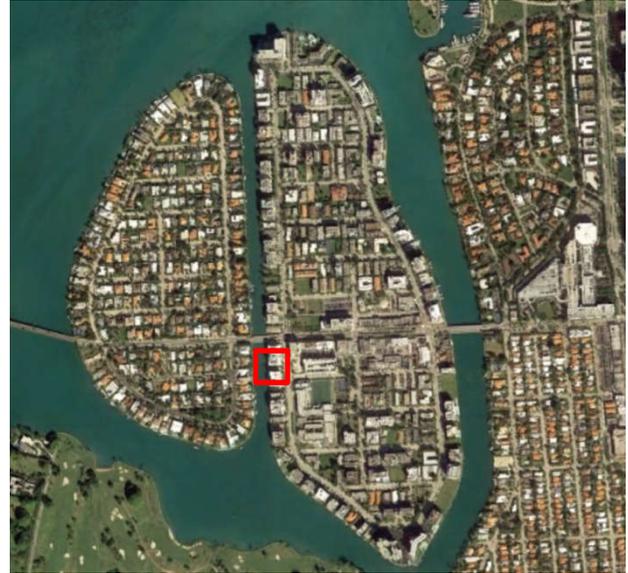
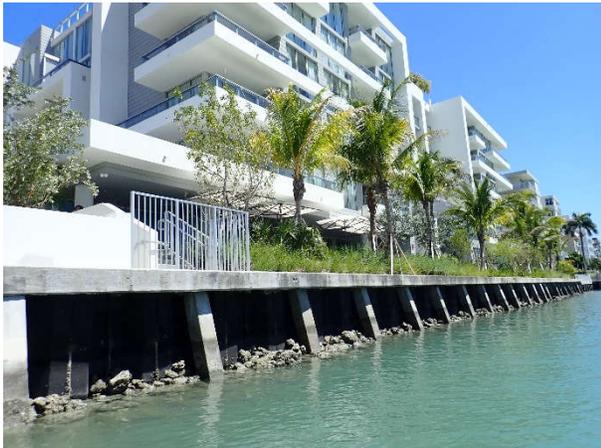
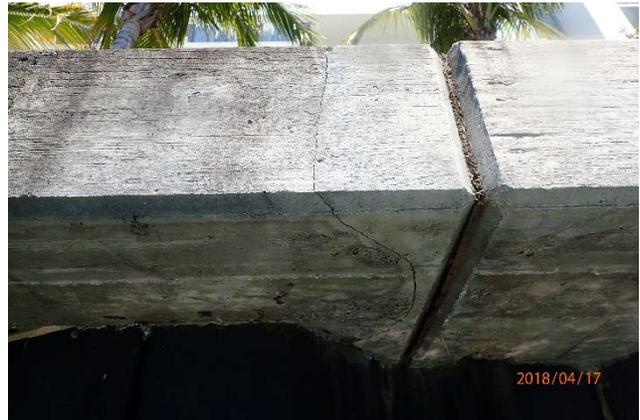
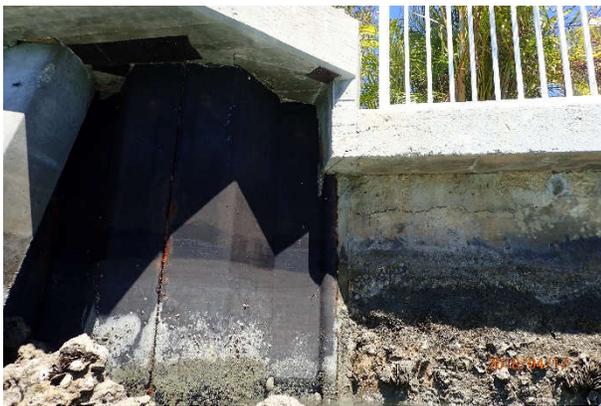
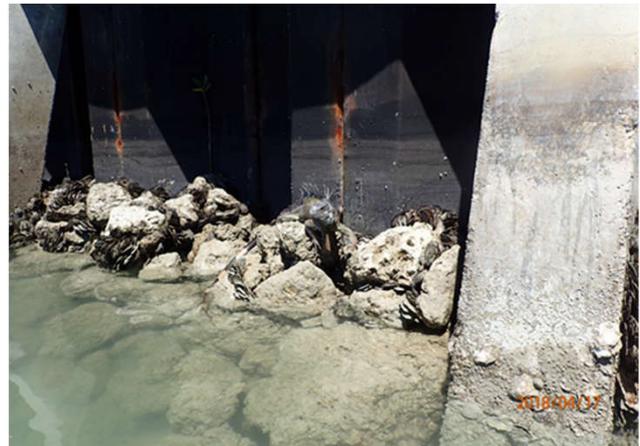
Property Address: 9540 W BAY HARBOR DR  
Bay Harbor Islands, FL 33154  
Location: S-1.1 Lot#73  
Date of Inspection: 4/17/2018 @ 2:40pm

- \*Cap – Minor cracking
- \*Wall Panels – Minor corrosion at splash zone
- \*Batter Piles – Minor cracking at pile heads

• Seawall Rating: Satisfactory      • Dock Rating: N/A

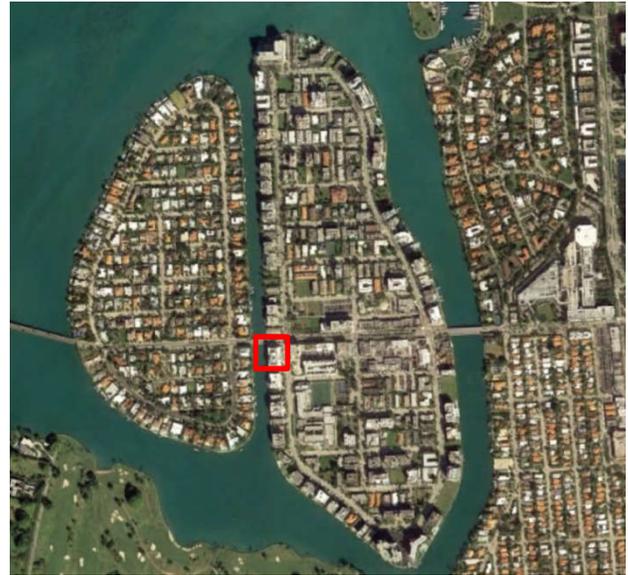
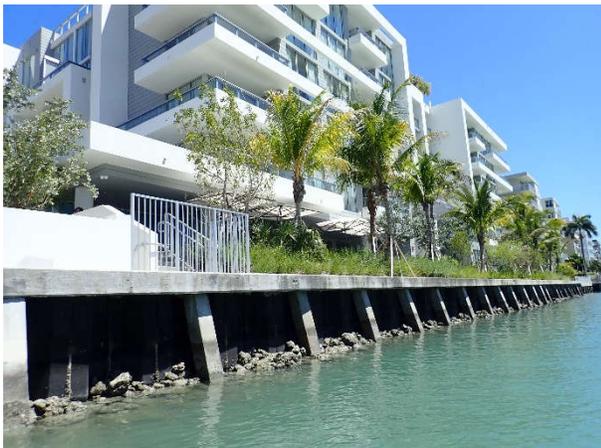
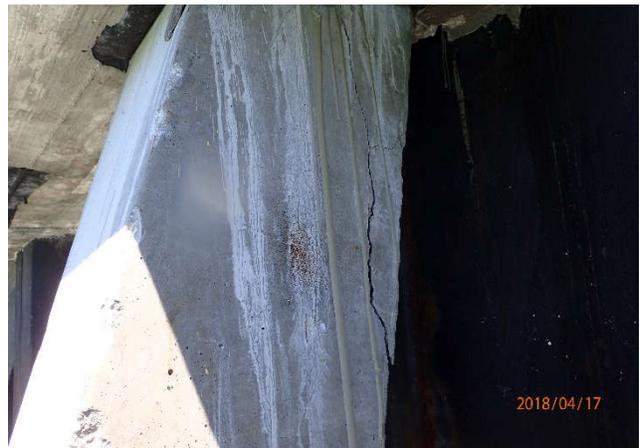
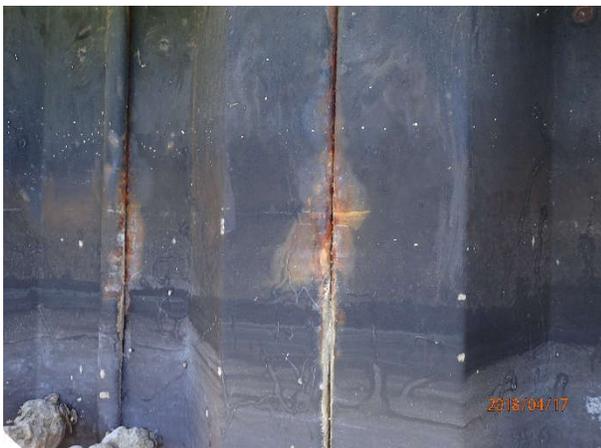
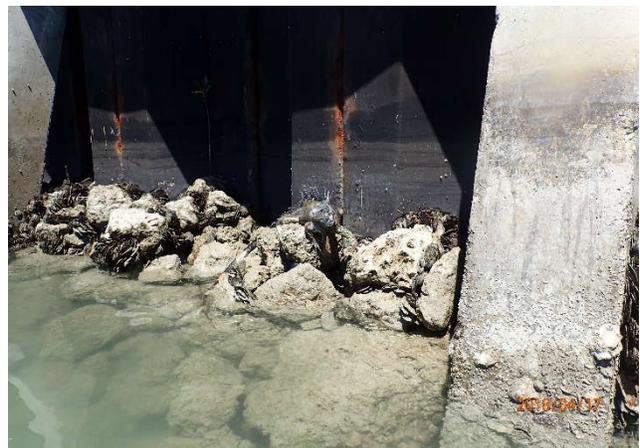
Property Address: 9540 W BAY HARBOR DR  
Bay Harbor Islands, FL 33154  
Location: S-1.1 Lot#74  
Date of Inspection: 4/17/2018 @ 2:30pm

- \*Cap – New Construction
- \*Batter Piles – Cracking at pile heads
- \*Minor corrosion of sheet piles in splash zone

• Seawall Rating: Satisfactory                      • Dock Rating: N/A

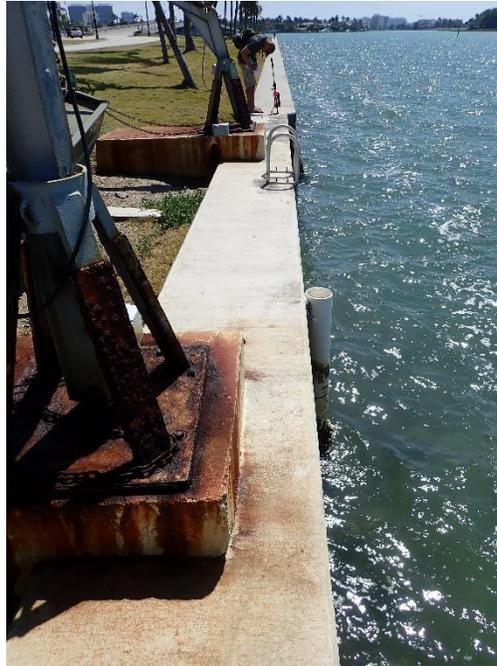
**Photo C.1: View of boat lift adjacent to Station 39+75' exhibiting heavy corrosion**

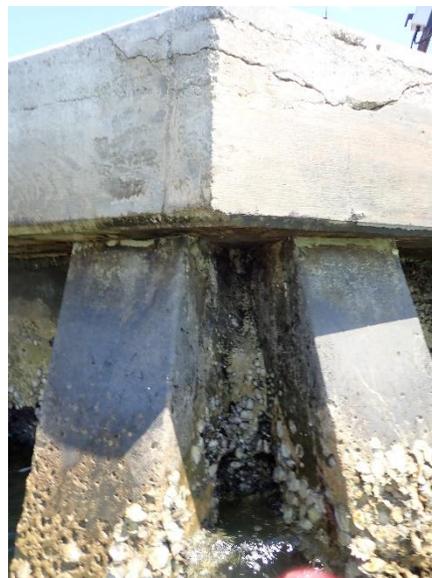
**Photo C.2: Cracking at the wet face of the cap at the return wall junction adjacent to Station 39+50'**

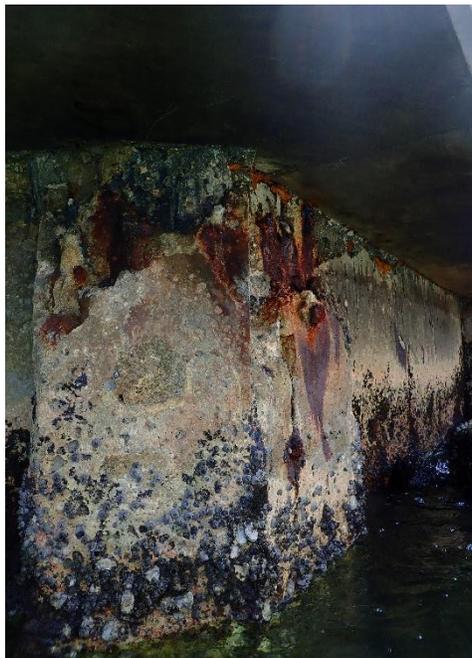
**Photo C.14: Severe deterioration at concrete piles with exposed steel reinforcement at North seawall**

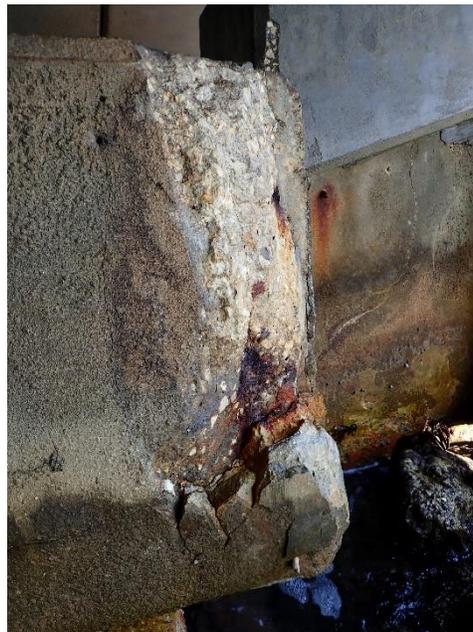
**Photo C.16: Spalling with exposed steel reinforcement at South East corner of West bridge bulkhead**

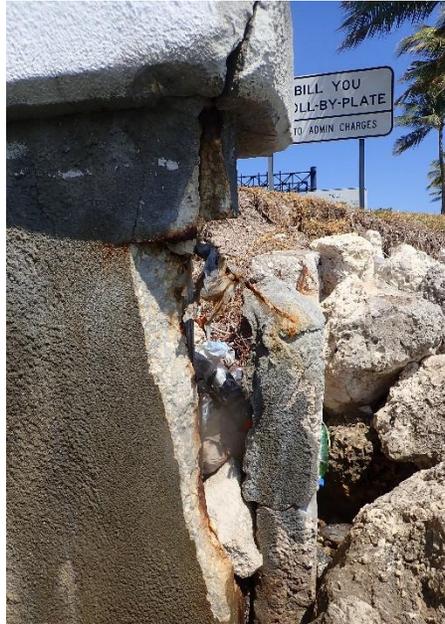
**Photo C.17: Severe concrete deterioration and section loss with exposed steel reinforcement at South bulkhead at West bridge seawall**

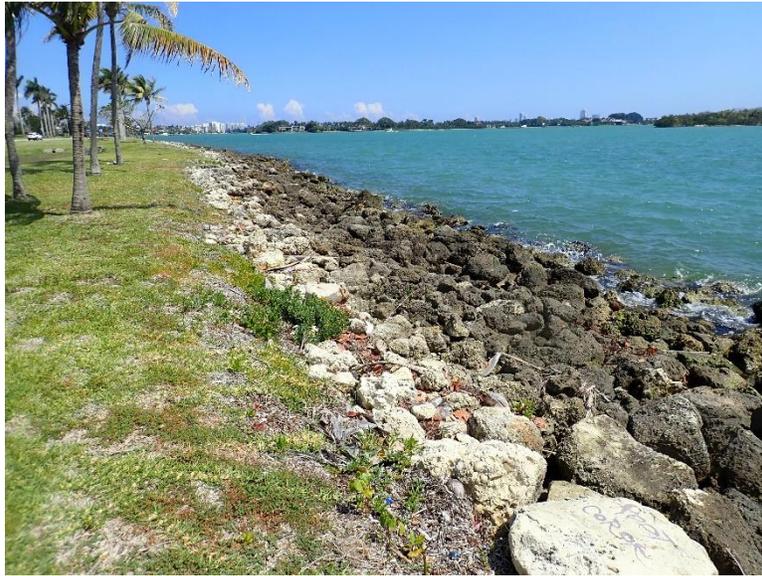
**Photo C.19: View of flat rock revetment along South shoreline**

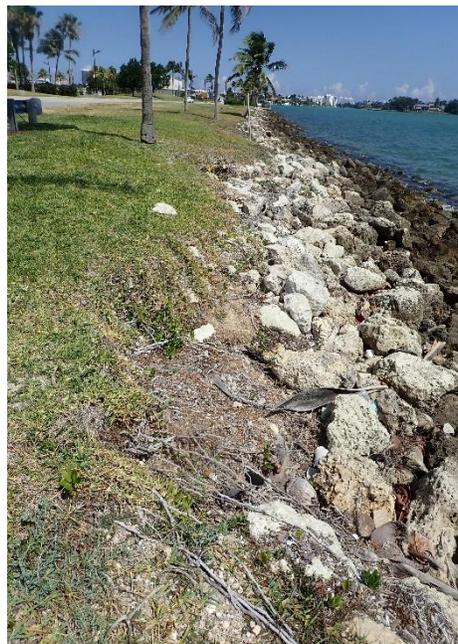
**Photo C.20: View of shoreline erosion and washout along South shoreline rock revetment**
